**CITY OF ALBANY
PARKS RECREATION AND OPEN SPACE COMMISSION AGENDA
STAFF REPORT**

SUBJECT: Street Tree Removal Applications

Tree Risk Assessment

**1444 Portland Avenue
Albany, CA**

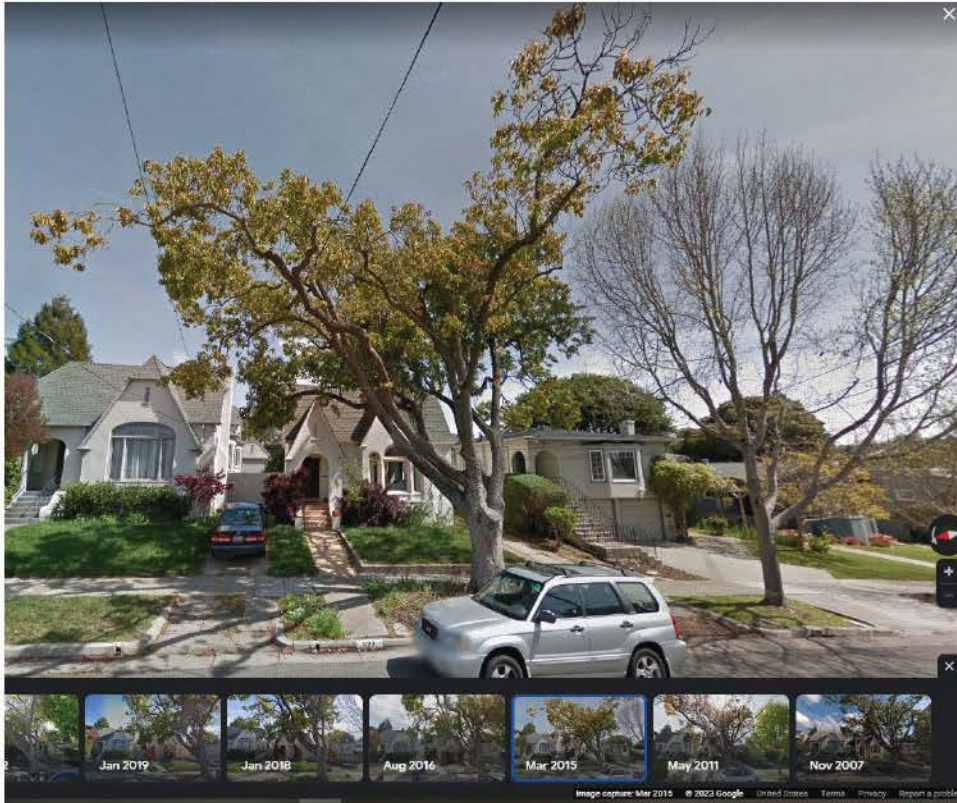
March 2015

A review of photos from Google Maps shows that the tree's canopy has increased over time.

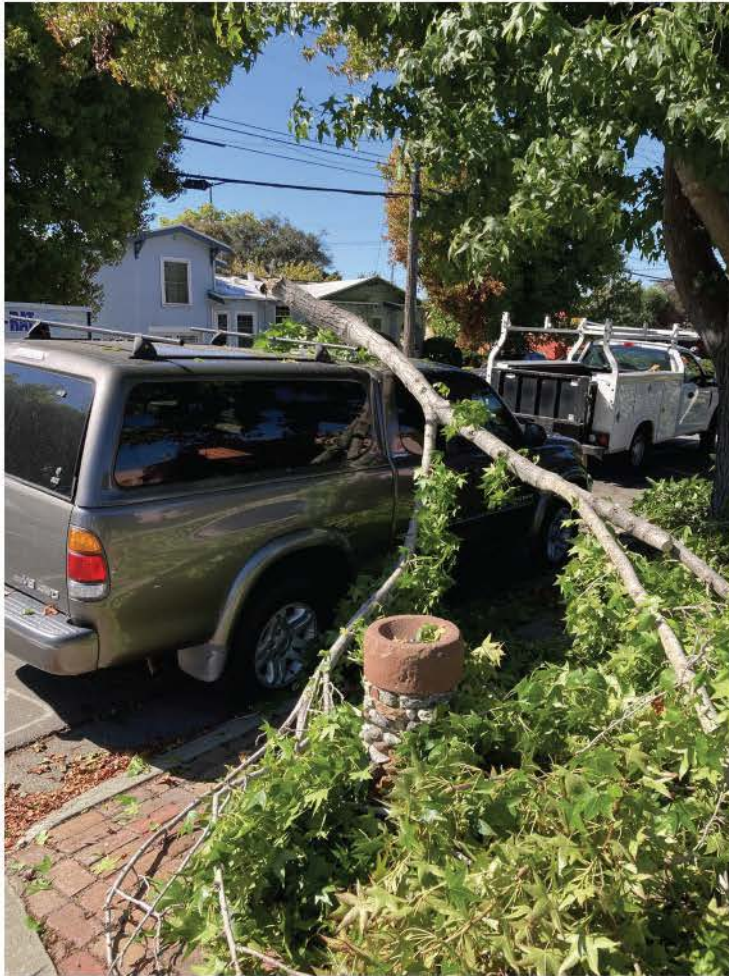
A Tree Risk Assessment for this tree was performed by HortScience which found the tree to be in fair condition (Attachment 5). The assessment recognized the tree’s poor structure due to multiple stems emanating from a single area of the tree, a history of limb failure, and the wounds caused by failed limbs which are difficult if not impossible to correct through pruning or other management strategies. Also noted were large surface roots that fill the tree basin. The assessment recommends replacing the tree with a more appropriate species.

After reviewing the tree and the Tree Risk Assessment from HortScience, staff determined that removal and replacement is the best course of action for this tree. Pruning to correct the affected areas and potential risk would be impossible due to the tree's large wounds from limb failures and its long-standing structural issues.

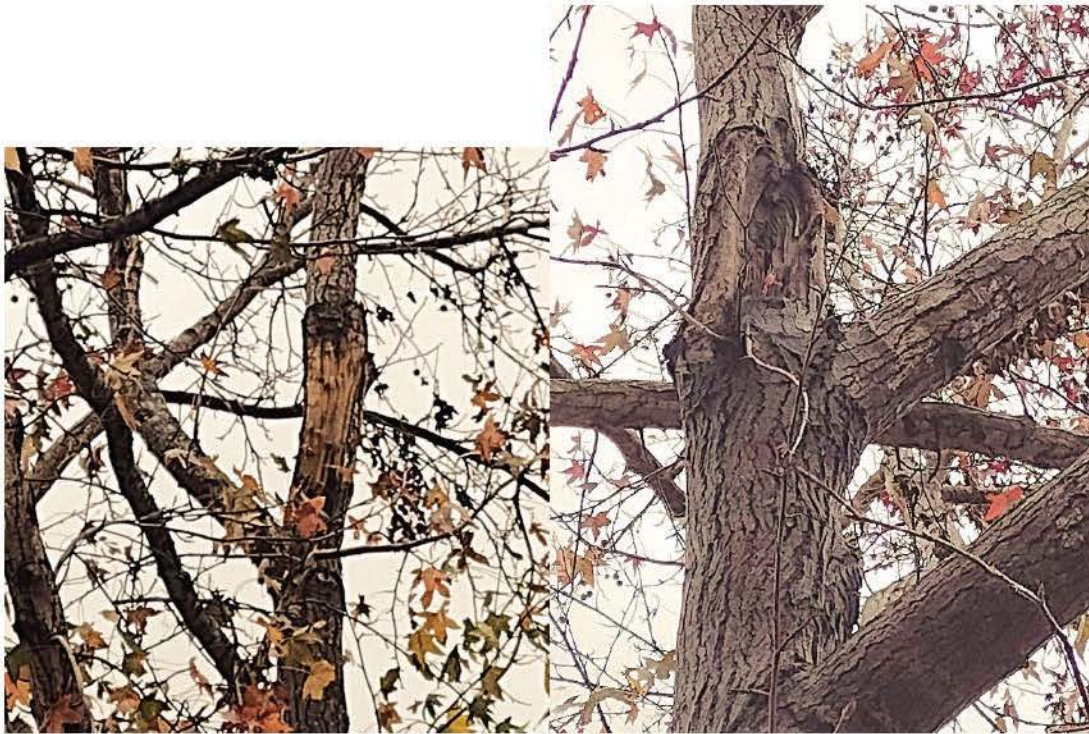
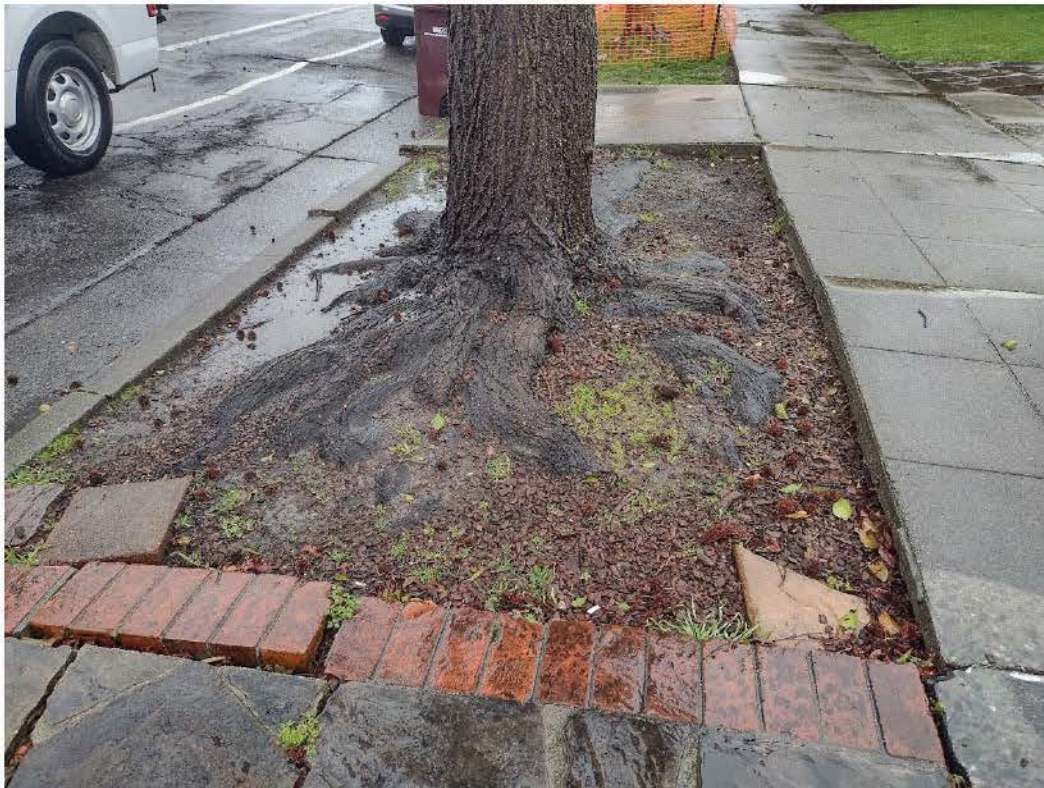
Staff assessment of this tree indicates that the tree had dropped two large limbs within 4 months of each other. The first limb fell in September 2022, attributed to Sudden Limb Drop, and caused damage to the owner's vehicle. The second limb failure occurred in January 2023. Repeated limb drop is an indicator that this tree is in decline. A previous limb failure occurred in 2020. There have been other limb failures in the past as seen in part by tear wounds that are visible on the trunk. A more recent wound encompasses about half the diameter of the main stem, leaving this tree prone to further and more serious breakage. Another, older tear has some wound wood formation but around an area of decay.

The tree's roots have filled the approximately 10' x 5' tree basin. Some past repairs have been done to the sidewalk to remediate root damage. The damage continues along the sidewalk, driveway, curb, and street as large structural roots continue to expand.

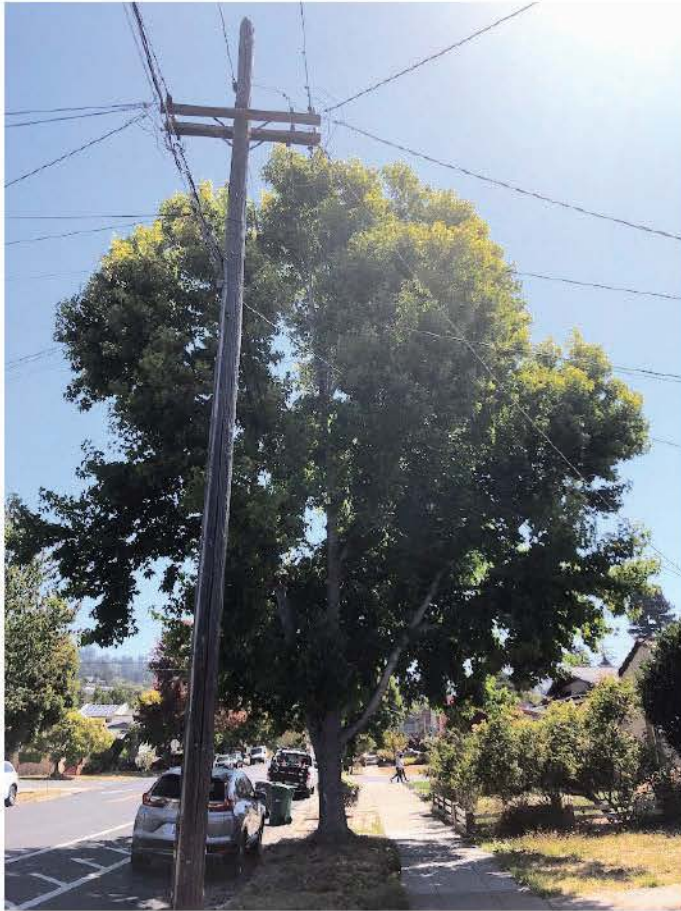
A Tree Risk Assessment for this tree was performed by HortScience who found the tree to be in fair condition overall with good vigor (Attachment 8). Tree risk was assessed as being low, with the tree having good structure and branching unions, stating that pruning could address some of the concerns and recommend preserving the tree.

Staff assessment indicates that the tree had dropped a small limb following pruning by PG&E for powerline clearance in May 2022. As well, the property owner was concerned about surface roots in his front yard, and a lateral limb extending towards his property and contacting his neighbor's electric service drop.

After reviewing the tree, staff determined that pruning, including removing the section contacting the service drop, will help stabilize the tree. The tree was pruned on April 22, 2023.

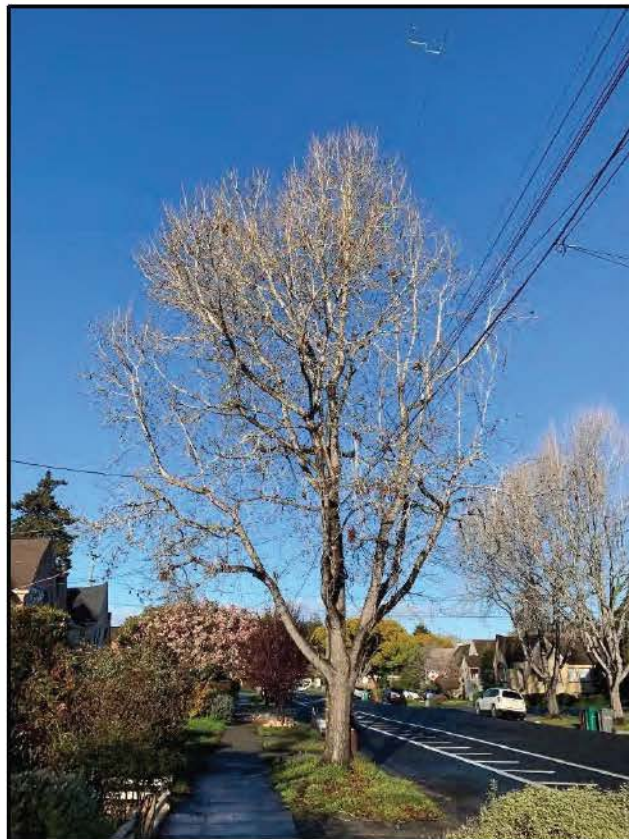
The mature sweetgum measured 19 inches in diameter, growing in the parkway between the sidewalk and the street. The tree was in fair condition overall with good vigor. It had a decurrent structure typical of the species. Several upright branches swept upwards with well-developed lateral branching. Three secondary electrical distribution lines and communication lines ran through the crown along the street.

Photo 1: Sweetgum in front of 1444 Portland Avenue was in fair condition with a vigorous crown and decurrent structure.

Based on my observations and assessment, I recommend preserving the tree.

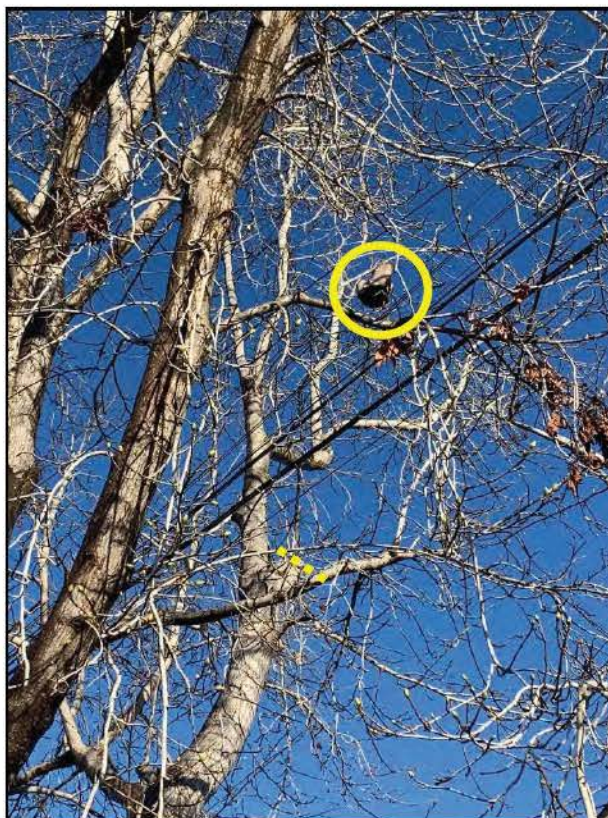
The tree had been pruned for secondary distribution line clearance, removing one approximately 6-inch diameter branch that had engulfed the street-side line (Photo 2). A small, approximately 2-inch diameter branch failure was present below the cut. The same line was touching a small, approximately 3-inch diameter branch. No line-deflection was evident to signify heavy loading pressure on the line. The other two secondary lines ran through the crown without touching branches.

Photo 2: A branch had been removed on the north side of the crown that had engulfed a secondary distribution line (yellow dash at cut point). A small piece of the branch was left (yellow circle).

If desired, branches in contact with either the secondary line or the electrical service drop may be easily pruned to mitigate the conflict. Before pruning away from the service drop, contact PG&E for an Electric Service Temporary Disconnect (<https://tinyurl.com/Temporary-Disconnect>) to make conditions safe for the Arborist. Only a line-clearance qualified Arborist shall prune branches away from the secondary lines. PG&E contractors may provide this service at no cost to the homeowner. More information can be found online (<https://tinyurl.com/2zf87nyv>).

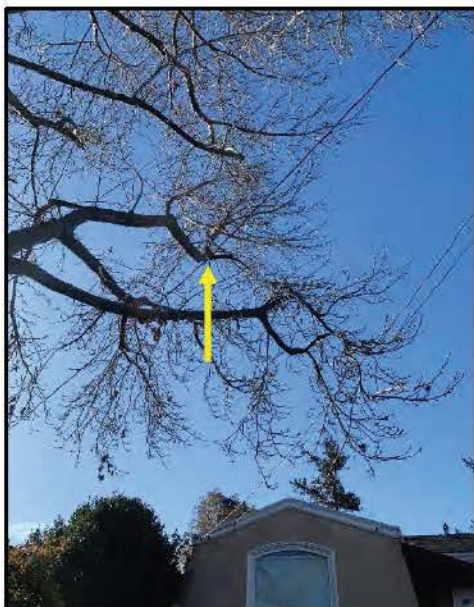
Photo 3: The electrical service drop for 1446 Portland Avenue was contacting a small branch on the south side of the tree (yellow).

The electrical service drop to 1446 Portland Avenue was contacting an approximately 3-inch diameter branch (Photo 3). No line-deflection was evident to signify heavy loading pressure on the line.

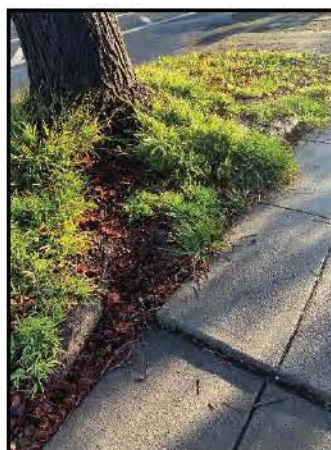
The tree had heaved the sidewalk upwards by approximately 1-inch at the trunk (Photo 4).

Photo 4: A root had displaced the sidewalk by approximately 1-inch.

The small sidewalk displacement may be mitigated by grinding down the heaved panel. Damage should be reassessed periodically as the tree ages.

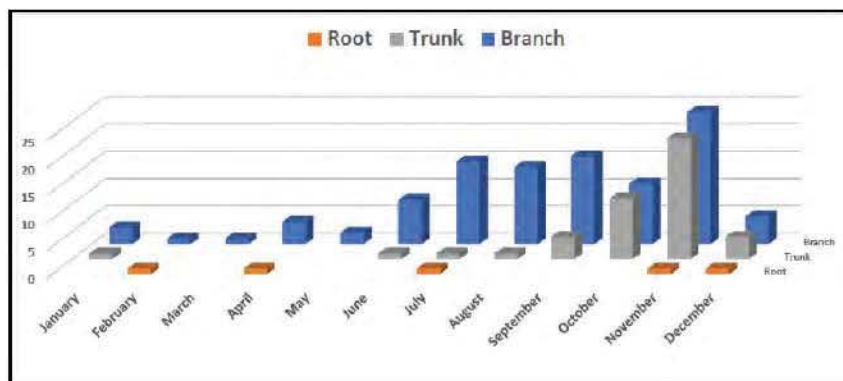
According to data from the Western Tree Failure Database, two-thirds of sweetgum failures are branches. The large majority of branches fail between June and November (Figure 1). The species is known to experience sudden limb drop where green, healthy, defect-free branches fail during normal weather. One small branch has failed on this tree in the past. Given this context, the likelihood of a live branch failure over the two-year timeframe was *possible*.

Failure 1: Western Tree Failure Database depiction of the times of year that sweetgums fail, categorized by tree part.

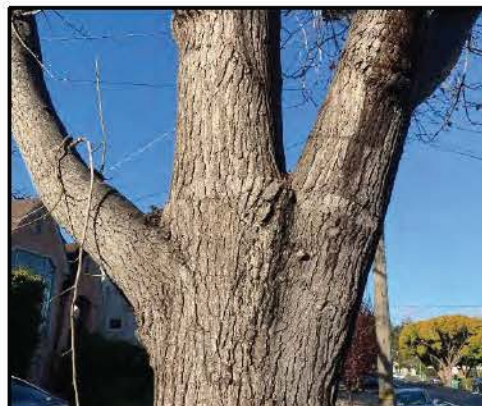
I assessed the likelihood of failure of the large stem on the street side of the tree in front of 1444 Portland Avenue as *improbable*. While several stems arose from a single point on the trunk, the attachment angles were strong and no included bark was present. Holding wood had formed to reinforce the attachments (Photo 5). No evidence of decay was visible.

Photo 5: Close up of the stem attachment, looking west.
