# Item 5-1. Pavement & Curb Rehabilitation Project – Marin Ave Phase 2

Presentation on Potential Tree Removals

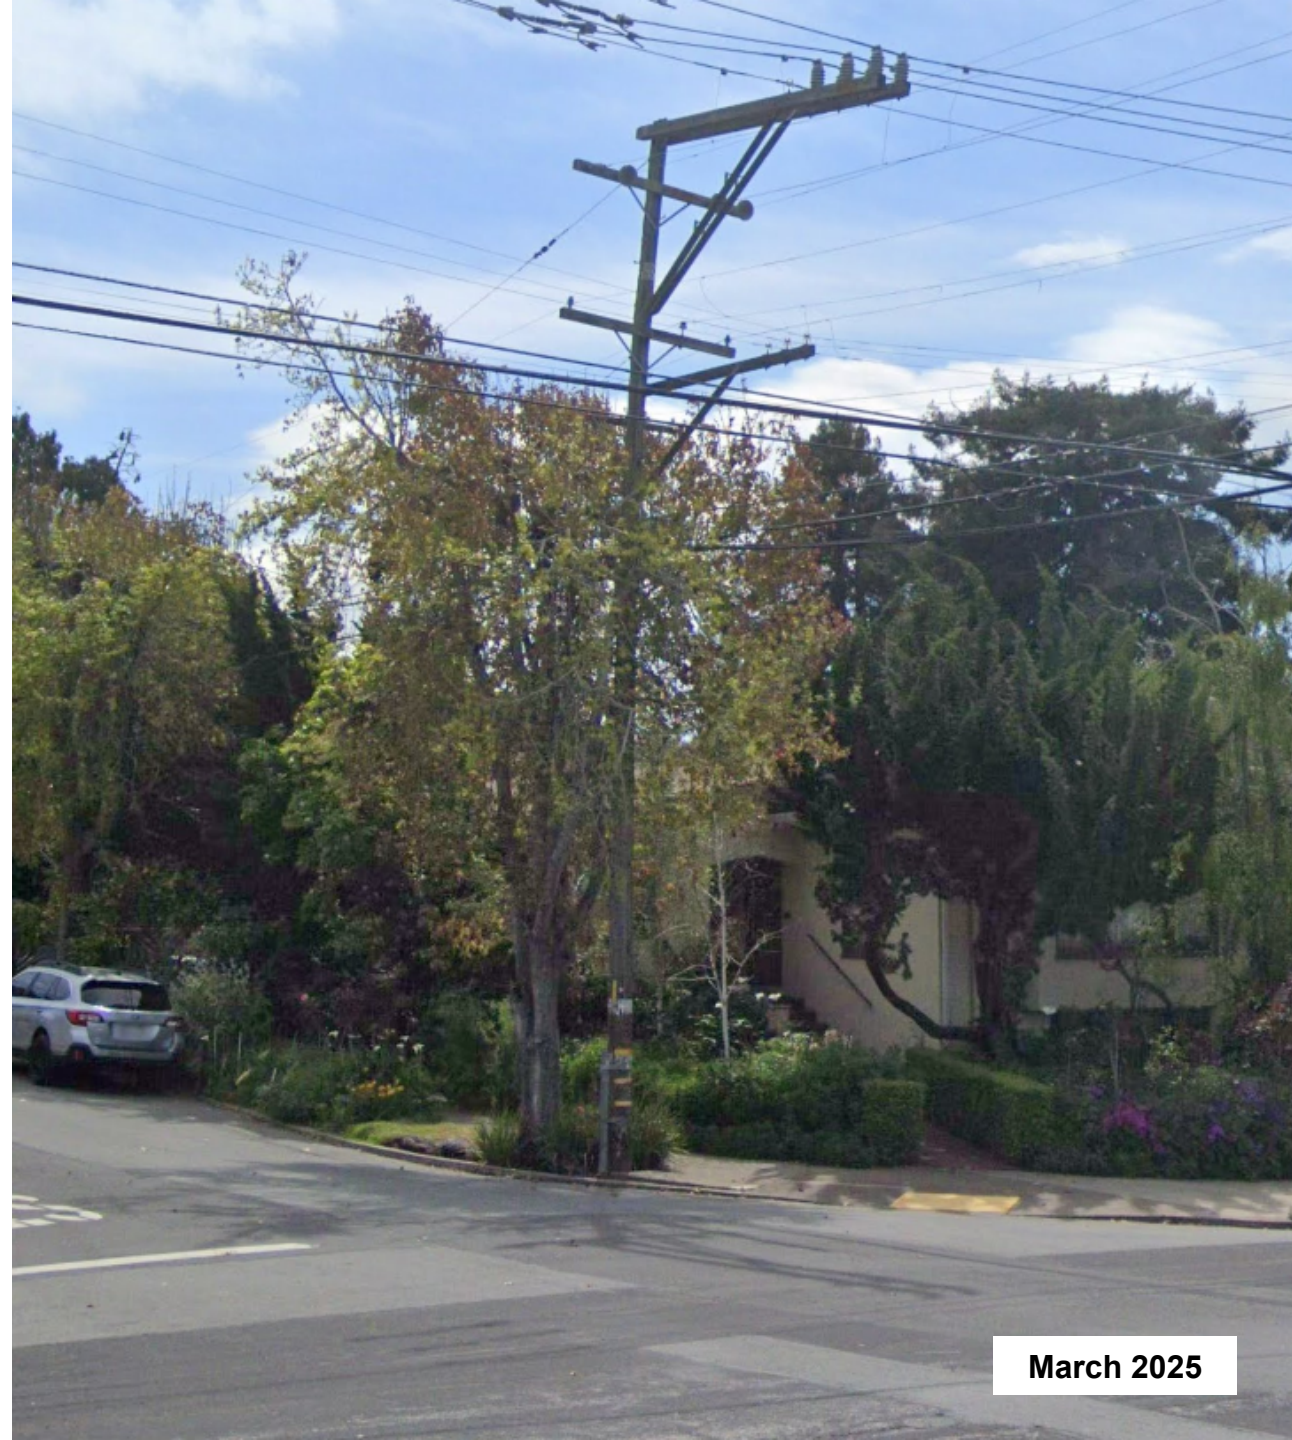
# Tree ID #2824

Liquidambar 18" DBH

Tree Condition: **Poor**

Location: 1498 Marin (on Neilson)

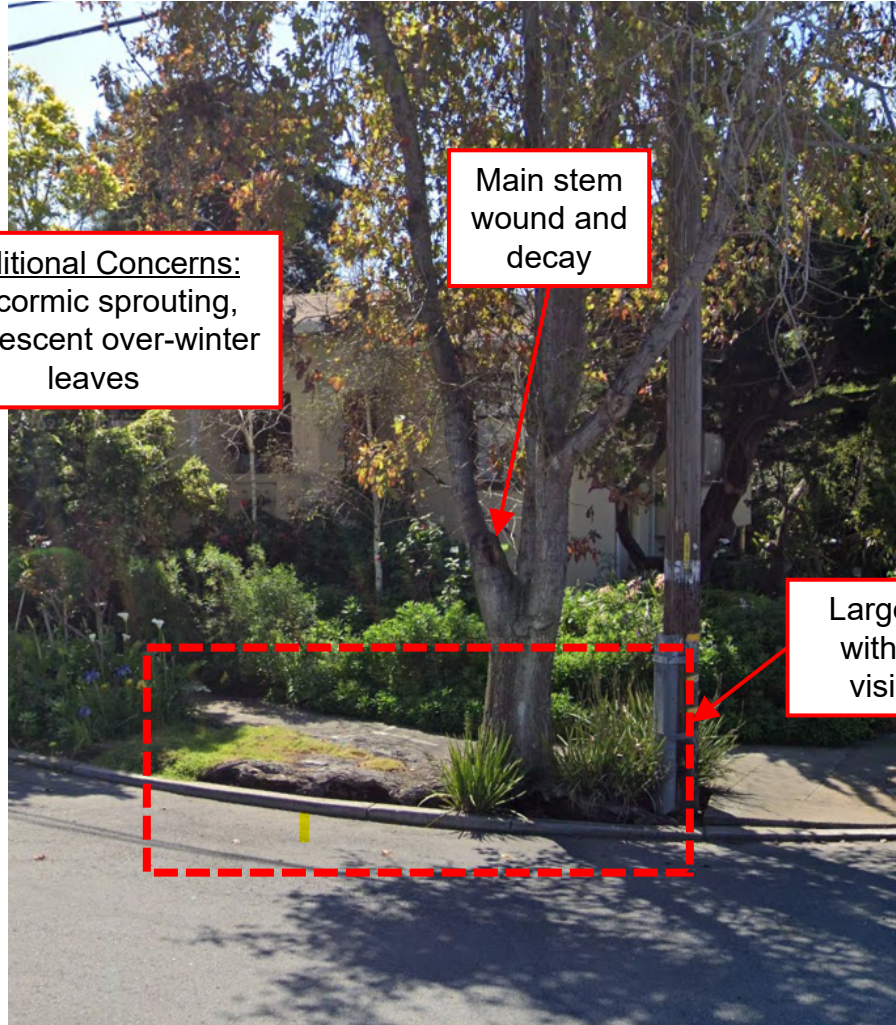
# Tree ID #2824 (at 1498 Marin)

Additional Concerns:  
Epicormic sprouting,  
Marcescent over-winter  
leaves

Main stem  
wound and  
decay

Large root plate  
with extensive  
visible decay

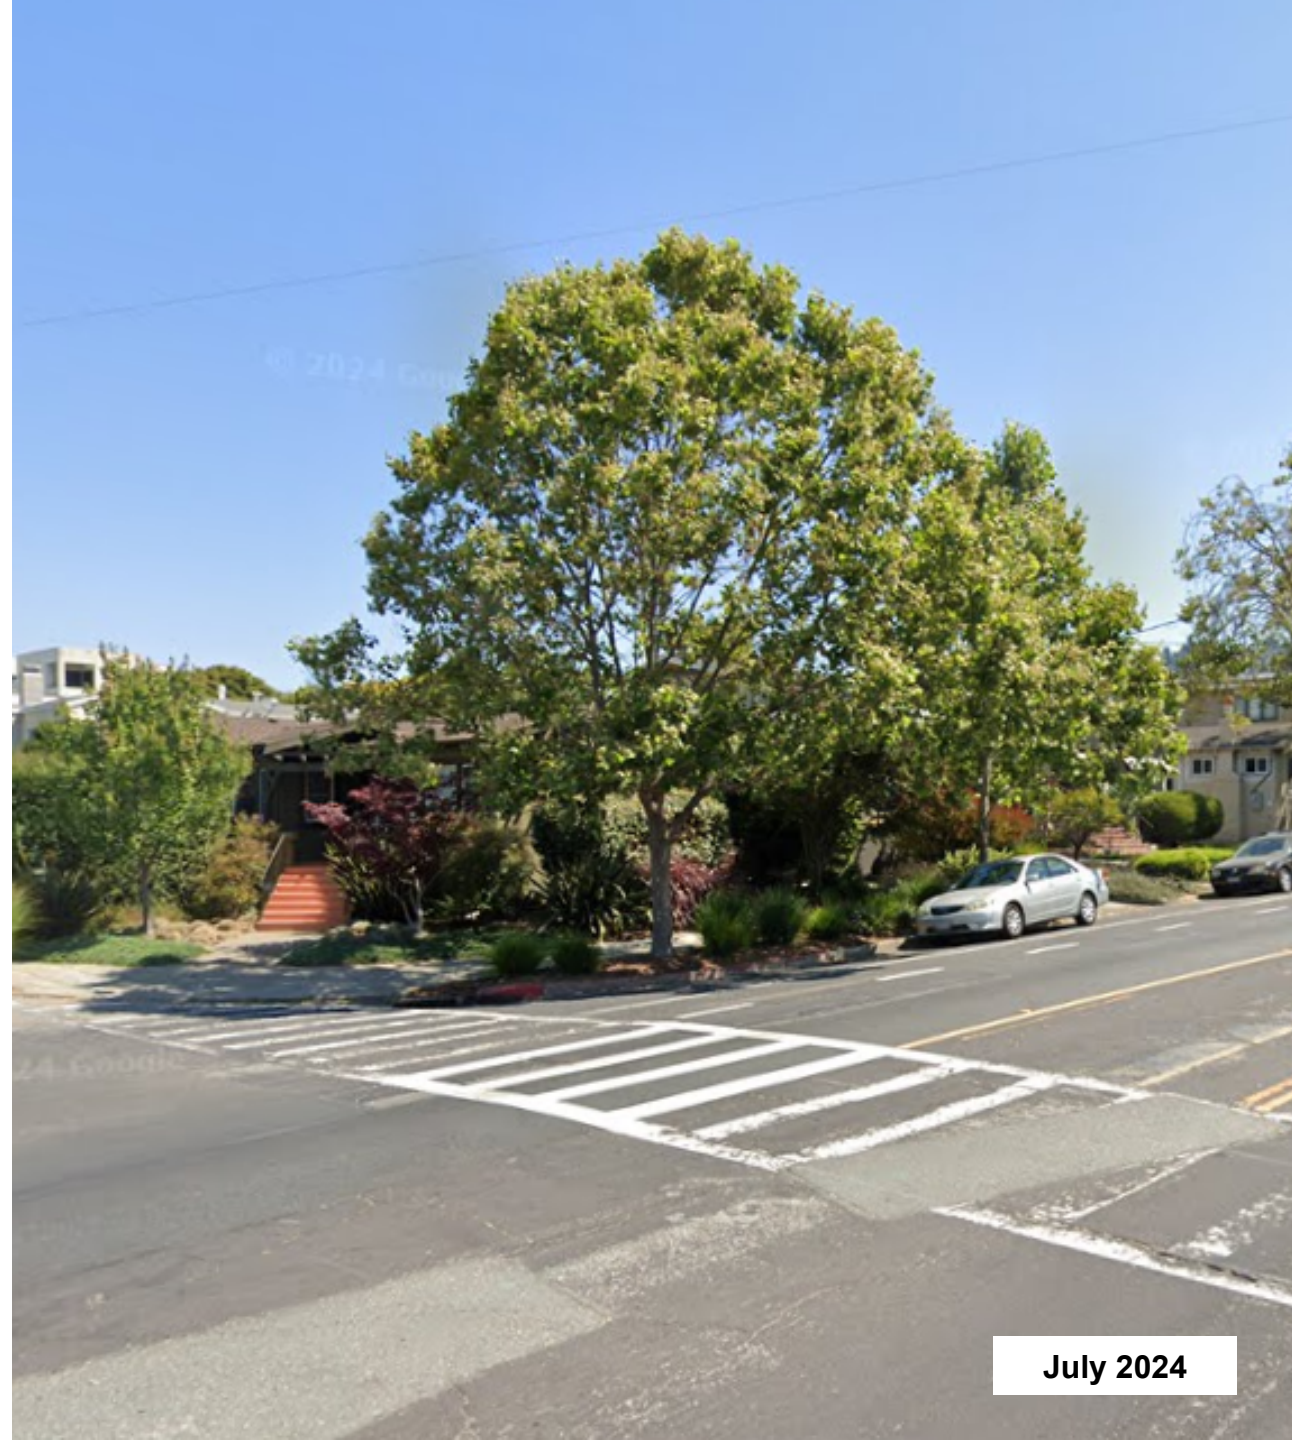
# Tree ID # 1639

London Plan Tree 12" DBH

Tree Condition: **Fair**

Location: 1501 Marin

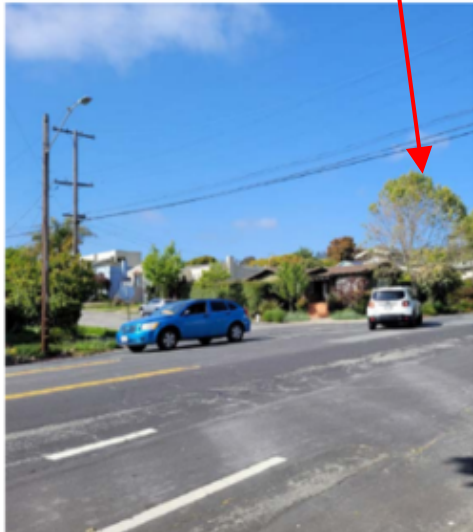
Tree #1639

SITE PHOTO: DAY

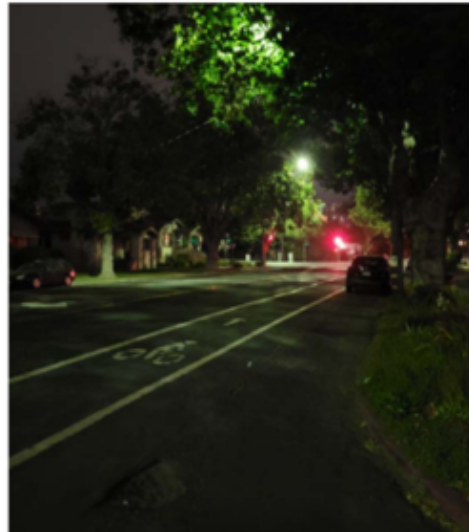
Tree #1639

SITE PHOTO: NIGHT

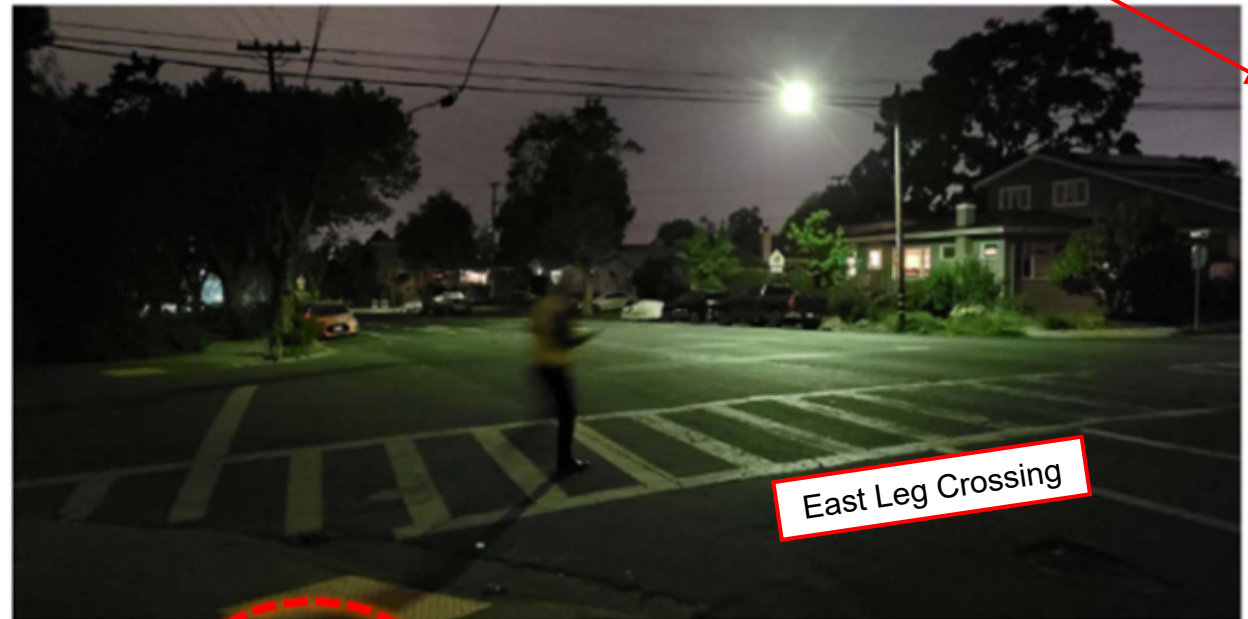
SITE PHOTO: POOR

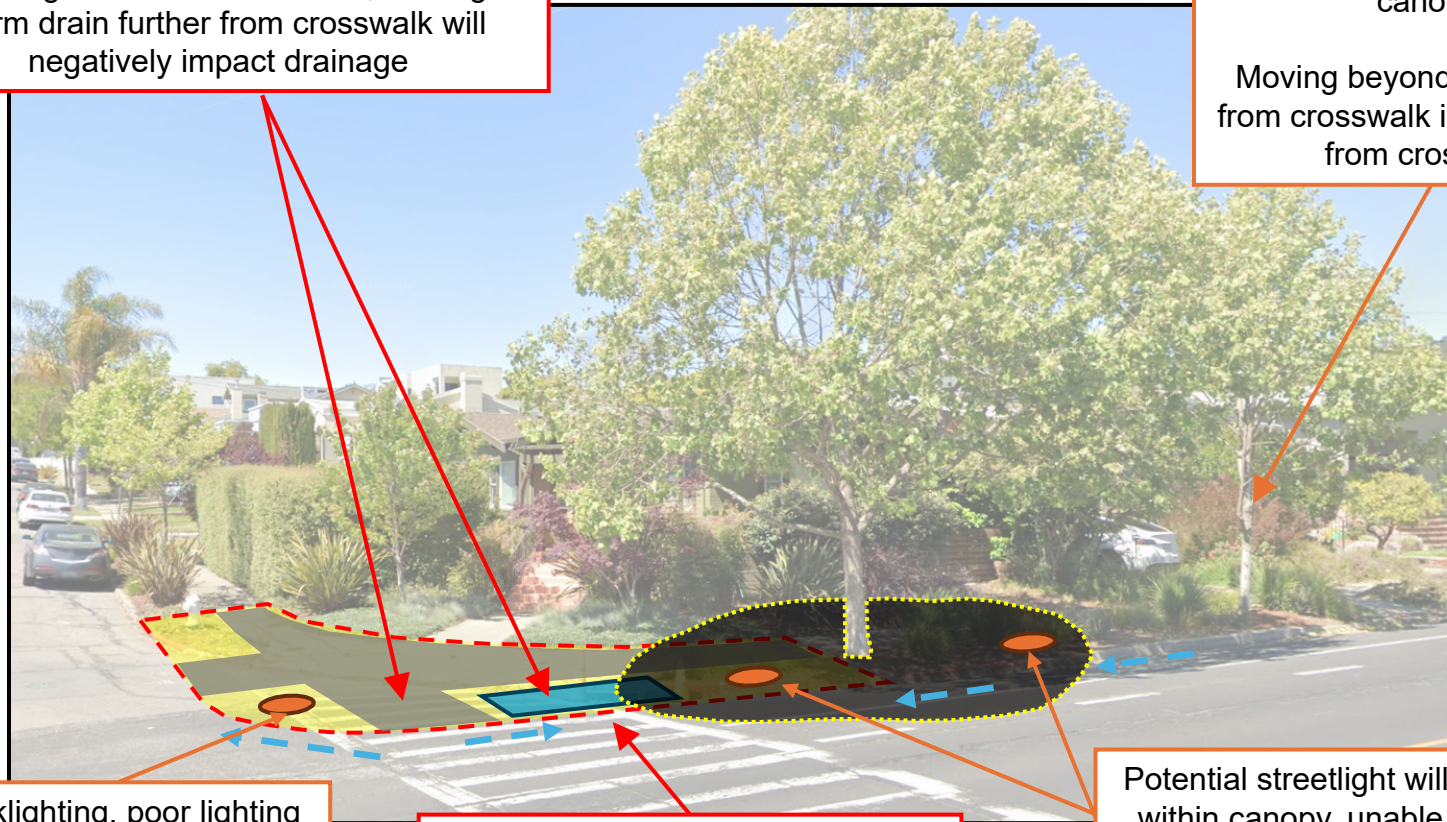
Storm drain & curb ramp prevent moving streetlight closer to crosswalk; moving storm drain further from crosswalk will negatively impact drainage

Second tree prevents moving streetlight further east out of canopy.

Moving beyond second tree from crosswalk is too far away from crosswalk

Backlighting, poor lighting condition persists

Potential streetlight will be within canopy, unable to adjust on either side

Reversing gutter to create artificial low point for local capture

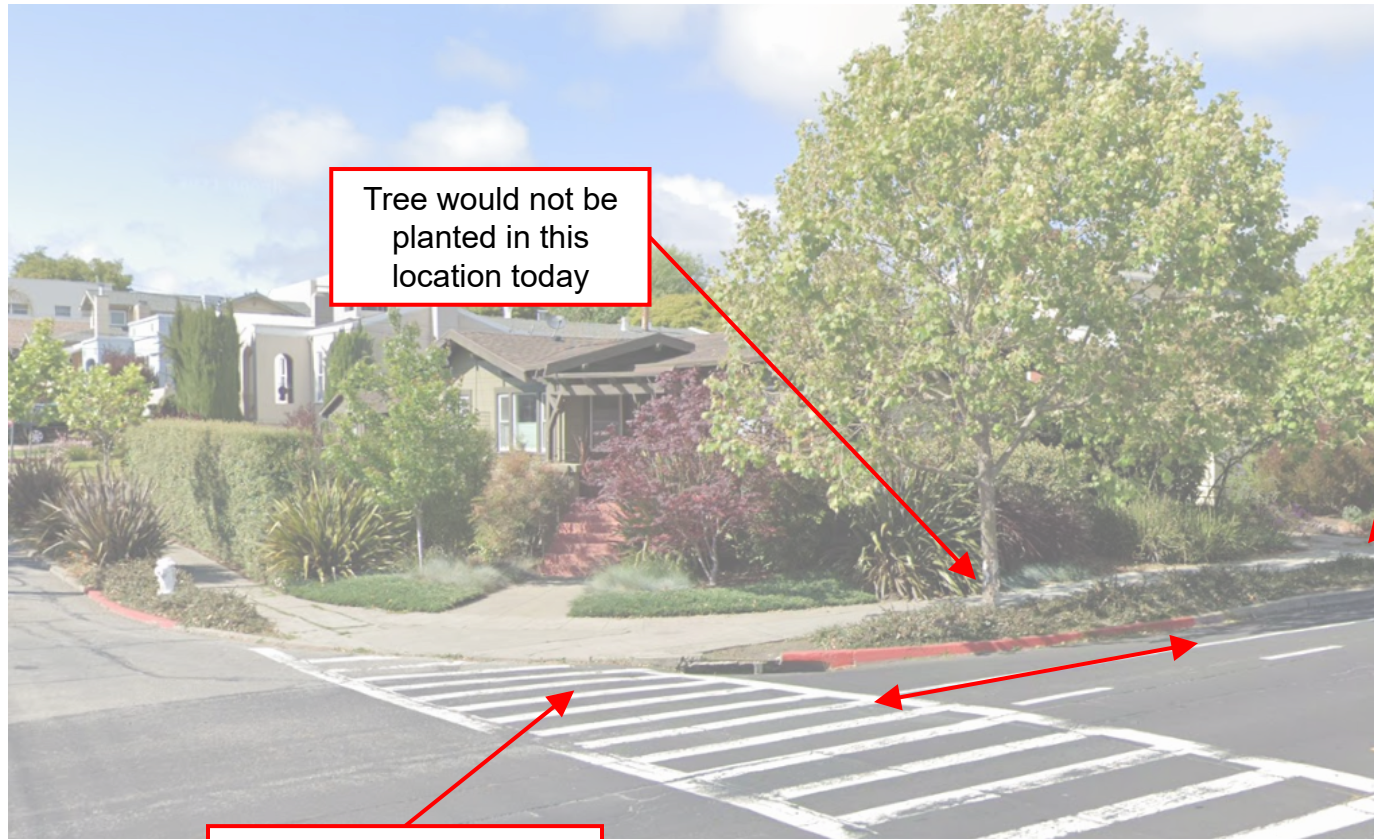
Tree would not be  
planted in this  
location today

Adjacent Tree 1638  
(Original Camphor location)

Crosswalk remaining in  
same general location to  
continue path of travel
