Arborist Report

ALBANY HILL EUCALYPTUS TREE SURVEY

DATE: July 23, 2021

SBCA TREE CONSULTING

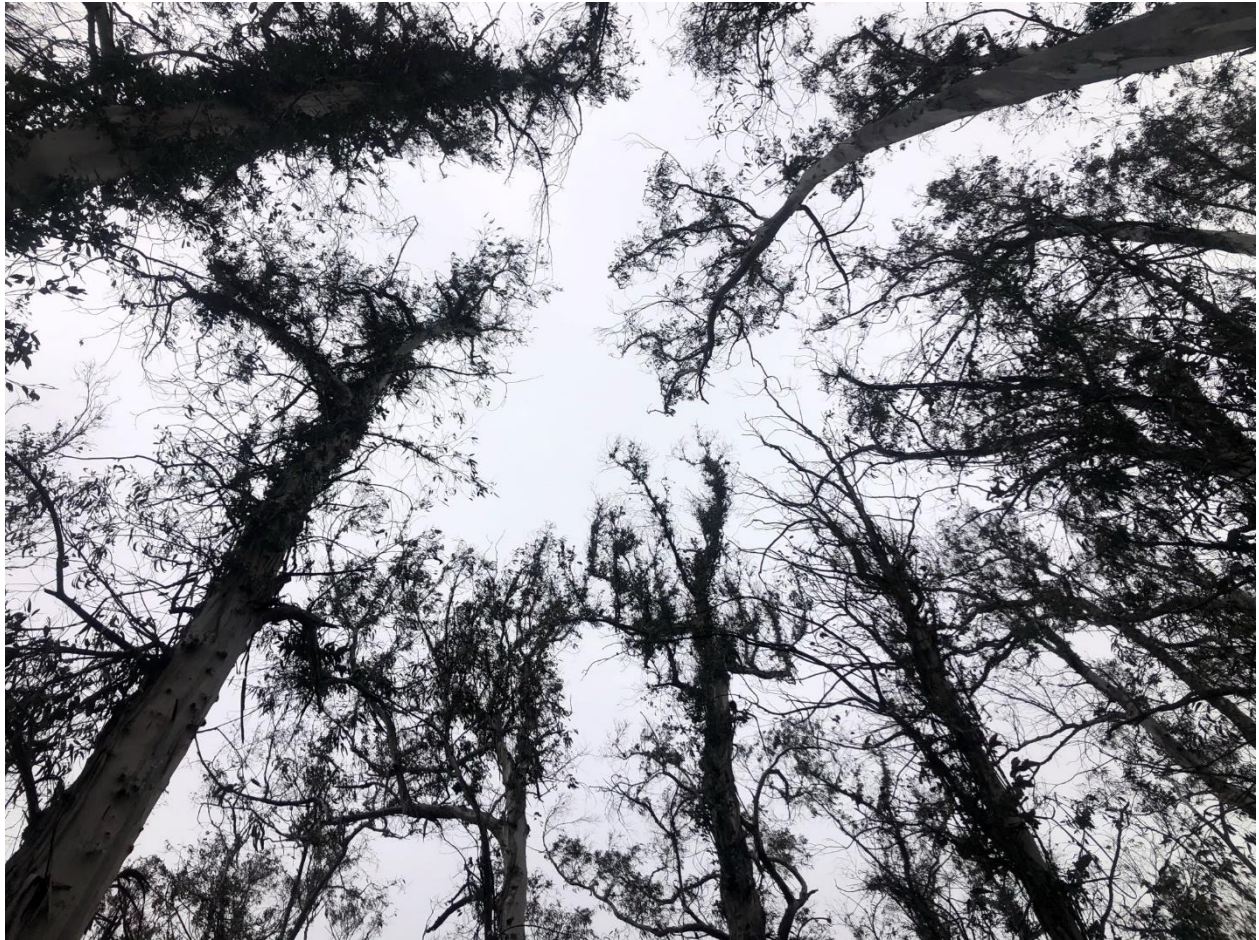
Photo 1. Photo above shows the tops of the Eucalyptus located in the EGHT area at the northwestern end of the park. Trees in this area were observed to be in the worst condition, with significant fire scars, dead tops, and live crown ratios less than 10%.

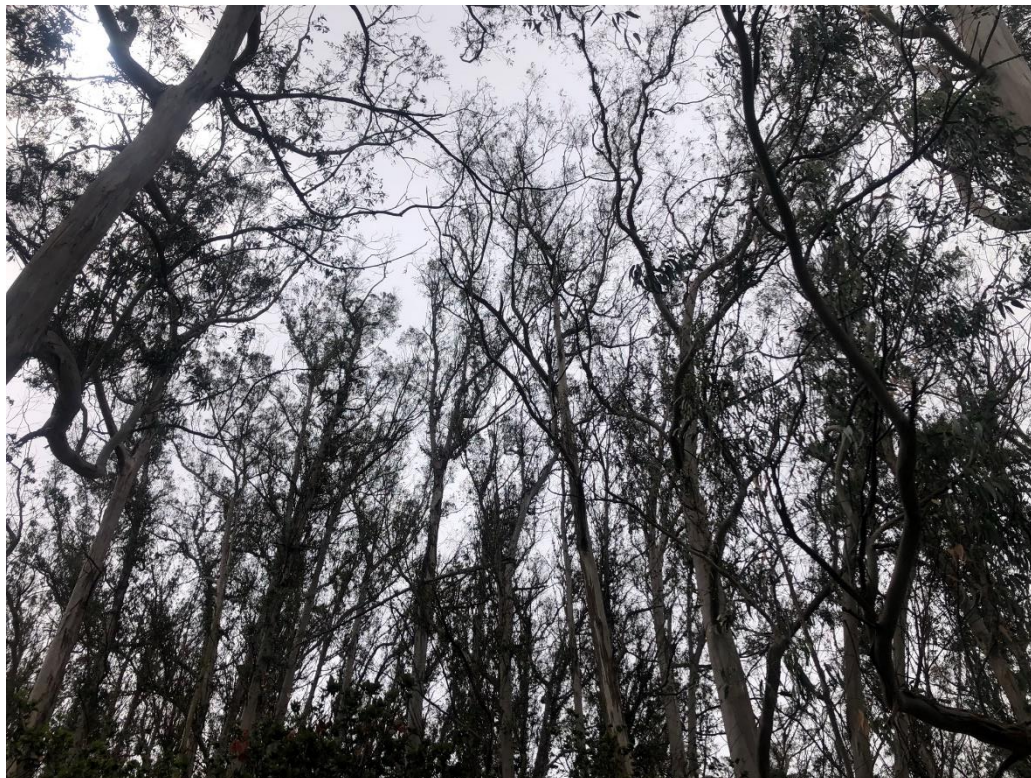
Photo 2. Photo left shows the condition of trees in the EHT area, between the trail and Taft. Trees have very little leaf cover to support their system due to the drought and fungal leaf infection(s).

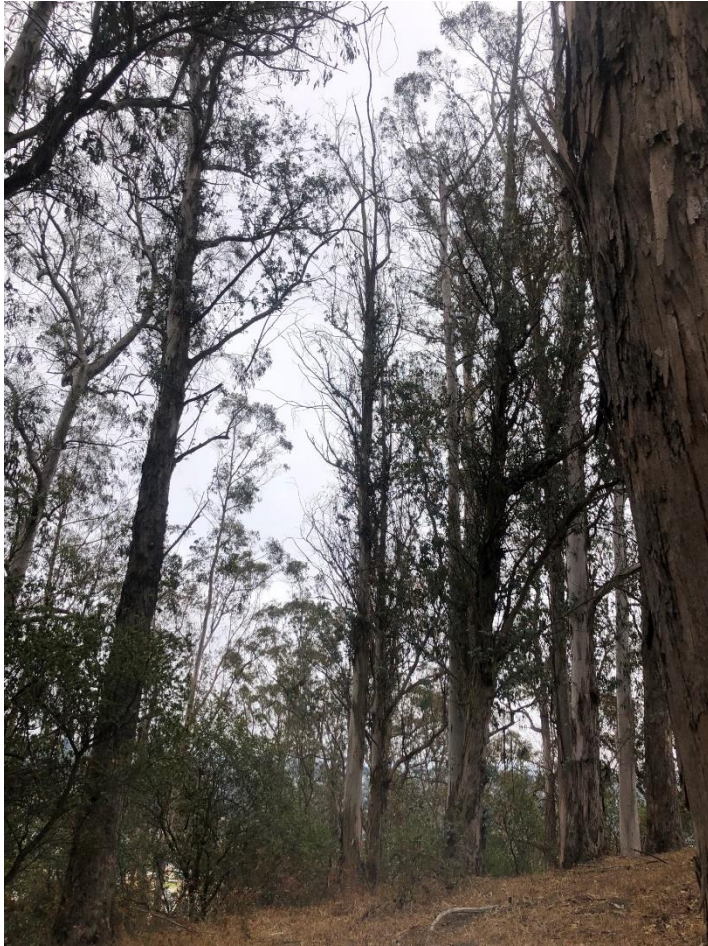
Photo 3. Photo left shows tree #17 in the middle, with a health condition rated as Poor-Dead. The top is noticeably dead.

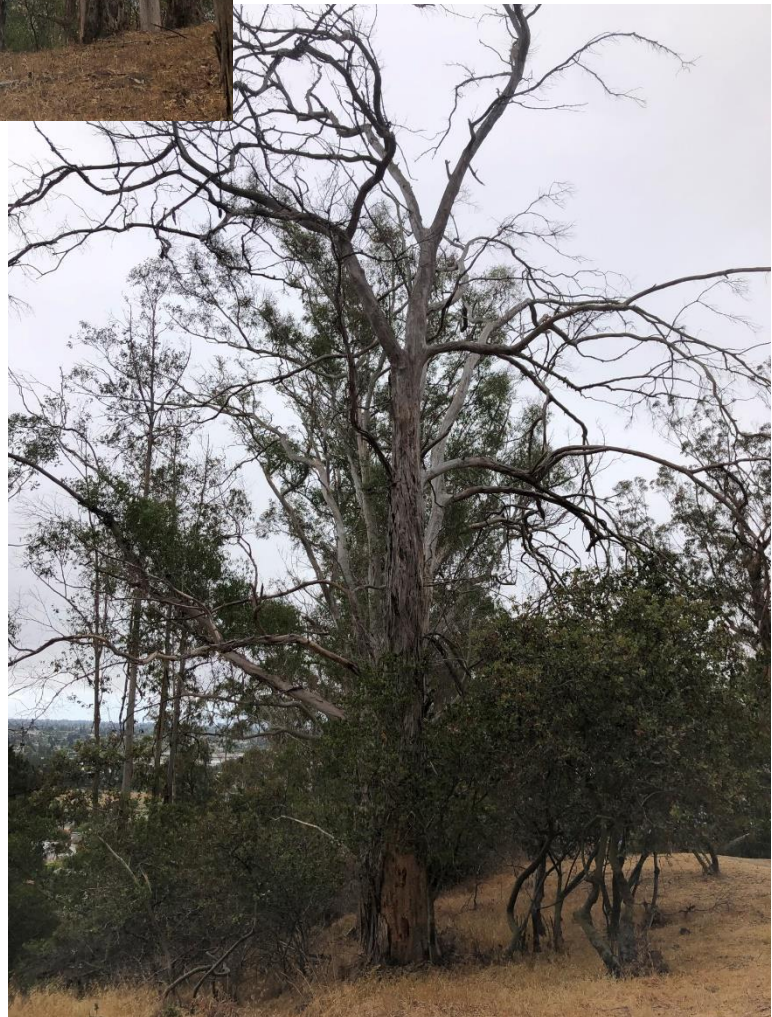
Photo 4. Photo right shows dead tree #181. Trees located at the top of the hill are in worse condition than those at the bottom, likely due to less moisture availability.

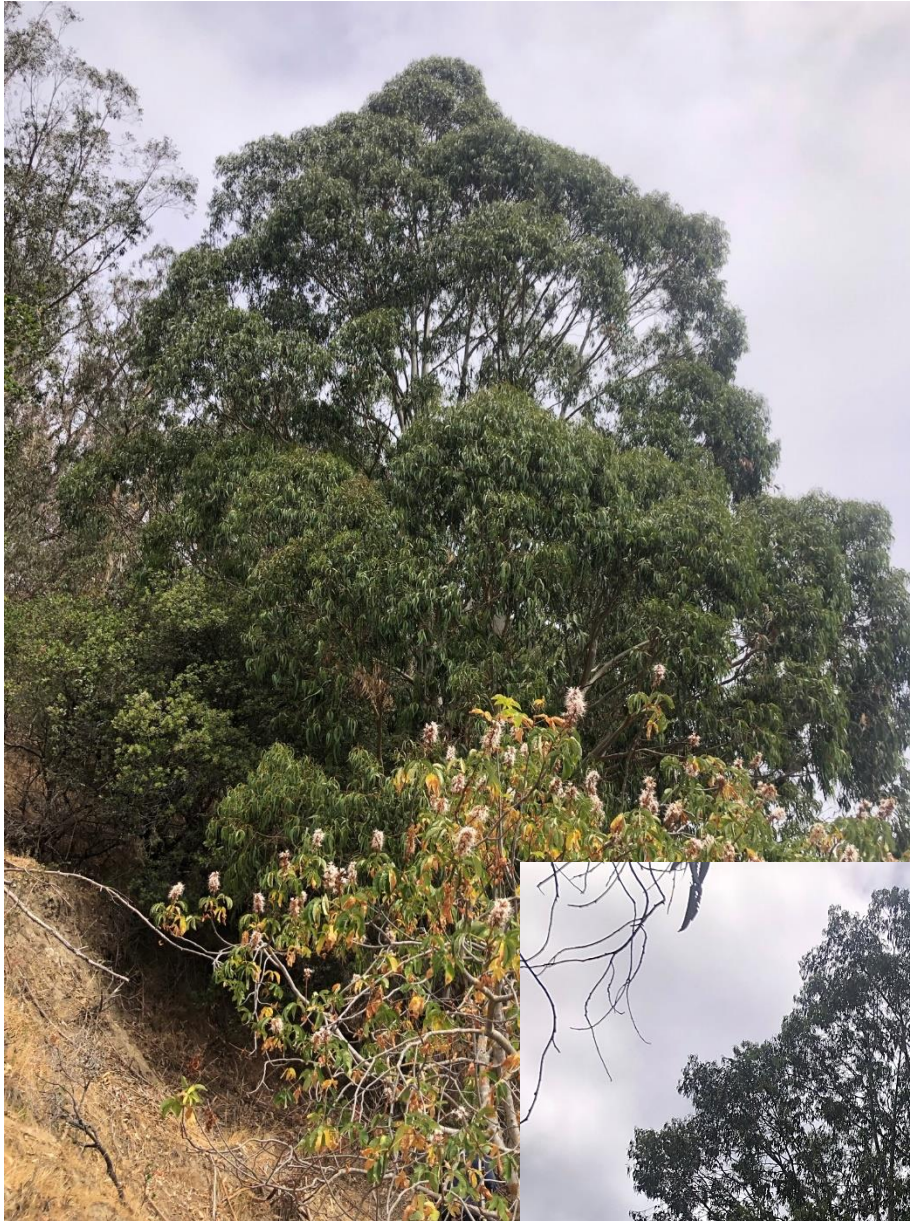
Photo 5. Photo left shows a very healthy Eucalyptus located along Jackson St. Trees in this area get less sun and wind (which means less evapotranspiration) and more water due to their location on the north side of the hill.

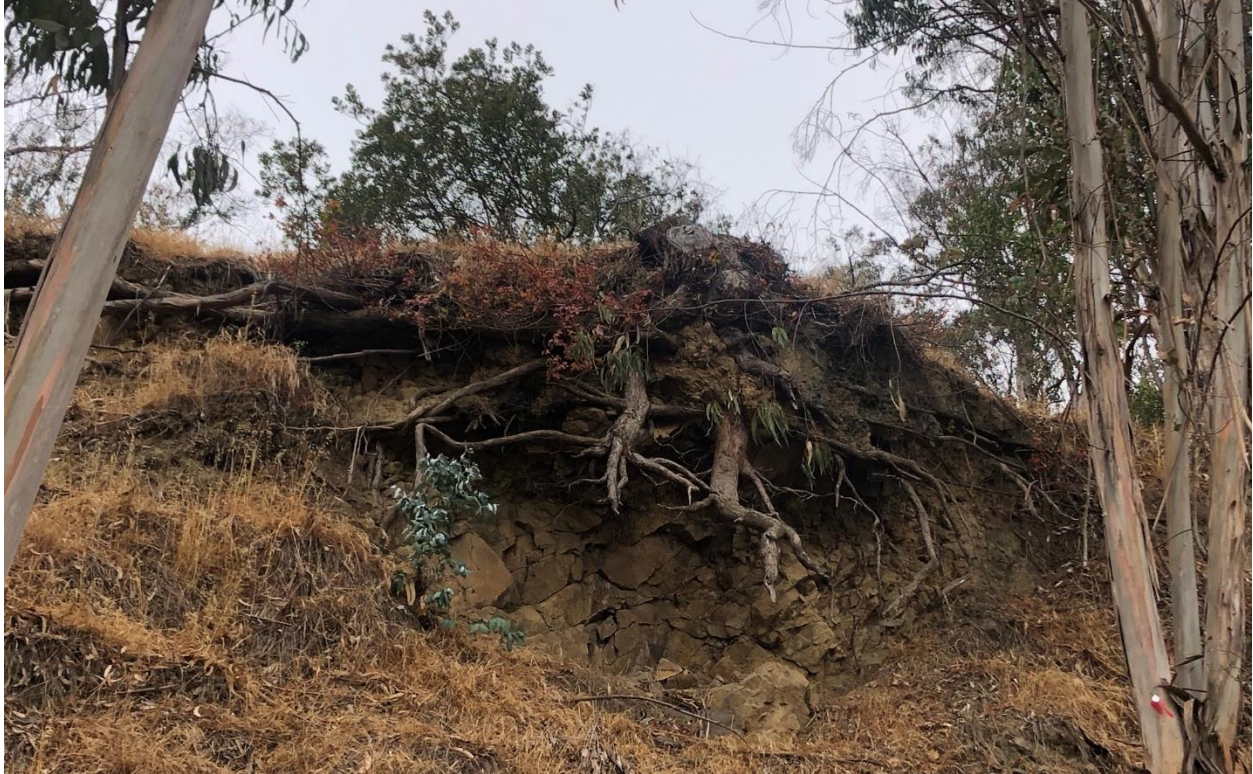
Photo 7. Photo above shows a previously removed tree that was destabilized due to the graywacke sandstone giving way underneath.

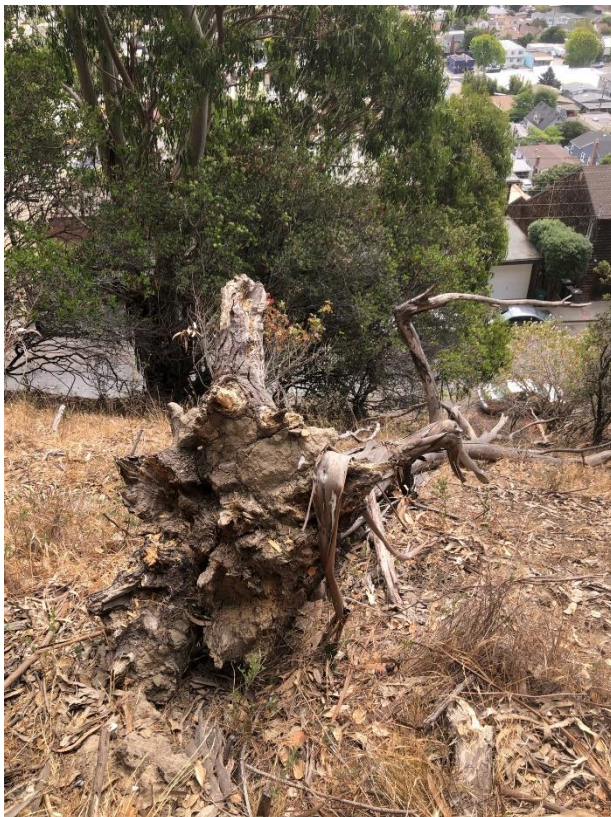
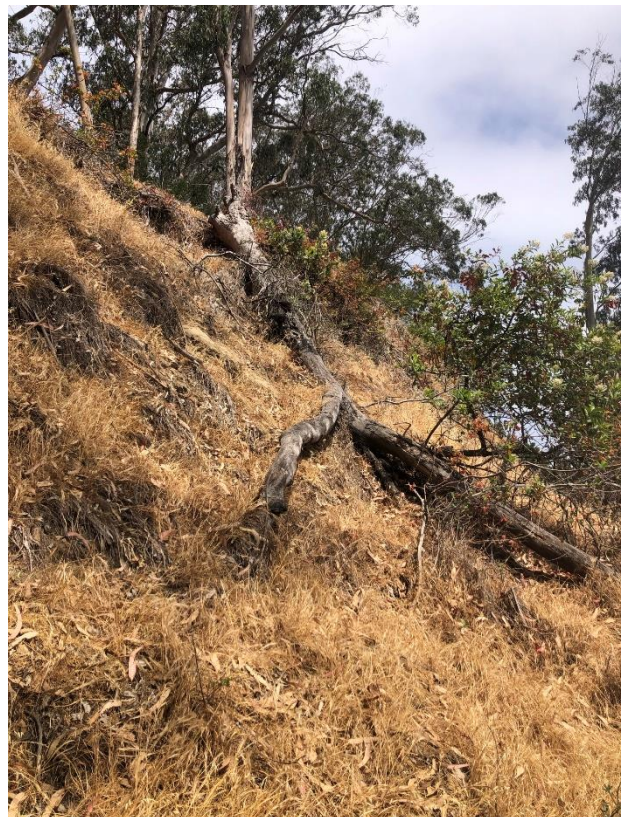
Photos 8 and 9. Photos below show two trees that previously failed by roots on the slope on the upper side of Taft.

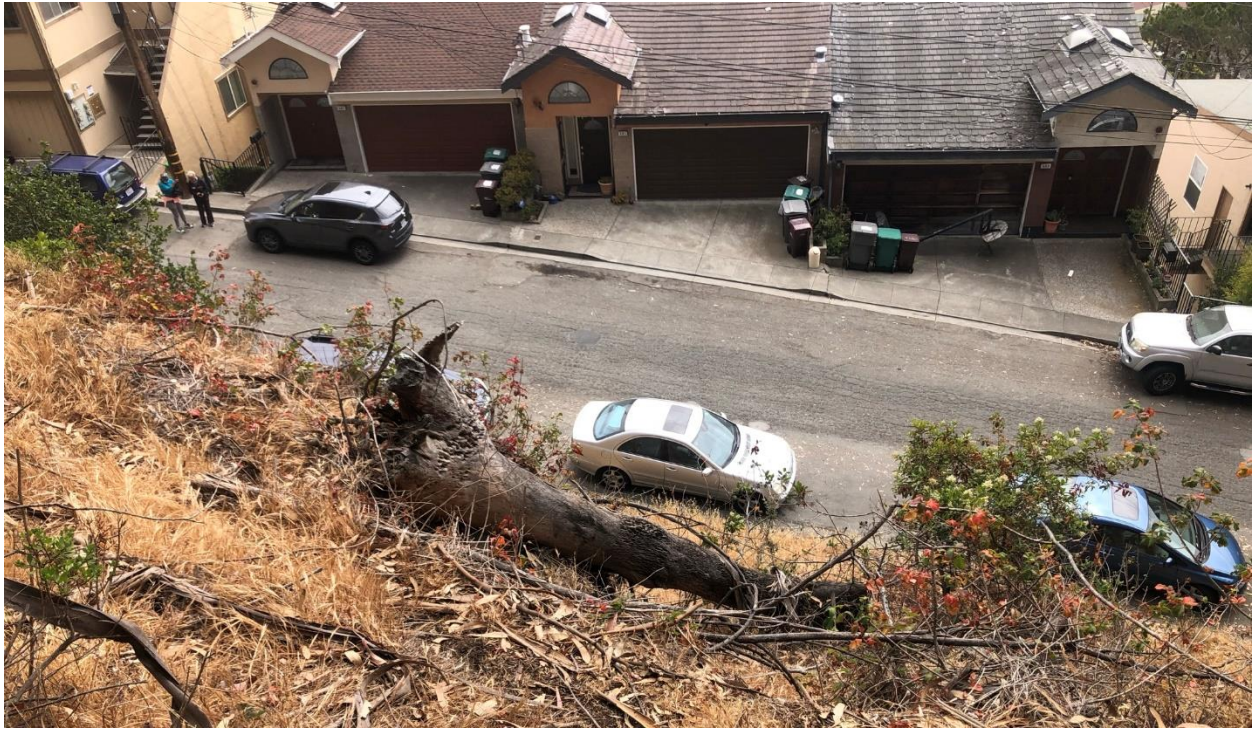
Photo 10. Photo above shows another downed tree on the slope above Taft.

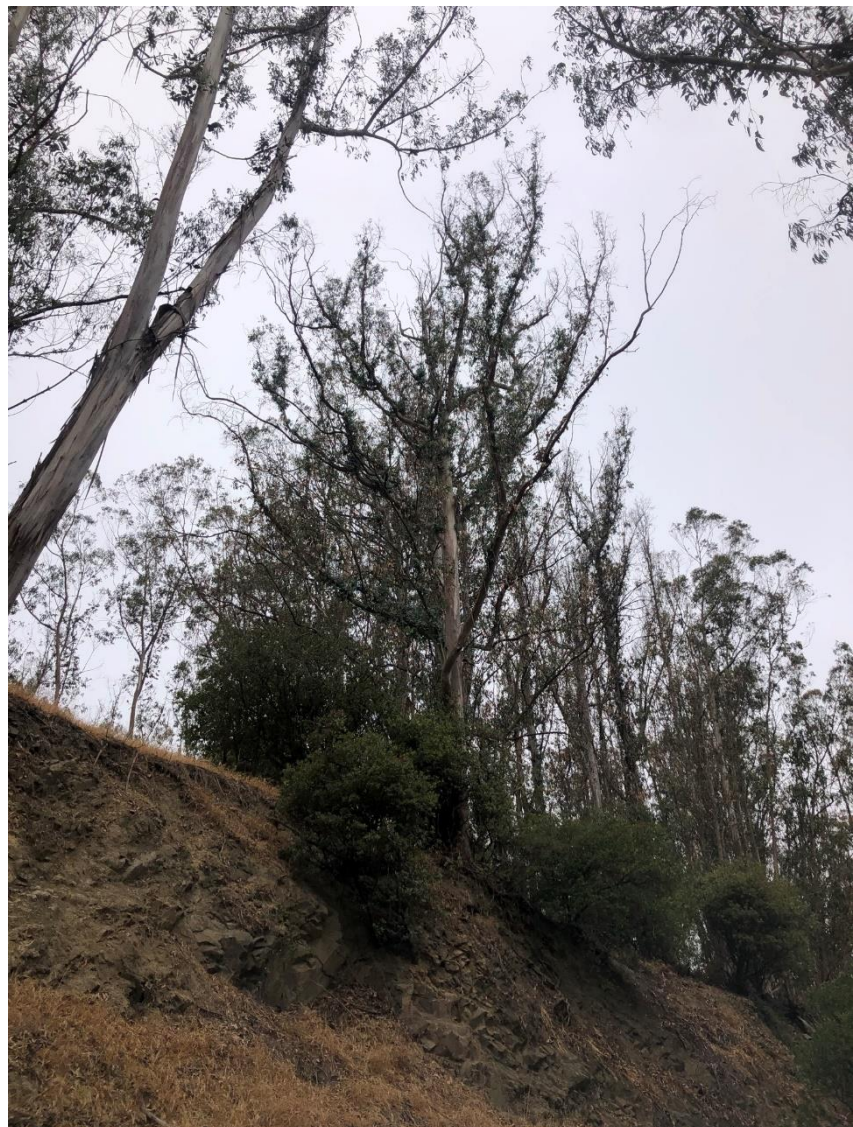
Photo 11. Photo right shows a tree in Poor health condition at the edge of the slope. There is a higher risk associated with this tree due to the road and residences below.

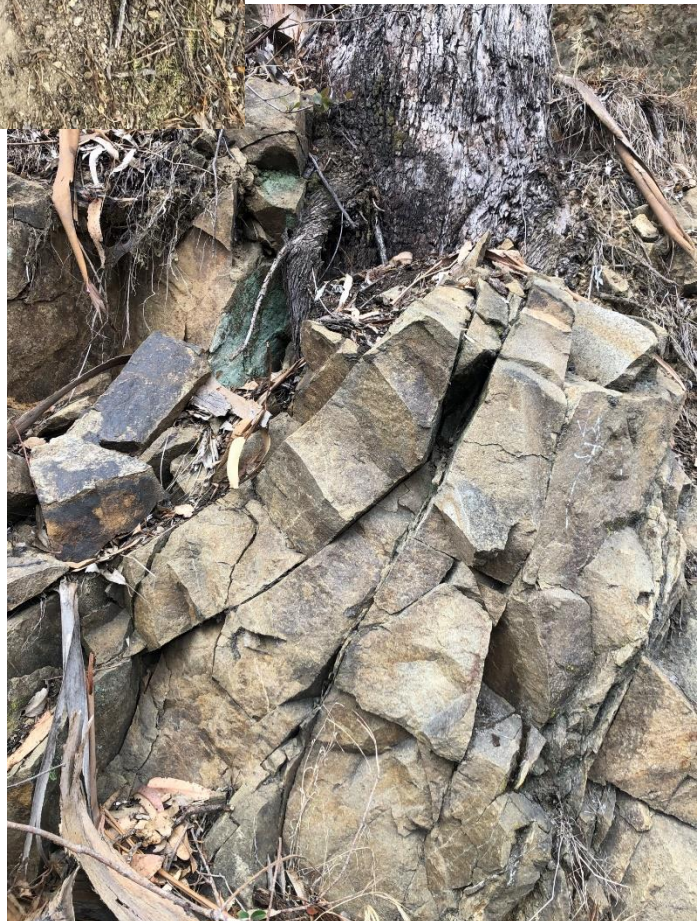
Photos 12 and 13. *Photos on this page show examples of how roots can work to loosen sandstone by forcing themselves between cracks and expanding. Windforces also create root movement which loosens soil. Trees do not work to stabilize slopes. In fact, it is just the opposite.*

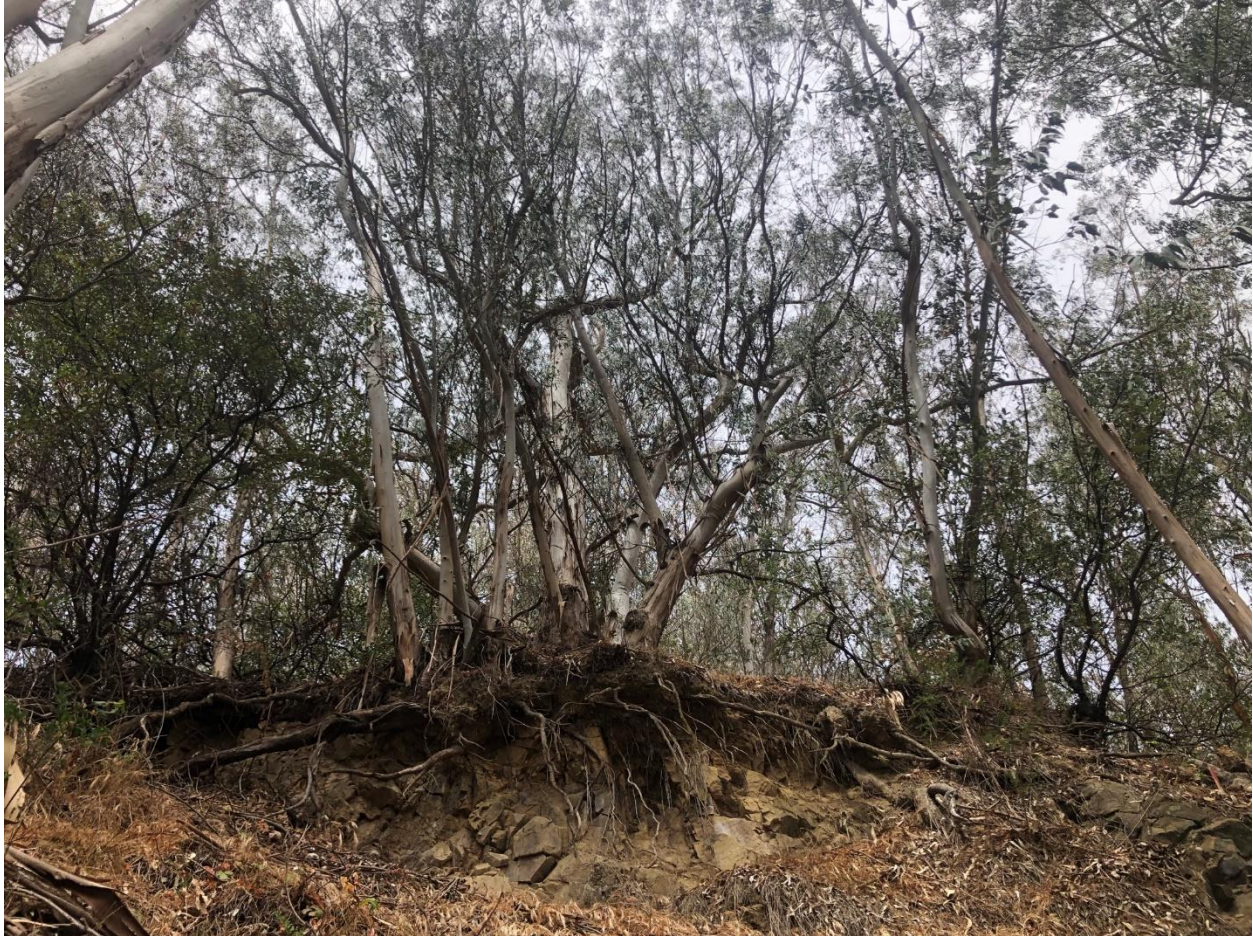
Photo 14. Photo above shows another example above of slope destabilization under trees.

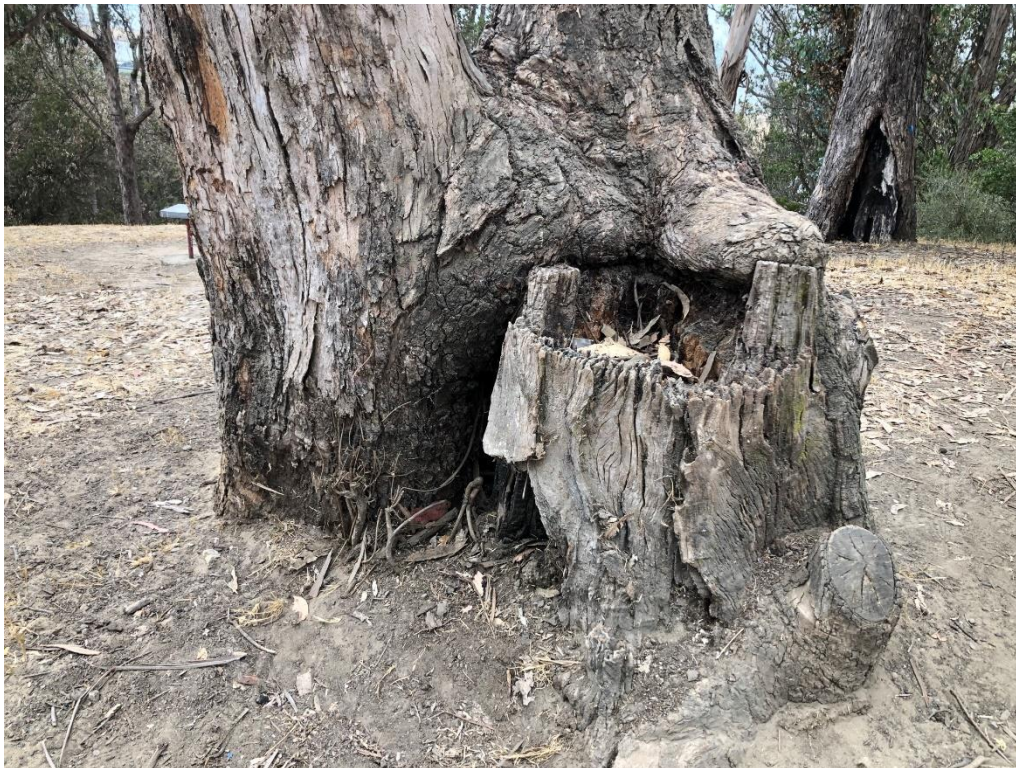
Photo 15. Photo left shows the base of tree #359. This tree was previously cut down, and the stub sprouts emanating from the cut trunk were allowed to grow large again. As the old trunk decays, the stability of the tree will become an issue.

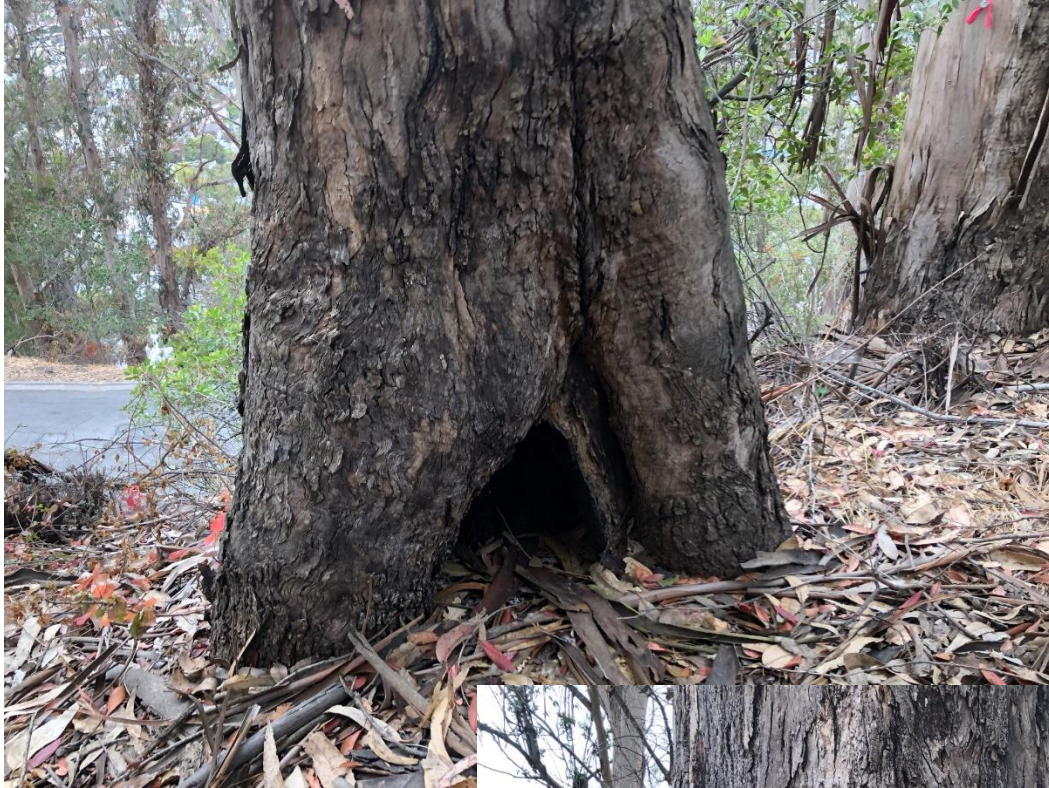
Photo 16.
*Photo left
shows the fire
scar at the base
of tree #100.*

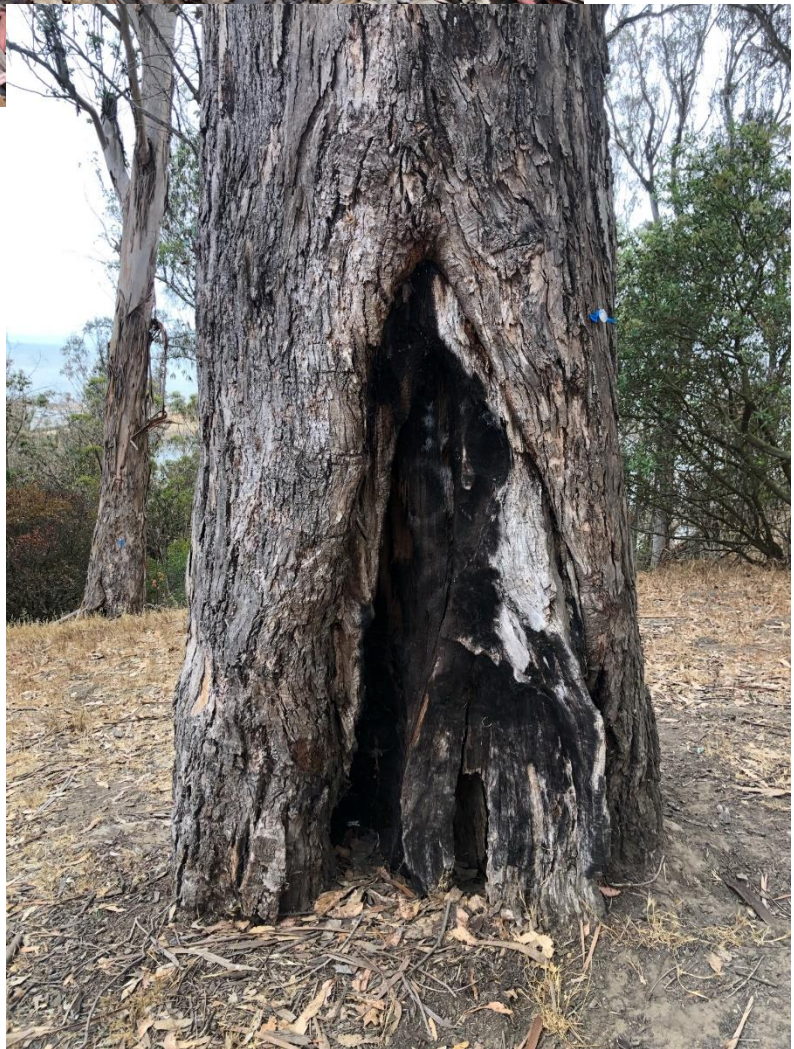
Photo 17. *Photo right shows the large
fire scar on tree #242.*

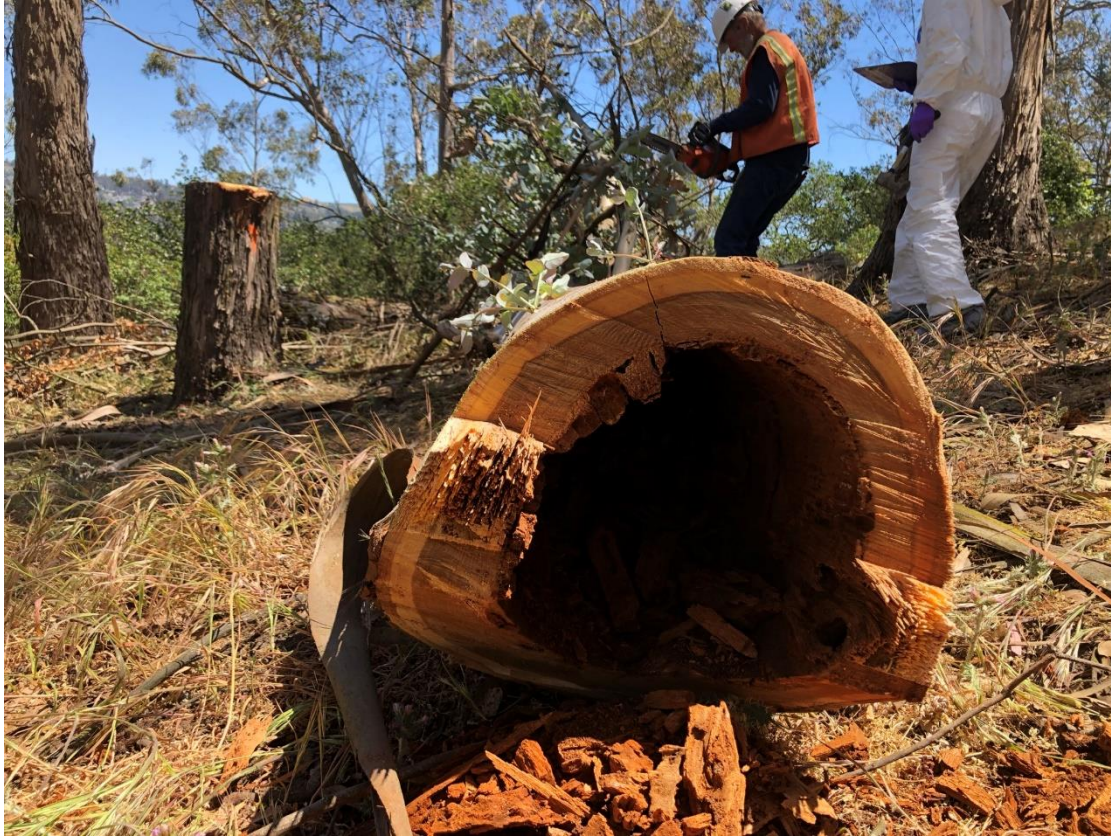
Photo 18. Photo above shows the hollowness discovered when one of the trees was felled for sample collection.

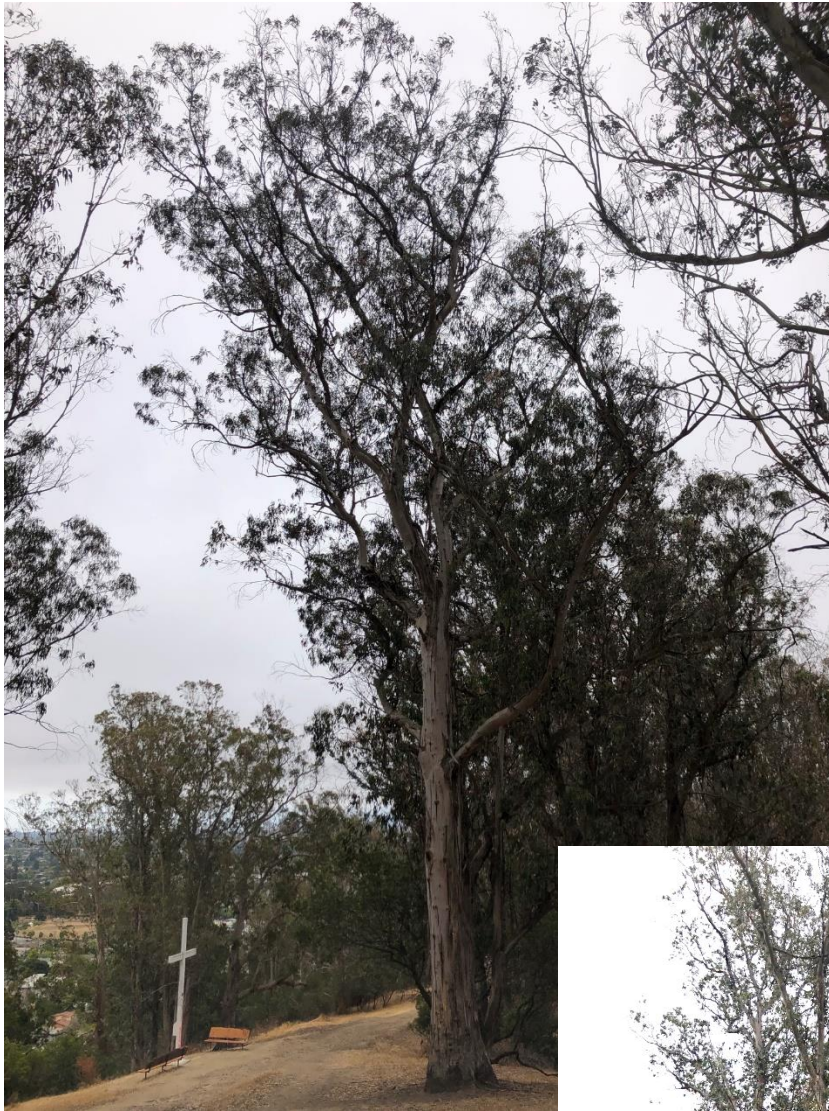
Photo 20. Photo left shows tree #249 in the ESHT area. This tree was given a “2” for Live Crown Ratio, meaning it has 10-50% of the total foliage a healthy tree of its size would have. The tree was recommended for pruning to remove dead wood over the path. If there is a desire to retain this tree, mulching and supplemental irrigation is recommended.

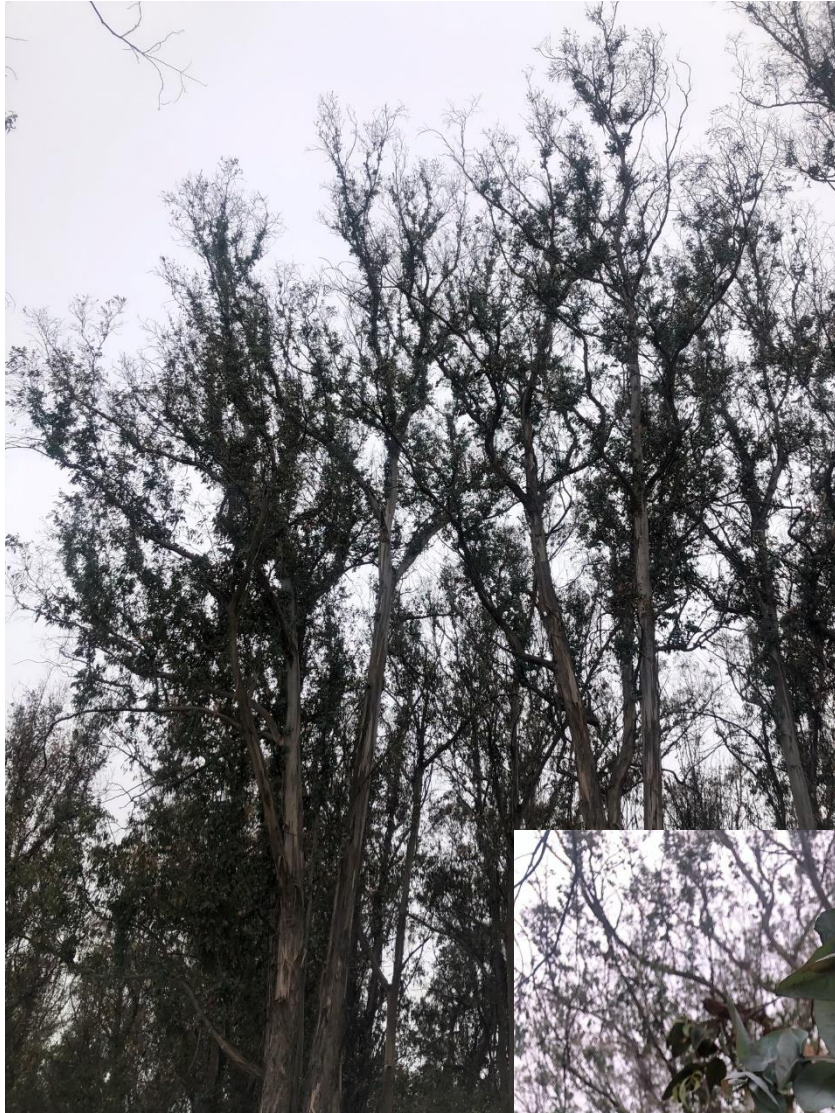
Photo 22. *Photo left shows a grouping of trees in the Butterfly area. All the growth on these trees is juvenile, meaning trees lost all their foliage due to disease and drought had to use carbohydrate storage to produce new leaves. Once carbohydrates are expended, trees often die.*

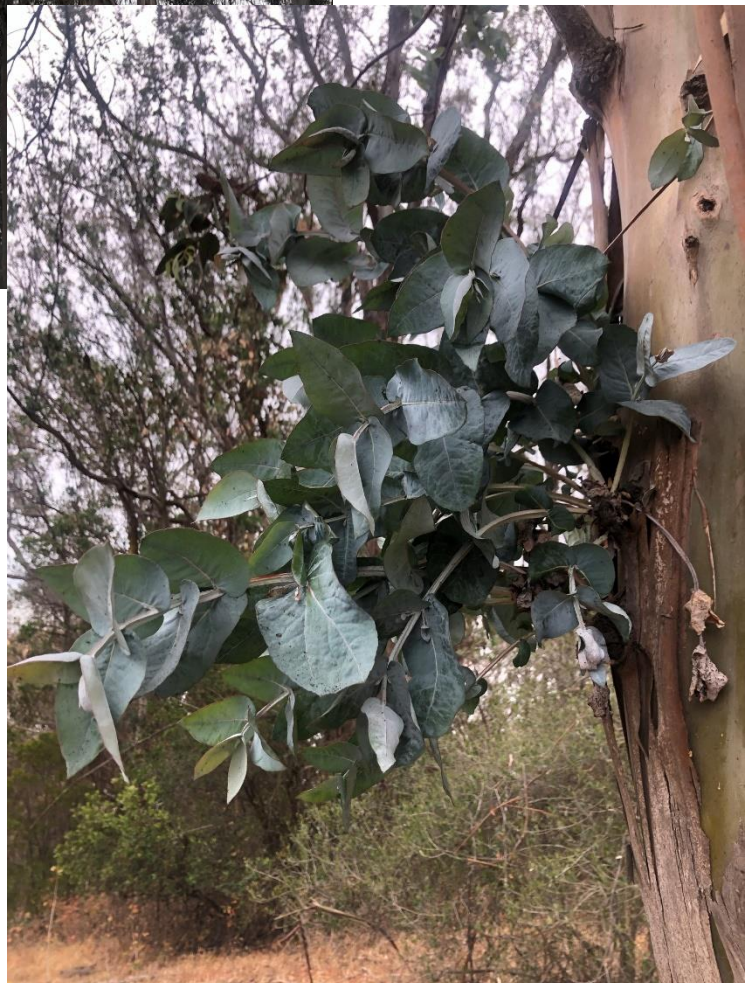
Photo 23. *Photo right shows the juvenile leaves of a Eucalyptus globulus. These appear more bluish than mature leaves, and are positioned opposite on the stem. Mature leaves are alternate.*
