MCNEIL ARBORICULTURE CONSULTANTS LLC

March 18, 2022

Assessment of Tasmanian blue gum trees, *Eucalyptus globulus* in Albany Hill Park

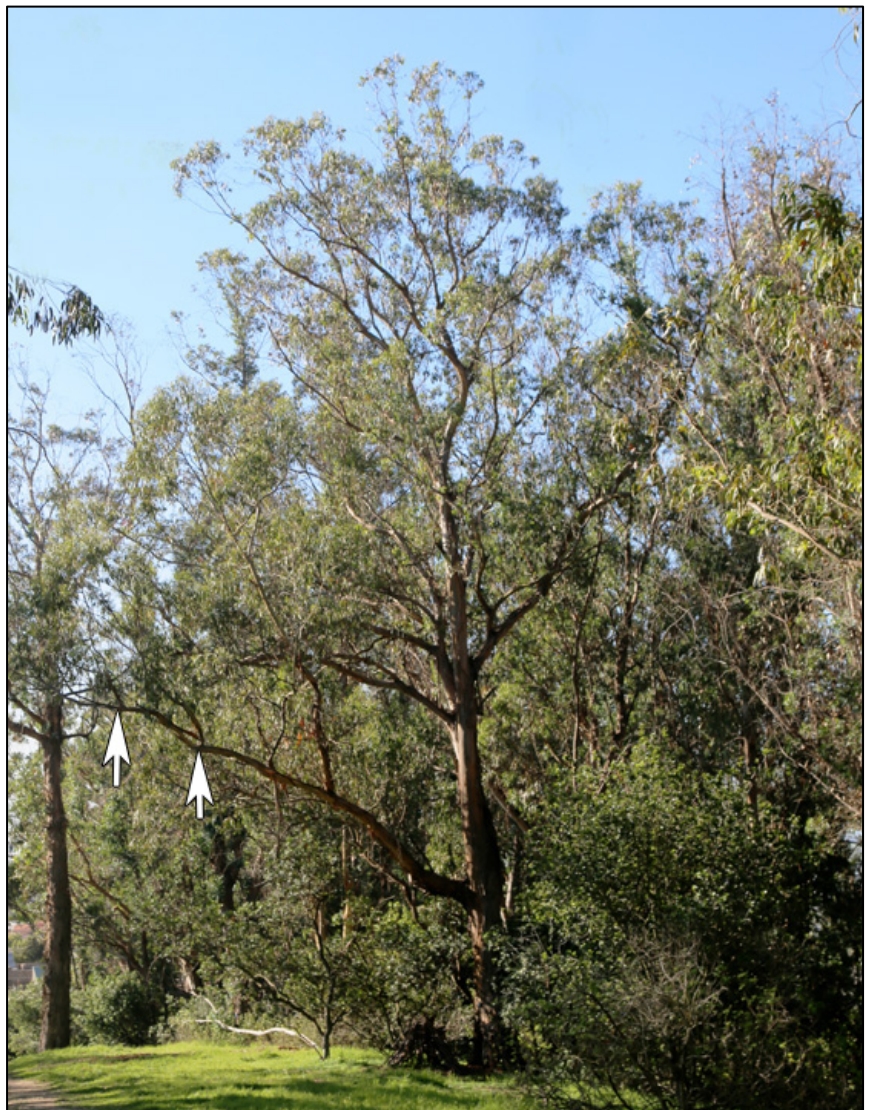
This tree, seen to the right is 49 inches in trunk diameter, measured at 54 inches above ground⁸.

1. The tree is 85 feet tall, but by 28 feet above ground the trunk diameter is half the diameter it is at 54 inches height.
2. At 47 feet, just over half the height of the tree, the trunk diameter is a quarter of the diameter at 54 inches.
3. The Live Crown Ratio, the percentage of height that is covered by limbs extending from the trunk is 85 percent.

These metrics are associated with highly stable trees, resistant to mechanical failure. The mass of the tree is concentrated low, close to the ground. During wind the tree develops minimal momentum, reducing stress on the base and the root system. The regular branching stabilizes the tree through mass damping⁹. In addition, the tree appears more vigorous and healthy than many neighboring Eucalyptus.

One long limb extends east over the path. Consider reducing this limb back to one of the arrows seen to the right, at the discretion of the climber. This will reduce potential for limb failure.

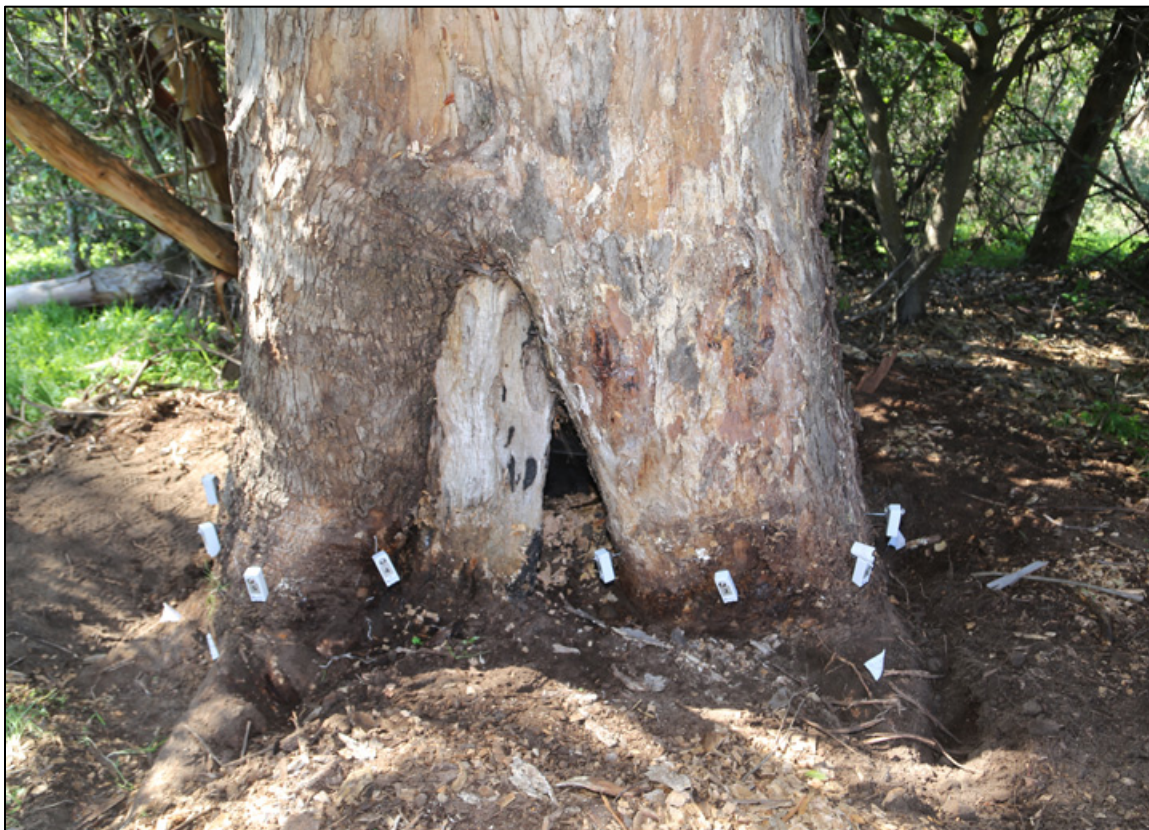
These tree stability attributes are critical for tree #258 because of significant fire injury at the base, with associated decay. In the photo below taken from the northeast a curtain of solid wood covers the left 2/3 of the injury opening, but the wood behind the curtain is decayed.

We tested the tree with the Resistograph at six points in roots, and while we found some decay, the sound portions of the roots are large, robust, and in our opinion capable of supporting the tree, given the stability attributes listed on the previous page.

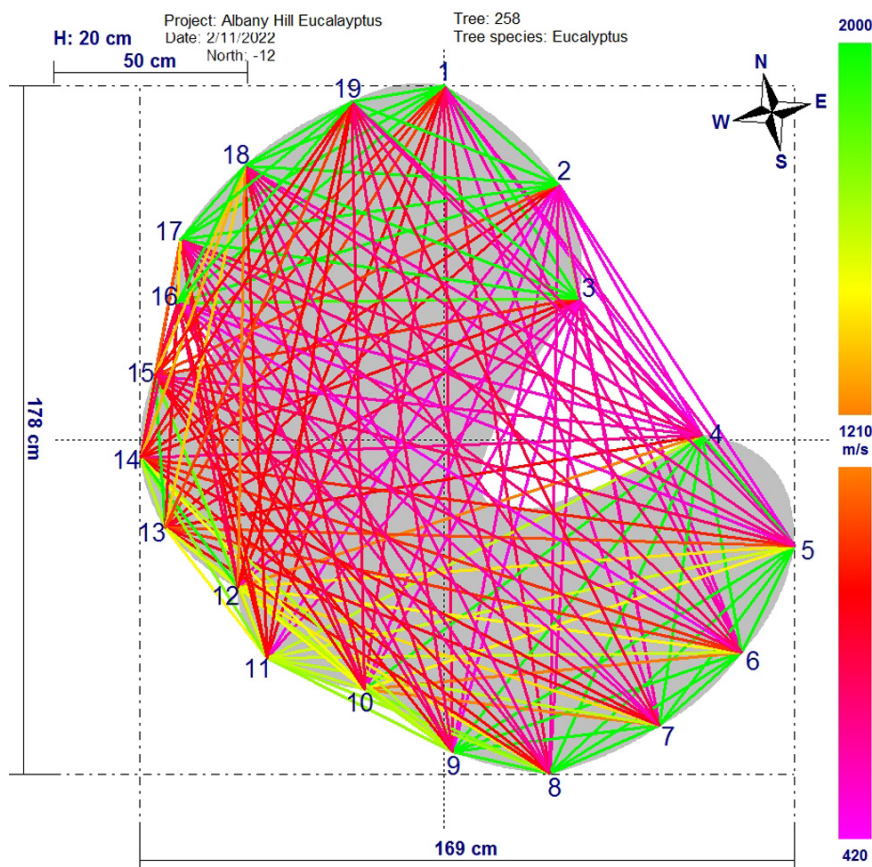
We assessed the tree with the Arbotom at a height of 20 centimeters, or just less than eight inches. One resulting graphic is to the right. Nineteen sensors were attached to the tree. Some are visible in the photo above. Each was tapped, in succession. The instrument measured the speed of the resulting compression wave between each pair of sensors. That speed is represented on the graphic by the color code at the right. The speed ranges from 420 meters/second to 2000 meters/second. A slow speed implies the signal, the compression wave must travel around a defect in the

tree, an area of low density due to decay, or a cavity.

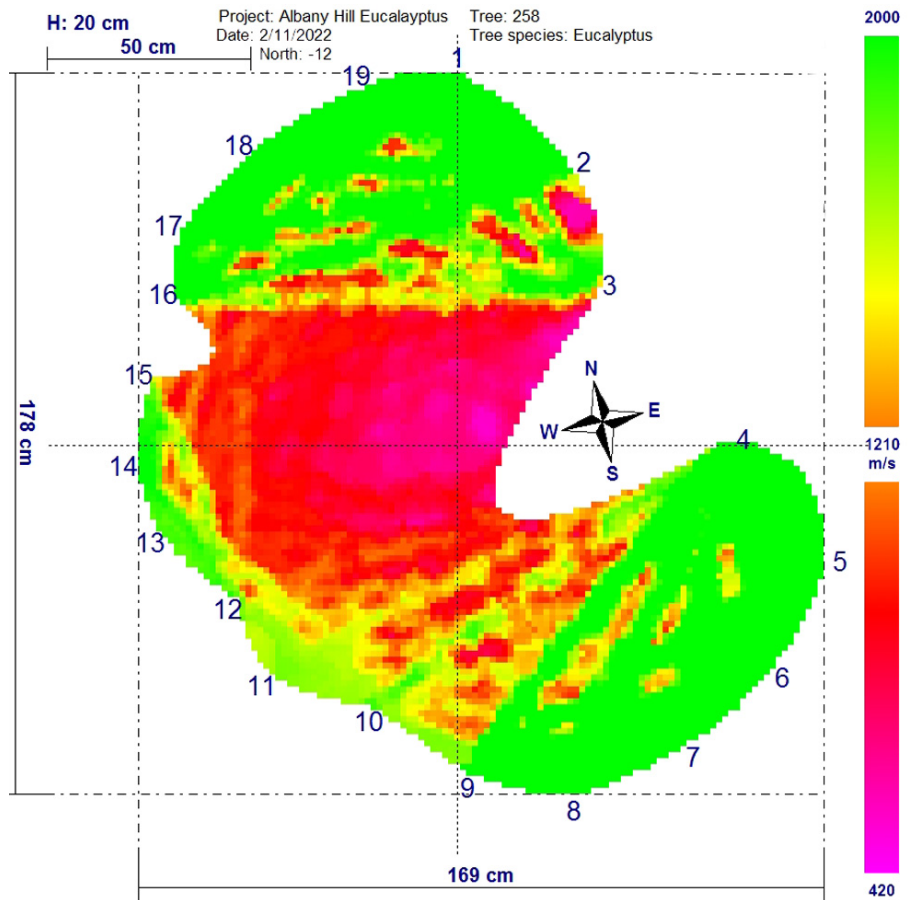
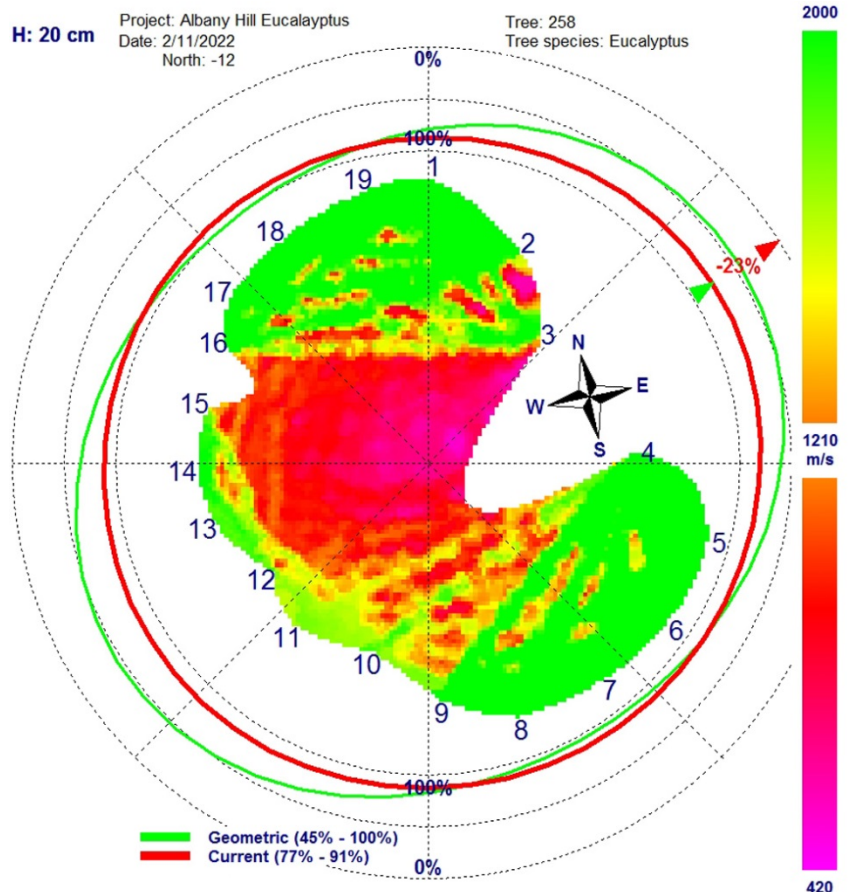
The upper graphic to the right has converted the graphic on the previous page to a surface-coded graph. Wood density is represented by color.

In our opinion the tree is more stable than might initially appear from seeing this graphic. The lower image is the result of mechanical calculations that suggest the tree trunk has lost about 23 percent of its strength across the trunk at 20 centimeters height, a location likely to be most critical, as the nexus of strength impairment due to injury or decay, and stress from wind loading above. All else held equal, the tree is least strong to the northeast, the direction in which it has lost 23 percent capacity.

However, the extreme taper of the trunk and limbs of the tree combined with the large trunk diameter relative to height and the favorable Live Crown Ratio more than buffer the tree against this strength loss, in our opinion.

It is our opinion this tree is stable against whole tree failure for at least the next five years. We suggest pruning dead limbs of two inch or larger diameter from the east side of the tree, where their failure could endanger persons on the trail.

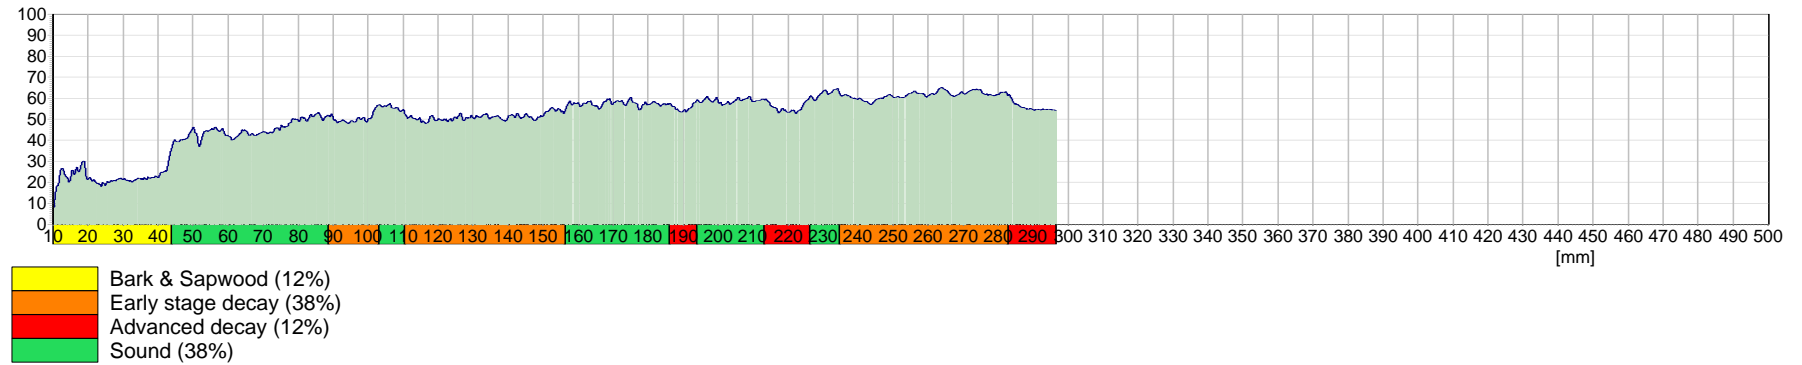
01560001 20220210 Albany Hill, Tree 156 Profile #1
Mixed sound with decay, functionally sound

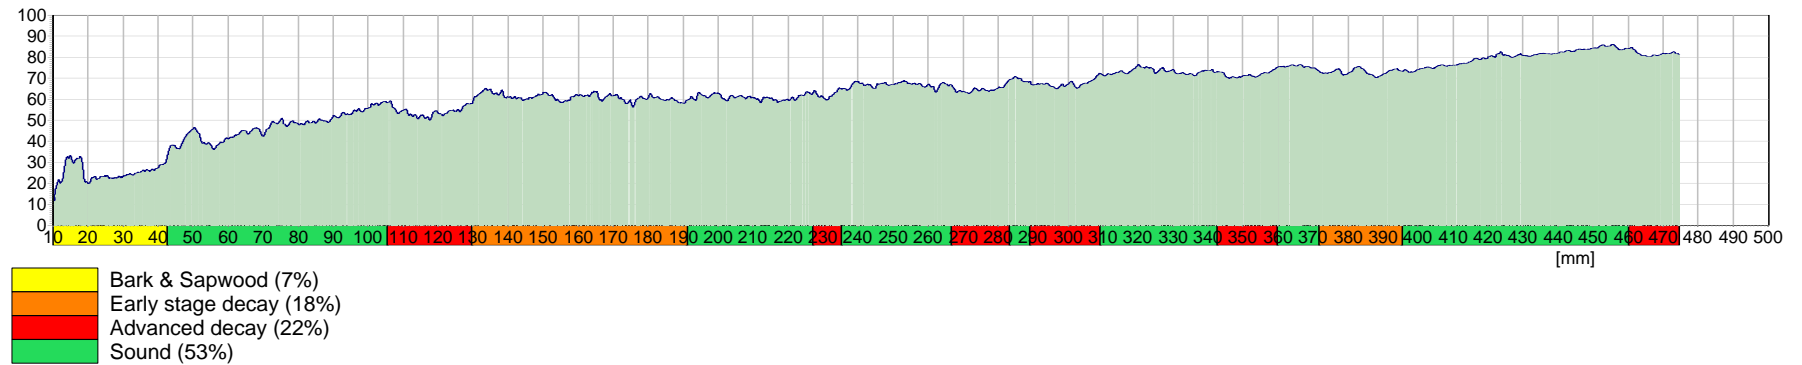
01560002 20220210 Albany Hill Tree #156 Profile #2
Mixed sound with decay, functionally sound

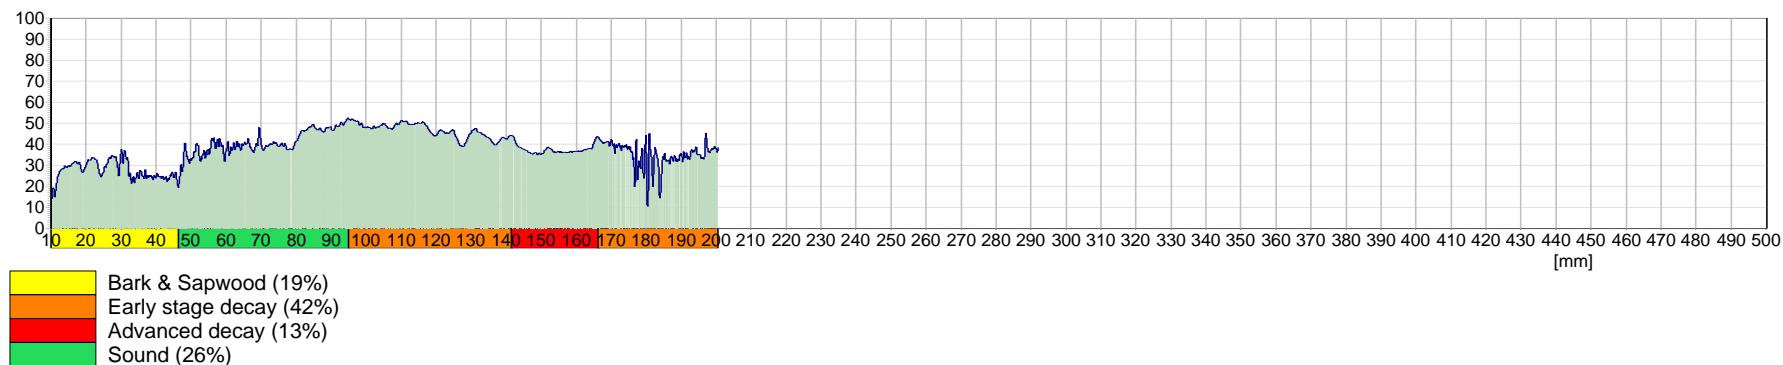
02280001 20220210 Albany Hill Tree 228 Profile #1

Mixed decay states past about 9.5 cm

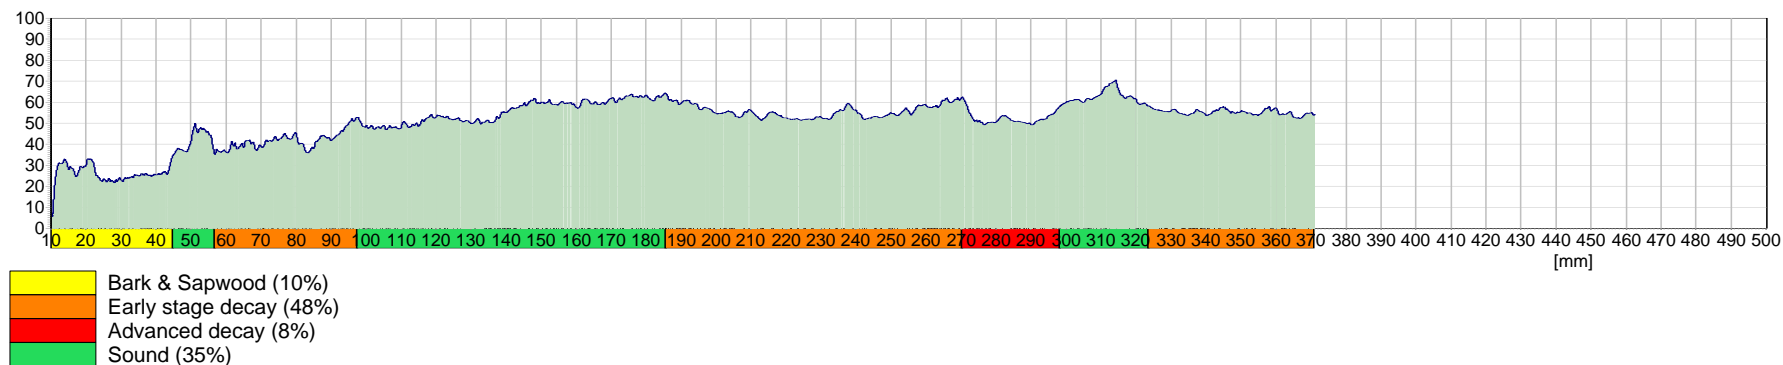
02280002 20220210 Albany Hill Tree 228 Profile #2

Mixed sound with decay states

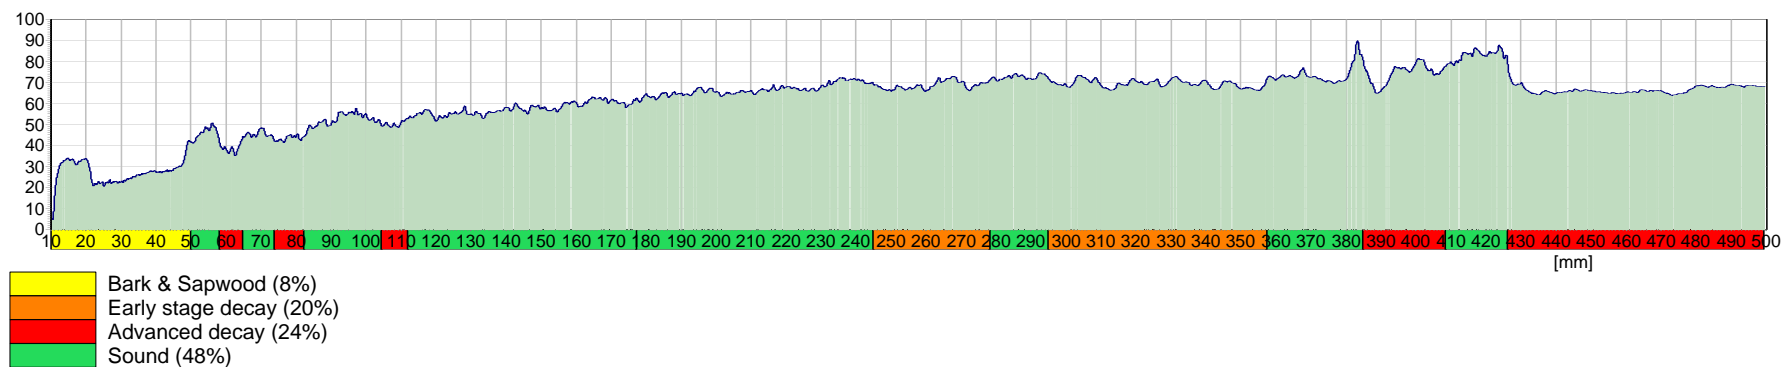
02280003 20220210 Albany Hill Tree 228 Profile #3

Mixed sound with decay, functionally sound

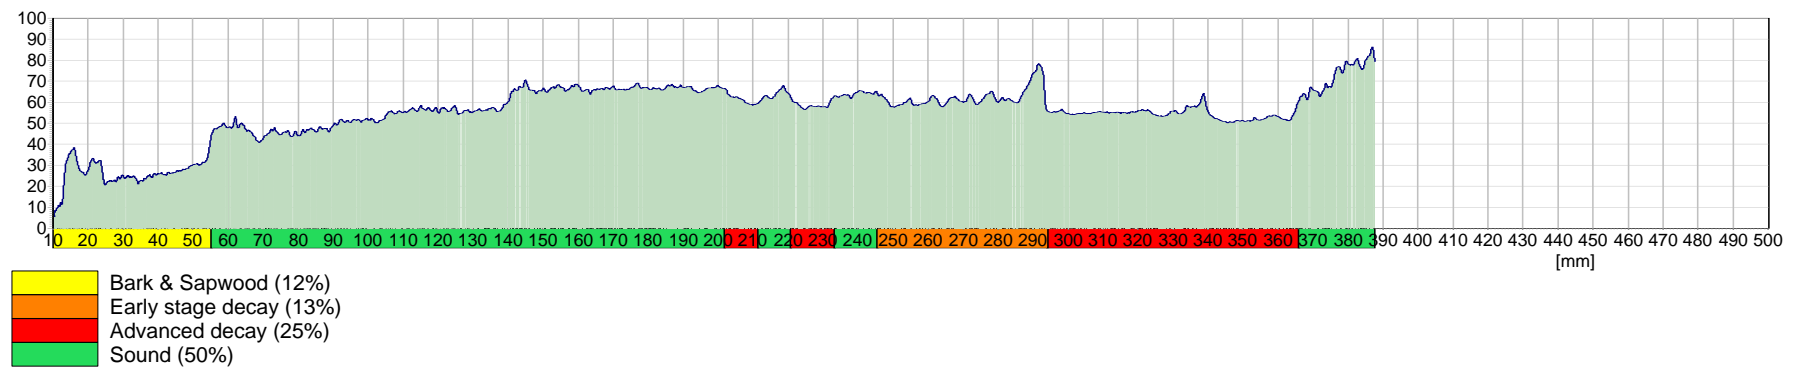
02280004 20220210 Albany Hill Tree 228 Profile #4

Mixed sound with decay, functionally sound given location in the tree

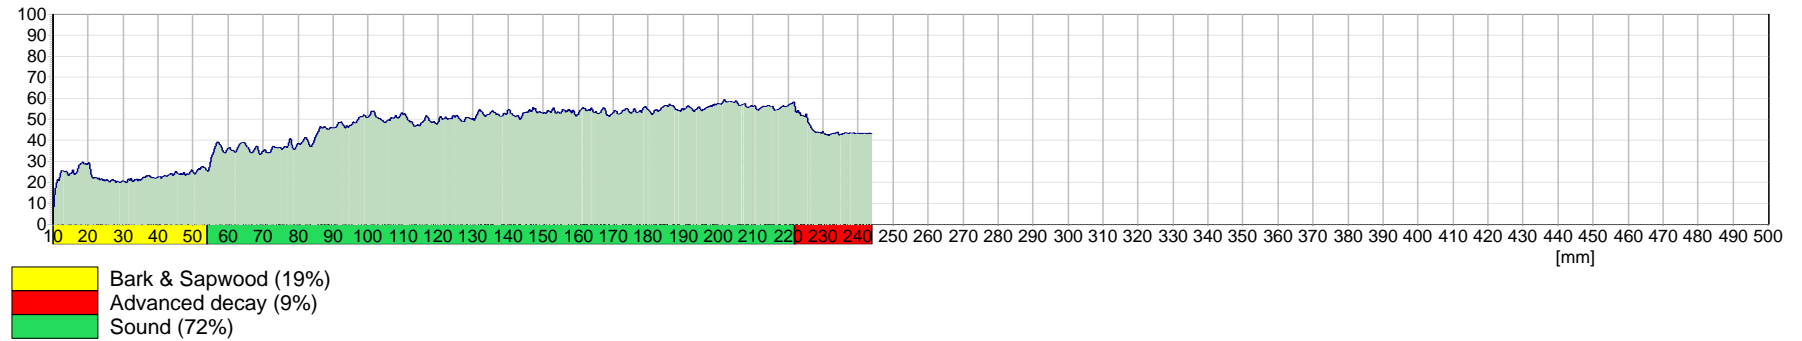
02320001 20220210 Albany Hill Tree 232 Profile #1
Sound

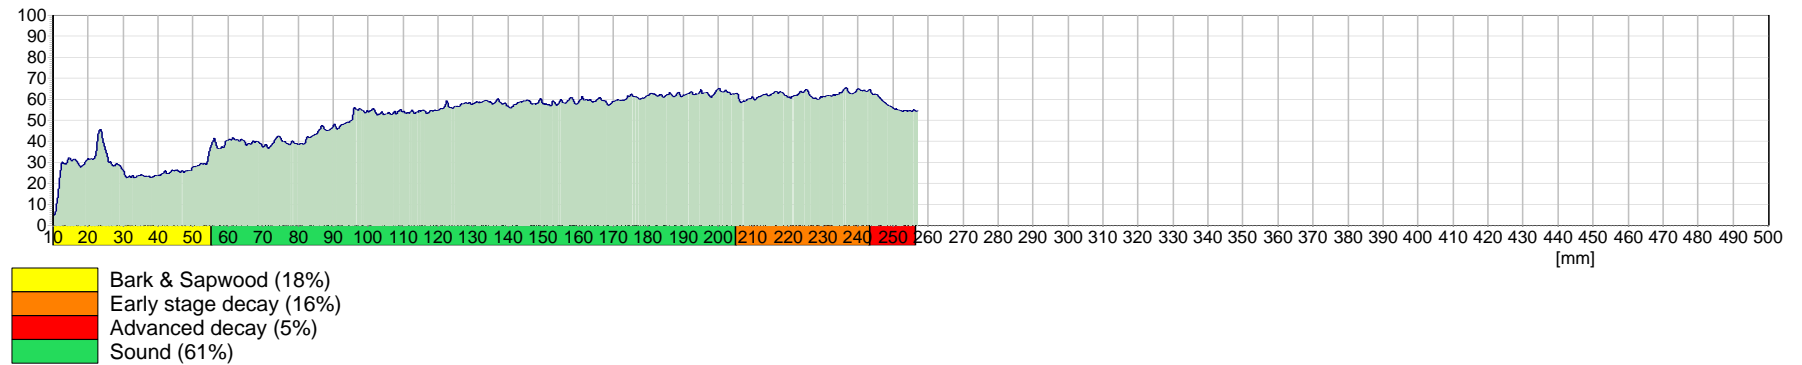
02320002 20220210 Albany Hill Tree 232 Profile #2
Functionally sound

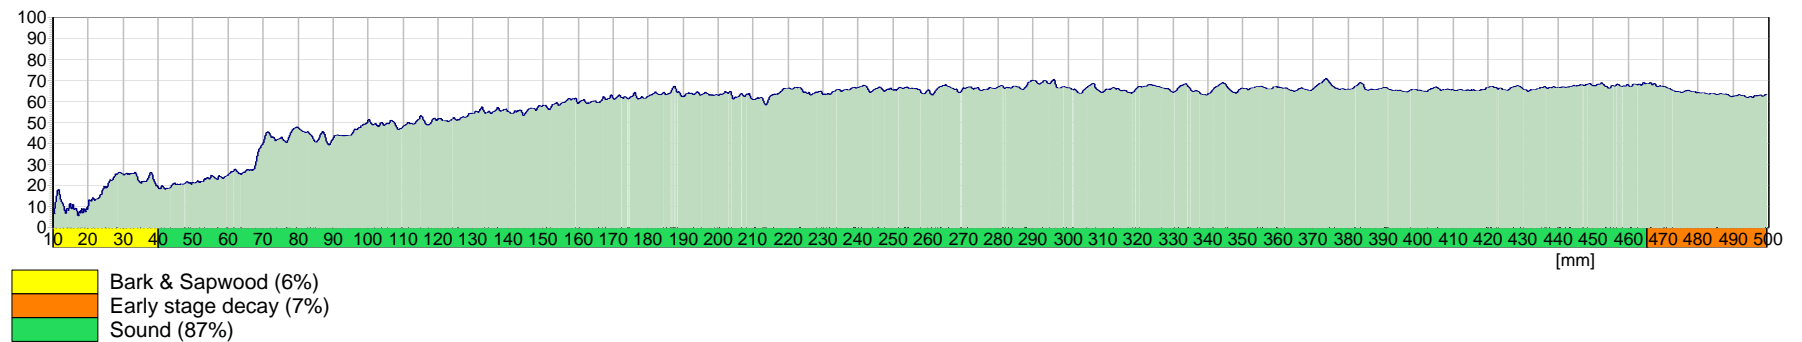
02320003 20220210 Albany Hill Tree 232 Profile #3
Sound

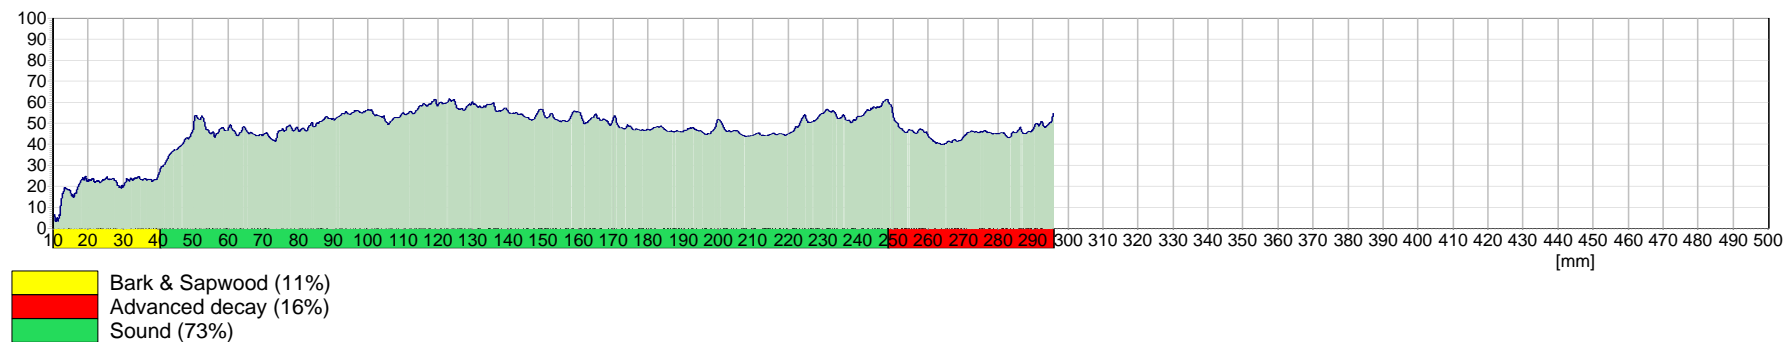
02420001 20220210 Albany Hill Tree 242 Profile #1

Sound to 24 cm, sufficient

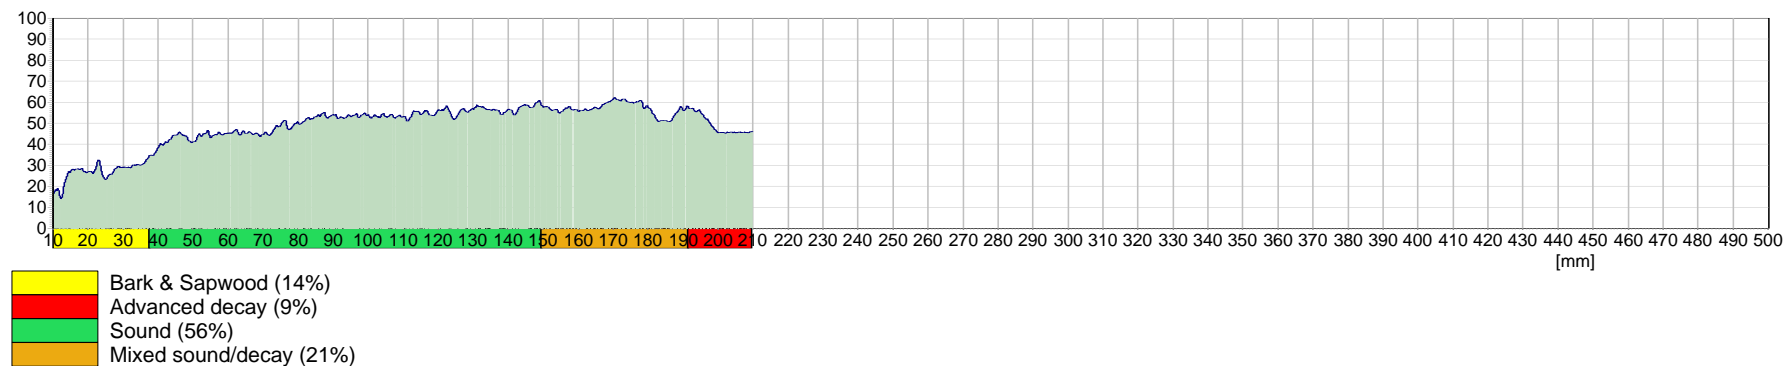
02420002 20220210 Albany Hill Tree 242 Profile #2

Sound to 15 cm in fissured zone opposite open wound, sufficient

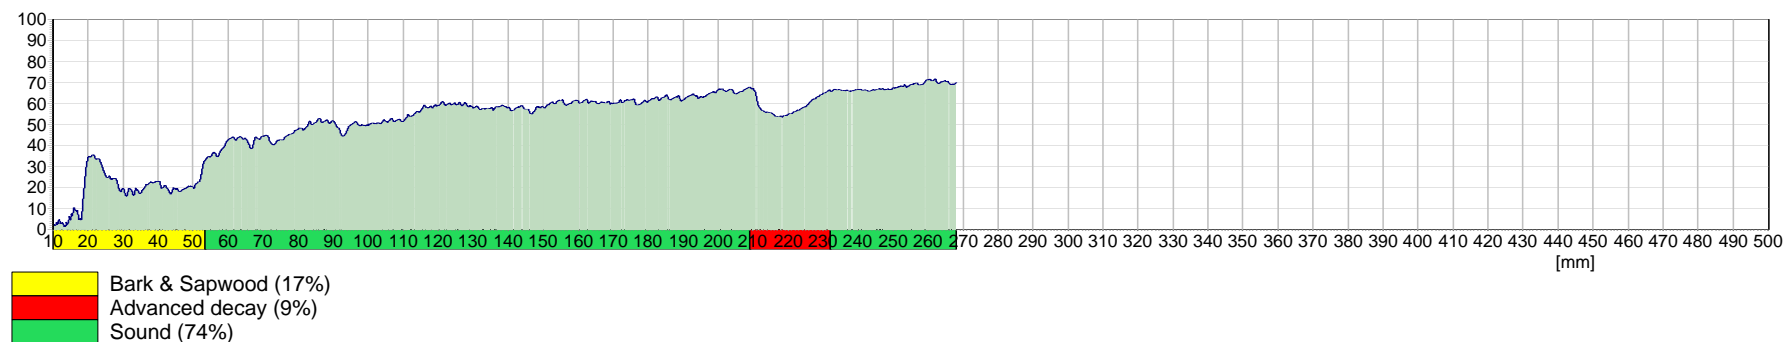
02420003 20220210 Albany Hill Tree 242 Profile #3

Functionally sound to 27 cm, sufficient, functionally sound

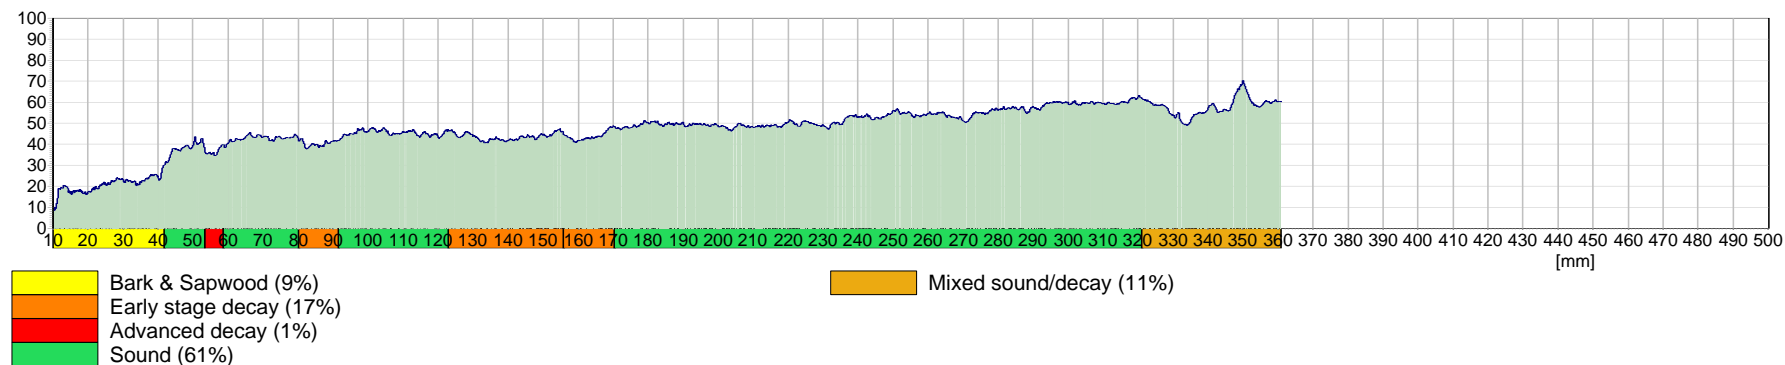
02580001 20220211 Albany Hill, Tree #258 Profile 1, by Arbortom Sensor 17
Functionally sound

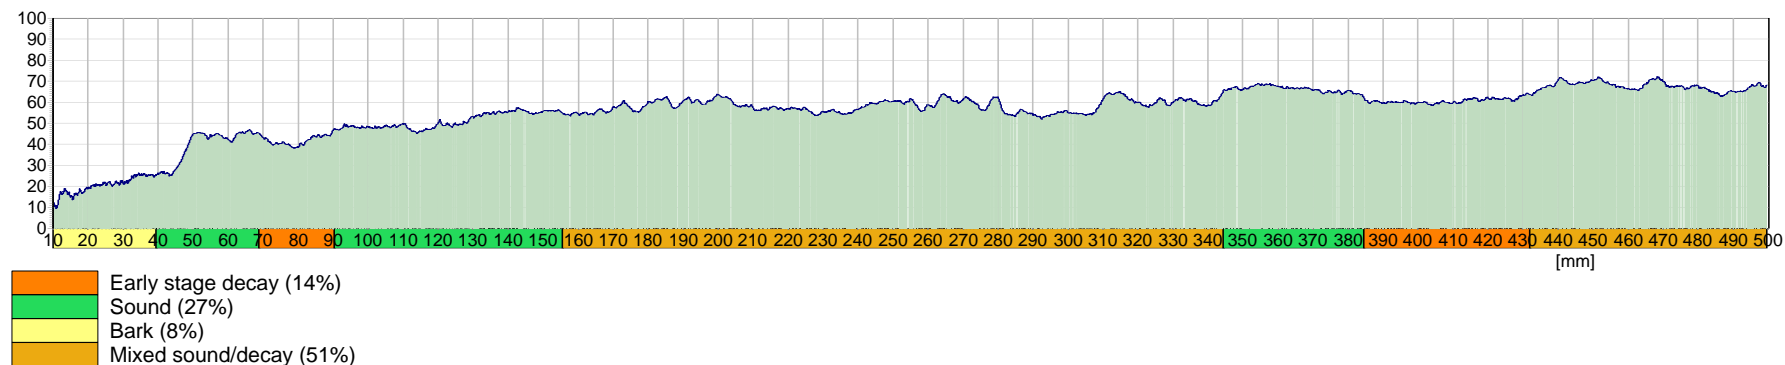
02580002 20220211 Albany Hill, Tree 258 Profile 2
Functionally sound to 17.5 cm

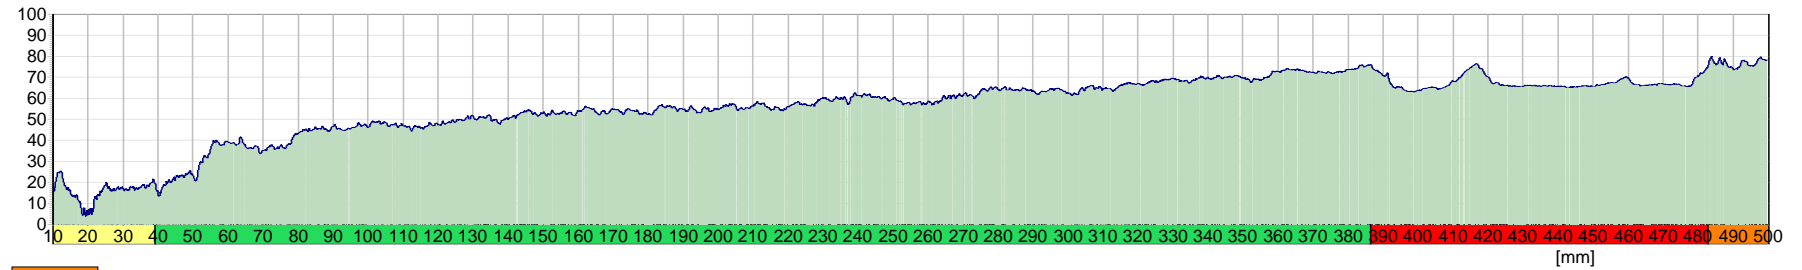
02580004 20220211 Albany Hill Tree 258 Profile #4
Sufficiently sound

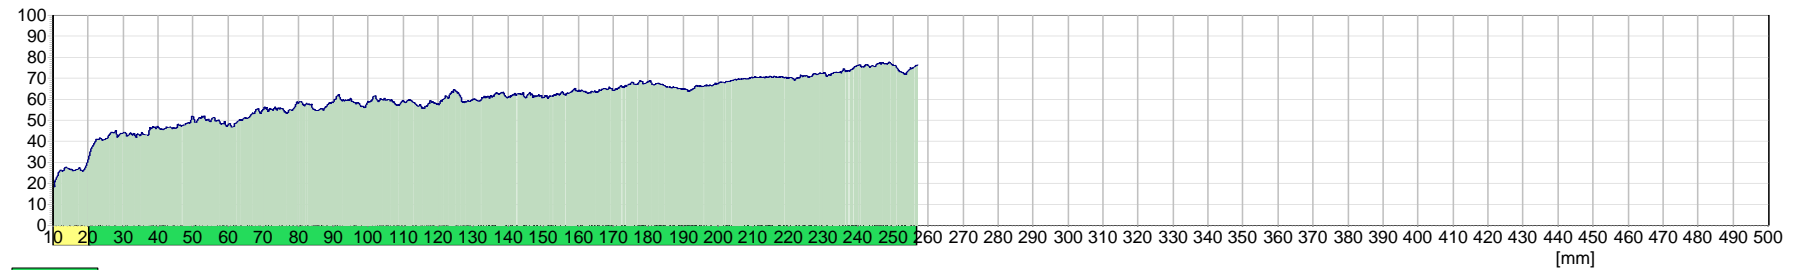
02580005 20220211 Albany Hill Tree 258 Profile #5, in root
Sound

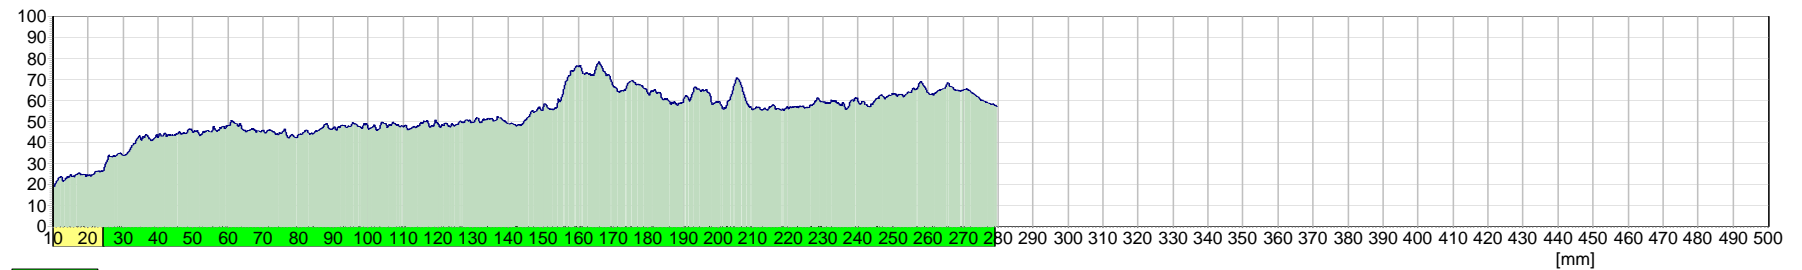
02580006 20220211 Albany Hill Tree 258 Profile #6 in root
Sound

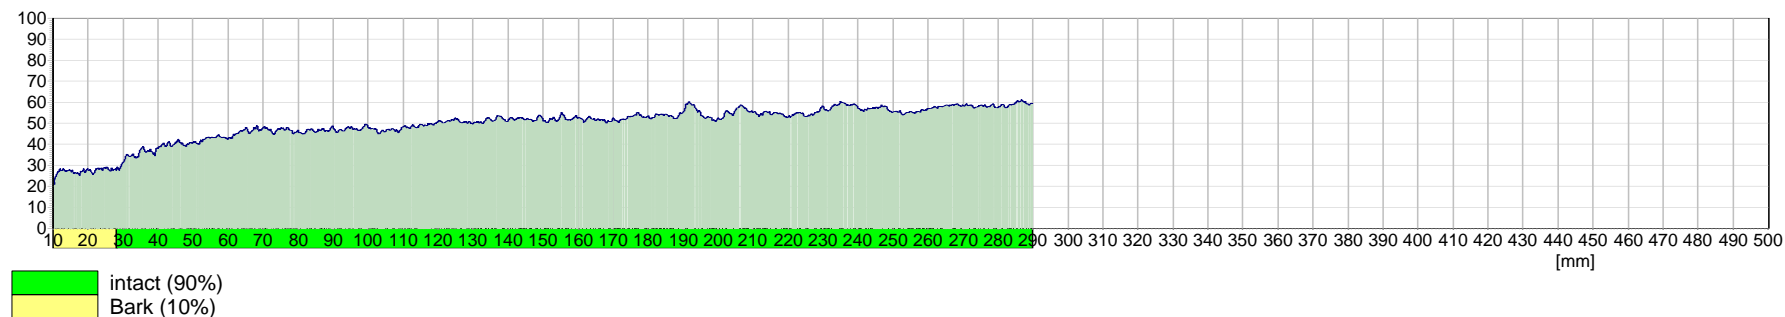
02580007 20220211 Albany Hill Tree 258 Profile #7 in root
Sound

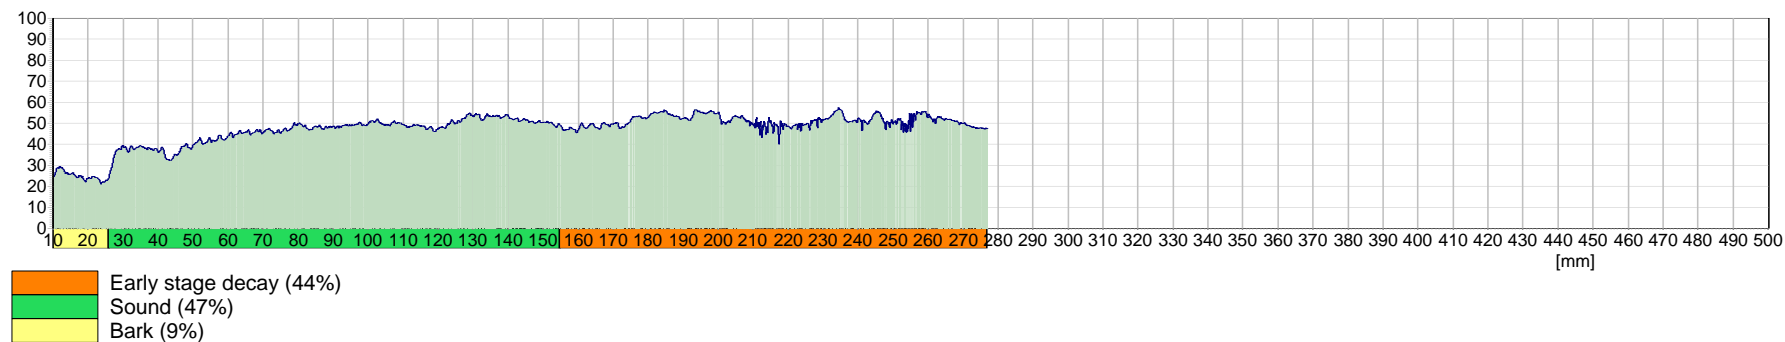
02580008 20220211 Albany Hill Tree 258 Profile #8 in root
Sufficiently sound

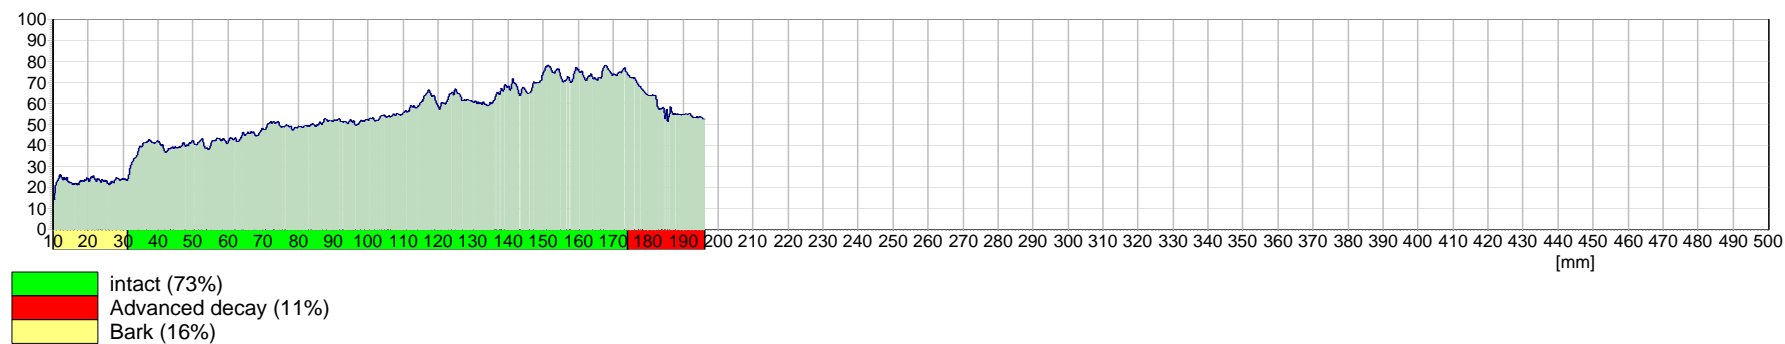
02580009 20220211 Albany Hill Tree 258 Profile #9 in root
Sound

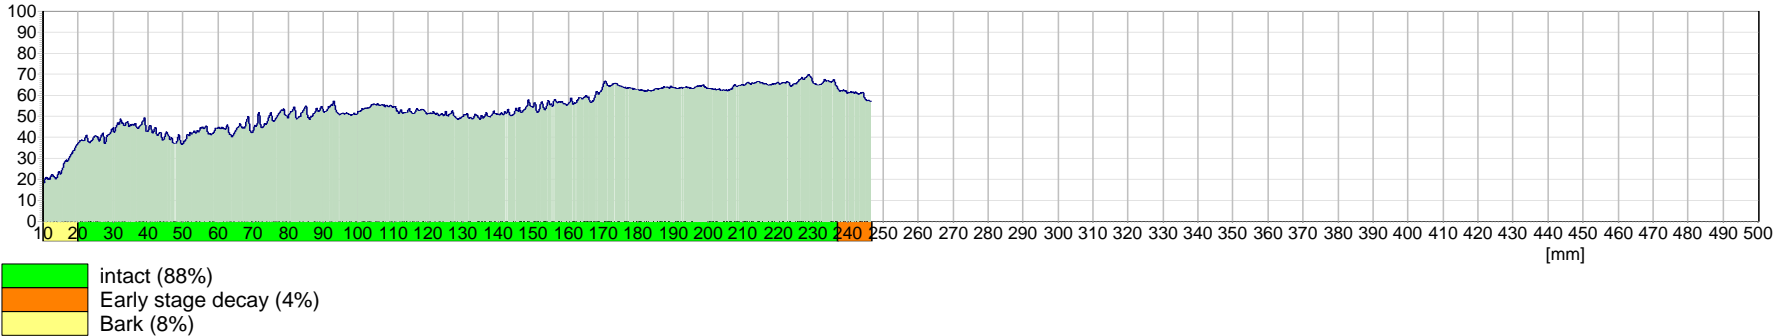
02580010 20220211 Albany Hill Tree 258 Profile #10 in root
Sound

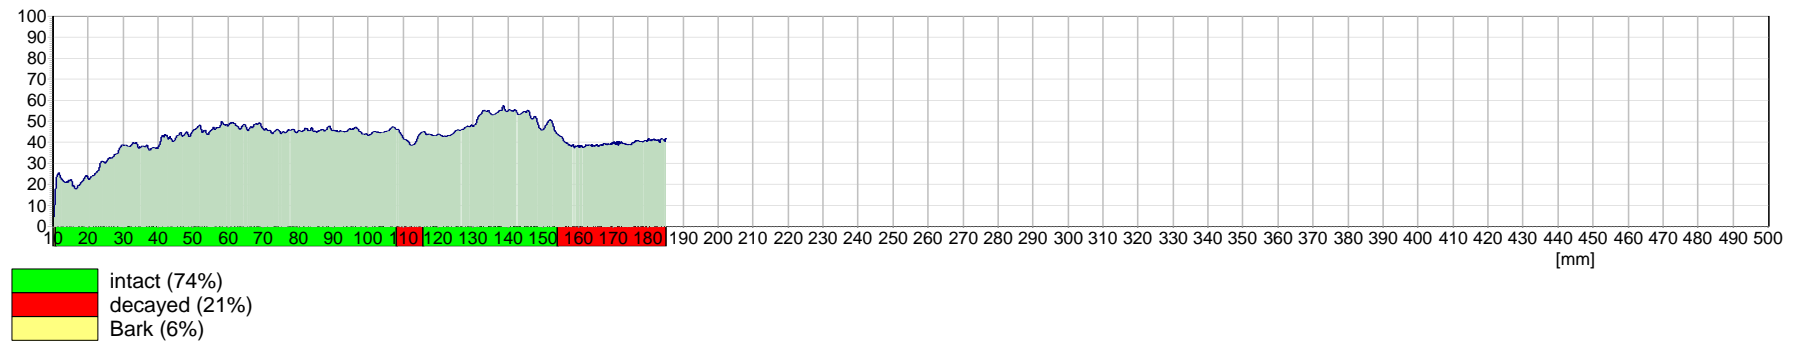
03890001 20220210 Albany Hill Tree 389 Profile #1
Sound as expected, in all new tissues outside the old stump
