City of Albany

SUBJECT: 5-1. Pavement & Curb Rehabilitation Project – Marin Ave Phase 2 Tree Removals

AGENDA DATE: June 12, 2025

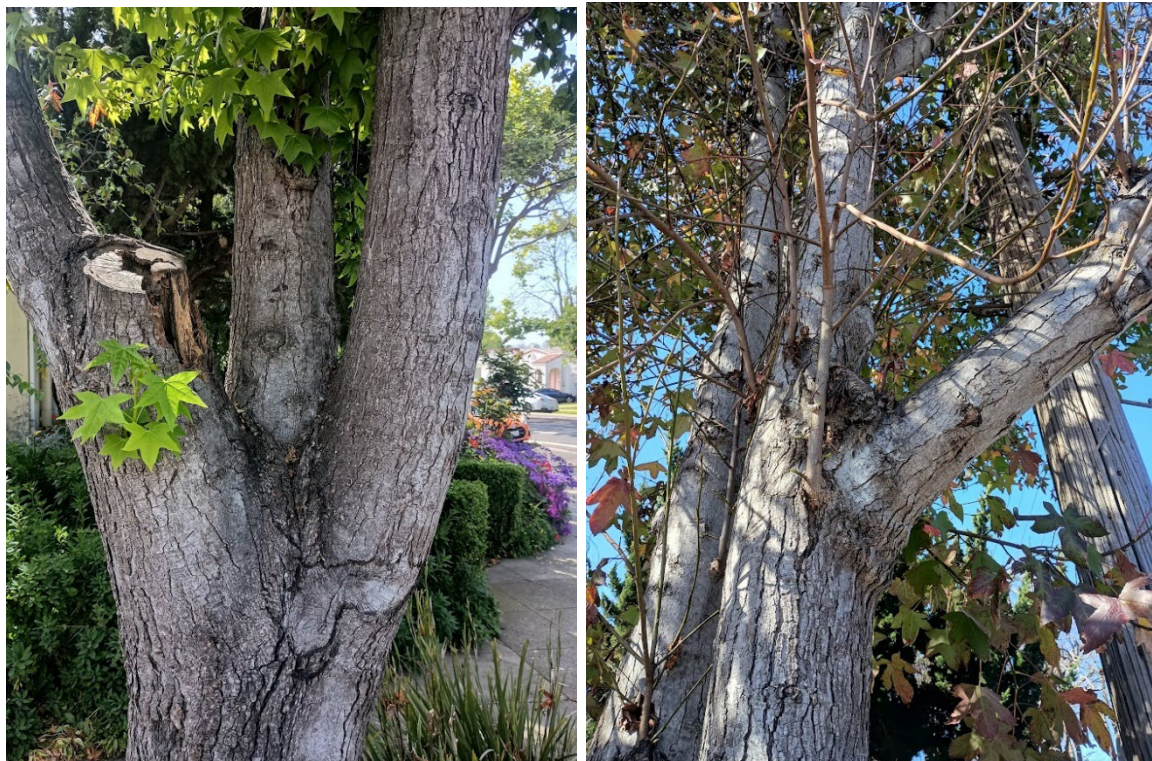
The tree is located a few feet from a power pole with roots visibly growing around, and possibly into the base of the pole. The tree is regularly topped for high-voltage powerline clearance. There is continued sidewalk lifting from the massive root plate that extends up and down the parkway. The tree also exhibits narrow branching unions, typical of the species, and has epicormic sprouting along its main stems, typically a sign of tree health decline. The over-winter leaves were marcescent (retained on the tree), often indicating a tree under stress.

(Narrow branching unions of main stems [left] and epicormic sprouting and marcescence [right])

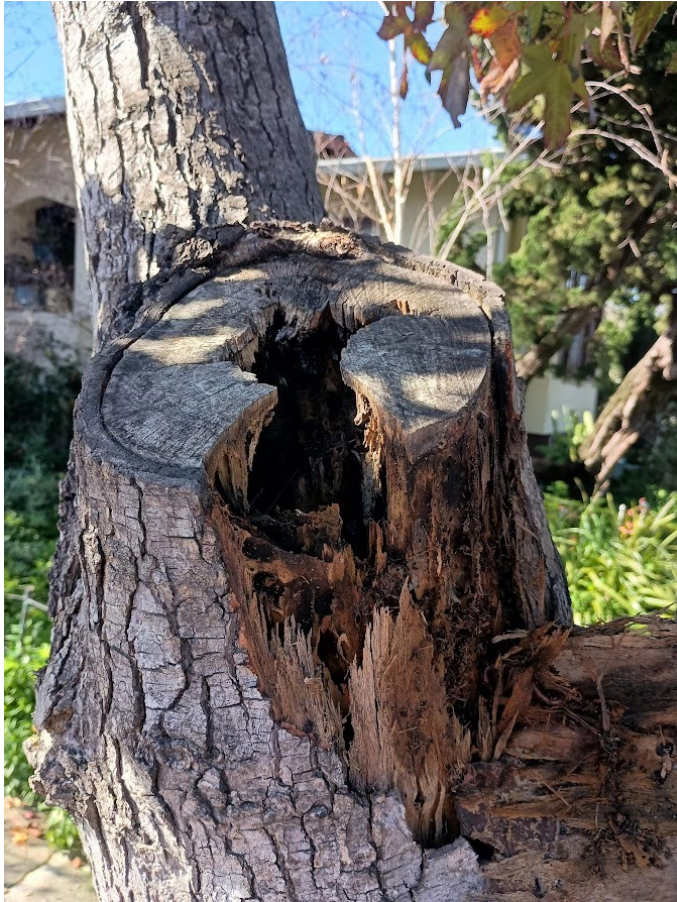
The main concern however is the extensive decay visible in the root plate and at the base of one of the three main lateral limbs. At the base of one of the remaining main stems is a wound that compromises the integrity of that, and possibly the other two main stems. Also, and more concerning, is the decay in the root plate, as can be seen on the curb side of the tree. *Armillaria mellea* (aka, white rot fungus or, root rot) fruiting bodies were observed growing from the root plate in February of this year.

(Decay at base of stem)

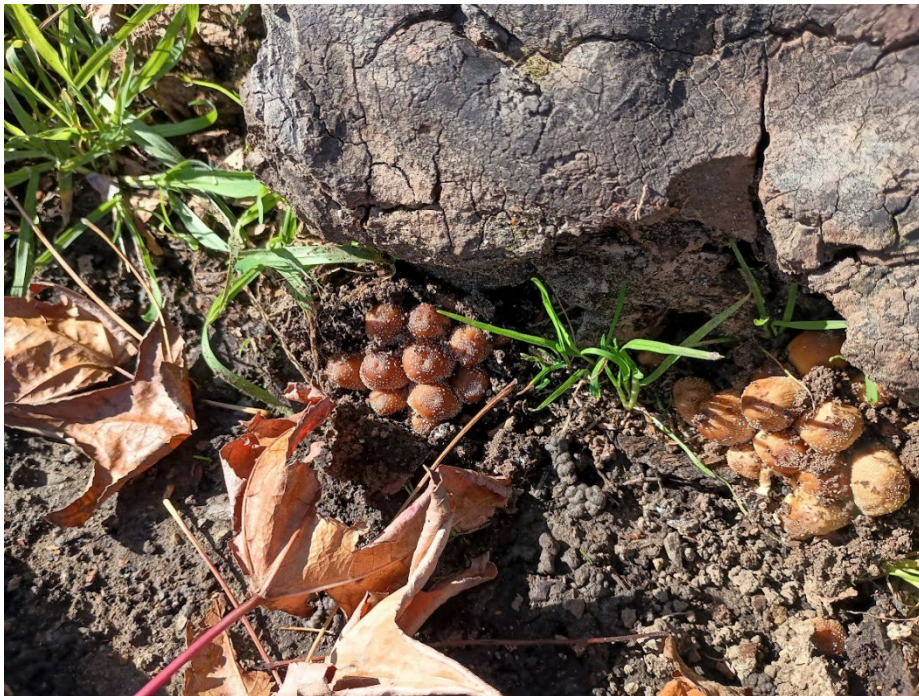
(Armillaria fruiting bodies)

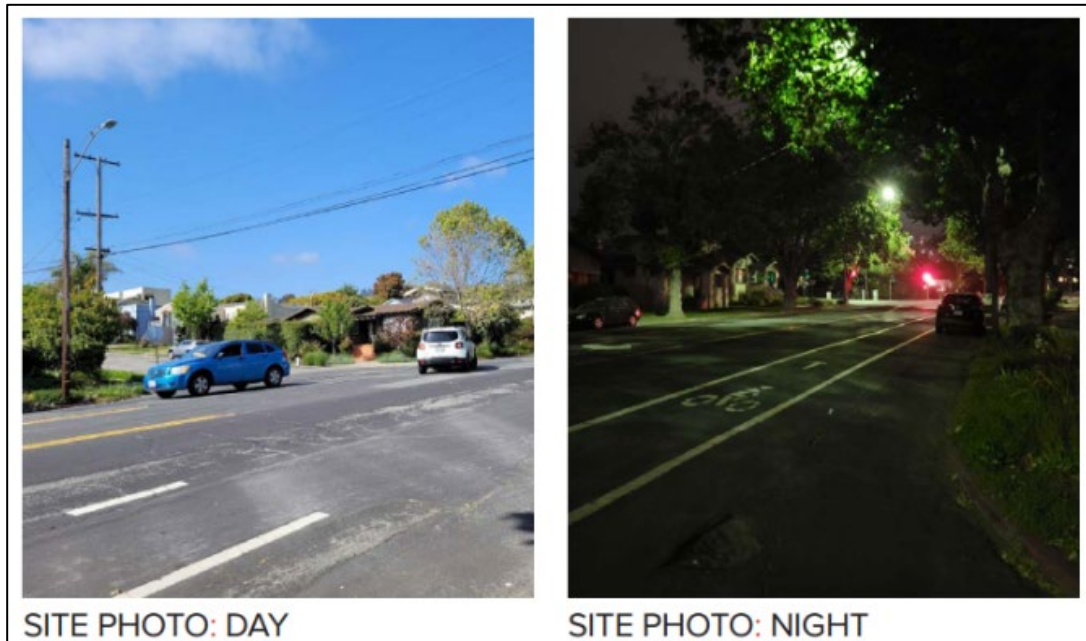
During this Citywide Streetlight Assessment, the Marin/Neilson intersection was coincidentally selected as one of the 10 sites where more in-depth and site-specific observations and measurements were performed. As seen in the photos, the intersection is low and unevenly lit; this is supported by illuminance data/luminance measurements showing that the intersection has light levels which are too far below criteria, resulting in inadequate visibility and safety concerns.

(NE Corner of Marin/Neilson – SLE, Existing Lighting Conditions)

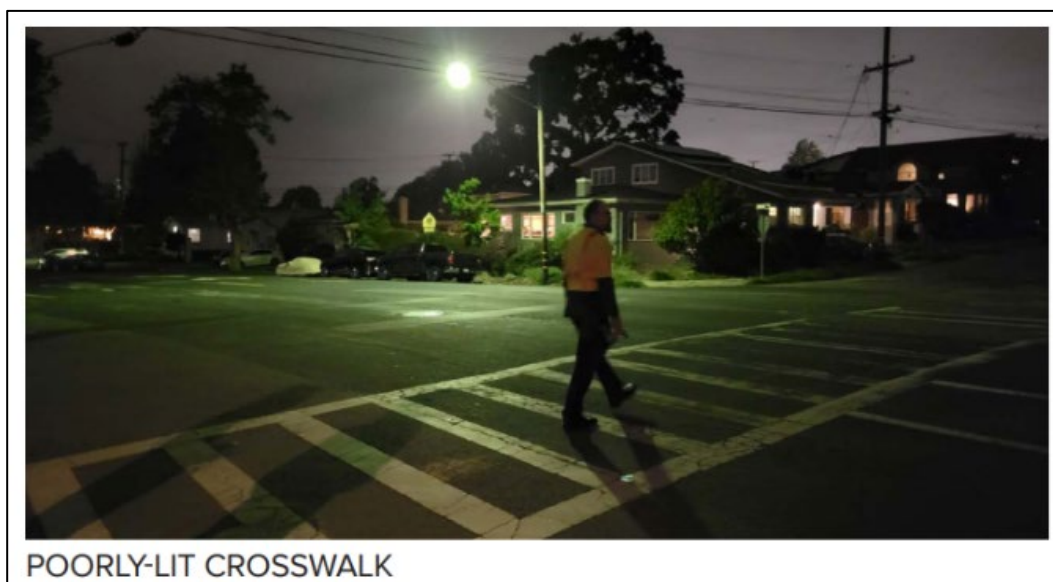
Not only does the intersection not meet a reasonable range of measurements, photos of the intersection (specifically the east leg of the Marin/Neilson intersection) were later used in the Citywide Streetlight Evaluation to showcase an example of poor lighting in Albany.

(Photo 1: NW Corner of Marin/Neilson at East Leg Crossing; – SLE, Existing Lighting Conditions)

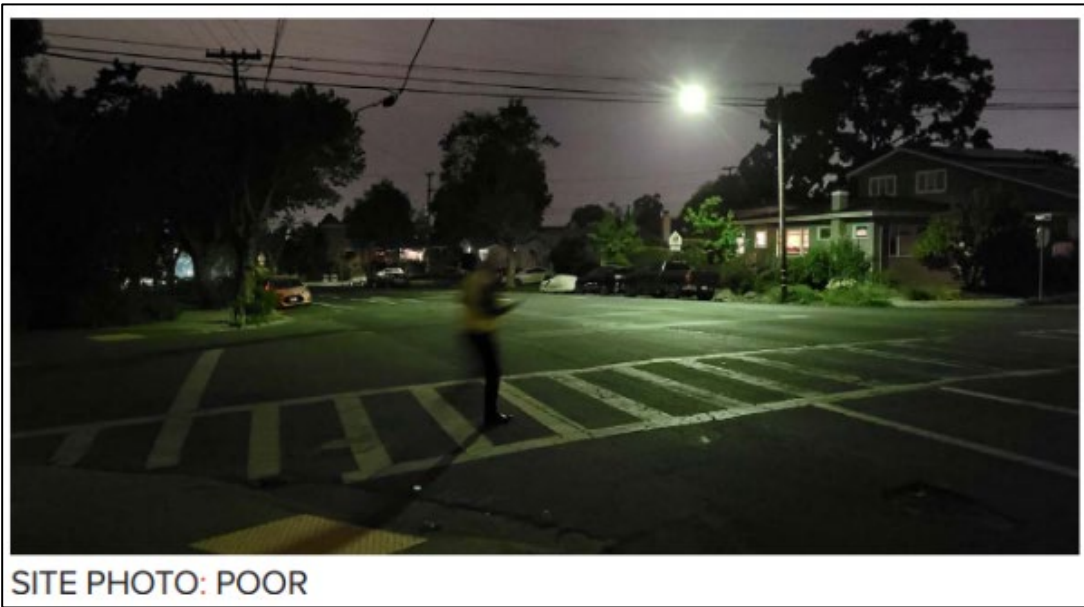
(Photo 2: NW Corner of Marin/Neilson at East Leg Crossing; – SLE, Existing Lighting Conditions)

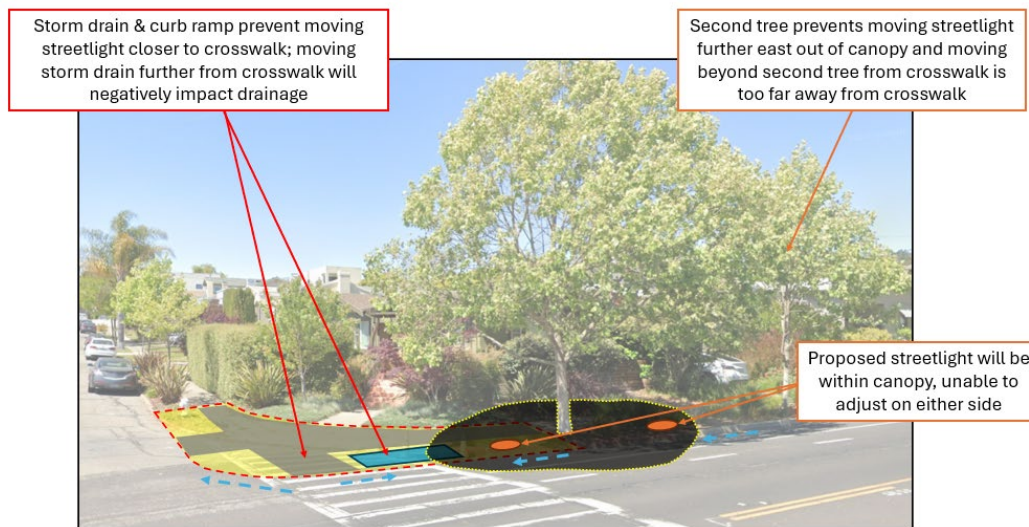
For the NE corner of Marin/Neilson, project design explored multiple options for adjusting the streetlight location but were unable to identify a location where the proposed streetlight could be placed with sufficient clearance from existing trees, while still providing 1) the level and quality of lighting per guidelines established in the Citywide Streetlight Evaluation, 2) maintaining accessibility requirements at the curb ramp, and 3) ensuring stormwater flow is properly captured upstream of the ADA curb ramp so as to prevent water ponding in the vicinity of the pedestrian crossing.

Specifically, there is insufficient space available to move the streetlight westward towards the curb ramp without relocating the storm drain inlet. Relocating of the storm drain eastward to avoid impacting the existing trees would result in water ponding at a low point in the vicinity of a shallow curb ramp/pedestrian crossing. For more background about the storm drain and curb ramp design challenges on the Project, refer to Attachment 1 (Marin Avenue Pavement & Curb Ramp Rehabilitation Project Report, Dated April 2025).
