# Item 5-1. Pavement & Curb Rehabilitation Project – Marin Ave Phase 2

Presentation on Potential Tree Removals

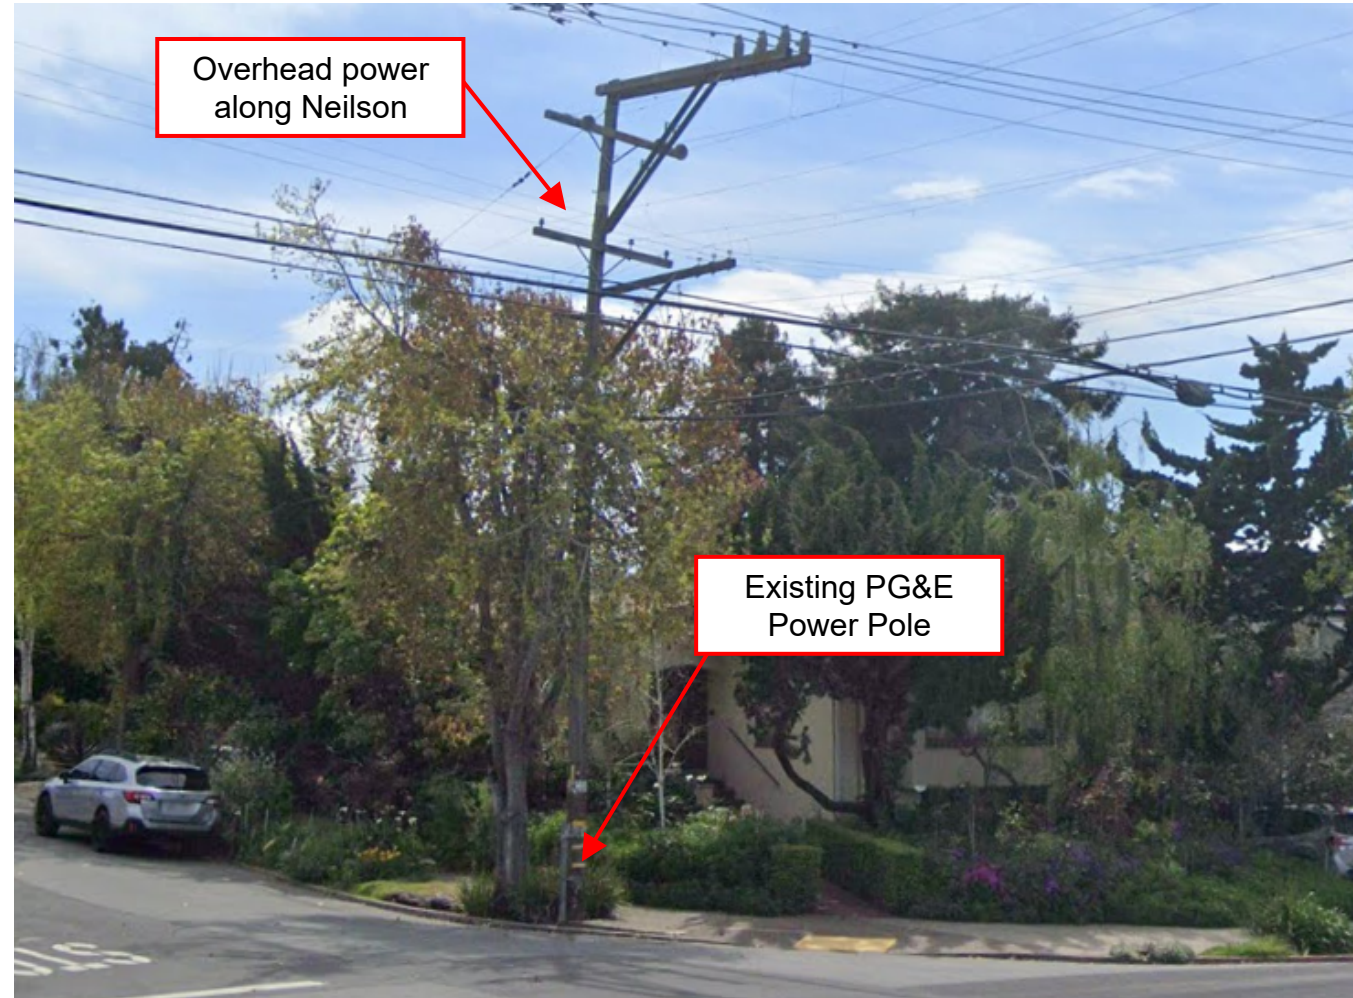
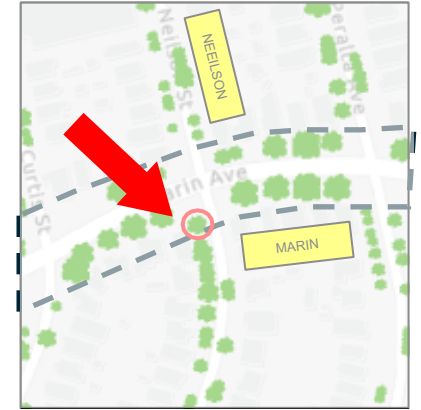
# Tree ID #2824 (at 1498 Marin)

Liquidambar 18" DBH

Tree Condition: **Poor**

Location: 1498 Marin (on Neilson)

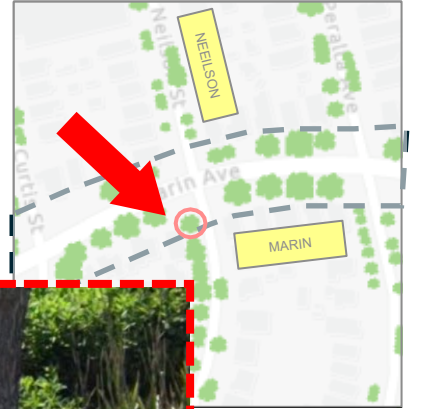
# Tree ID #2824 (at 1498 Marin)

Additional Concerns:  
Epicormic sprouting,  
Marcescent over-winter  
leaves

Main stem  
wound and  
decay

Large root plate  
with extensive  
visible decay

- 
- Storm drain graded at a low point; unable to move without negatively affecting drainage at curb ramp
- Existing PG&E Power Pole
- Reversing gutter to create artificial low point for local capture

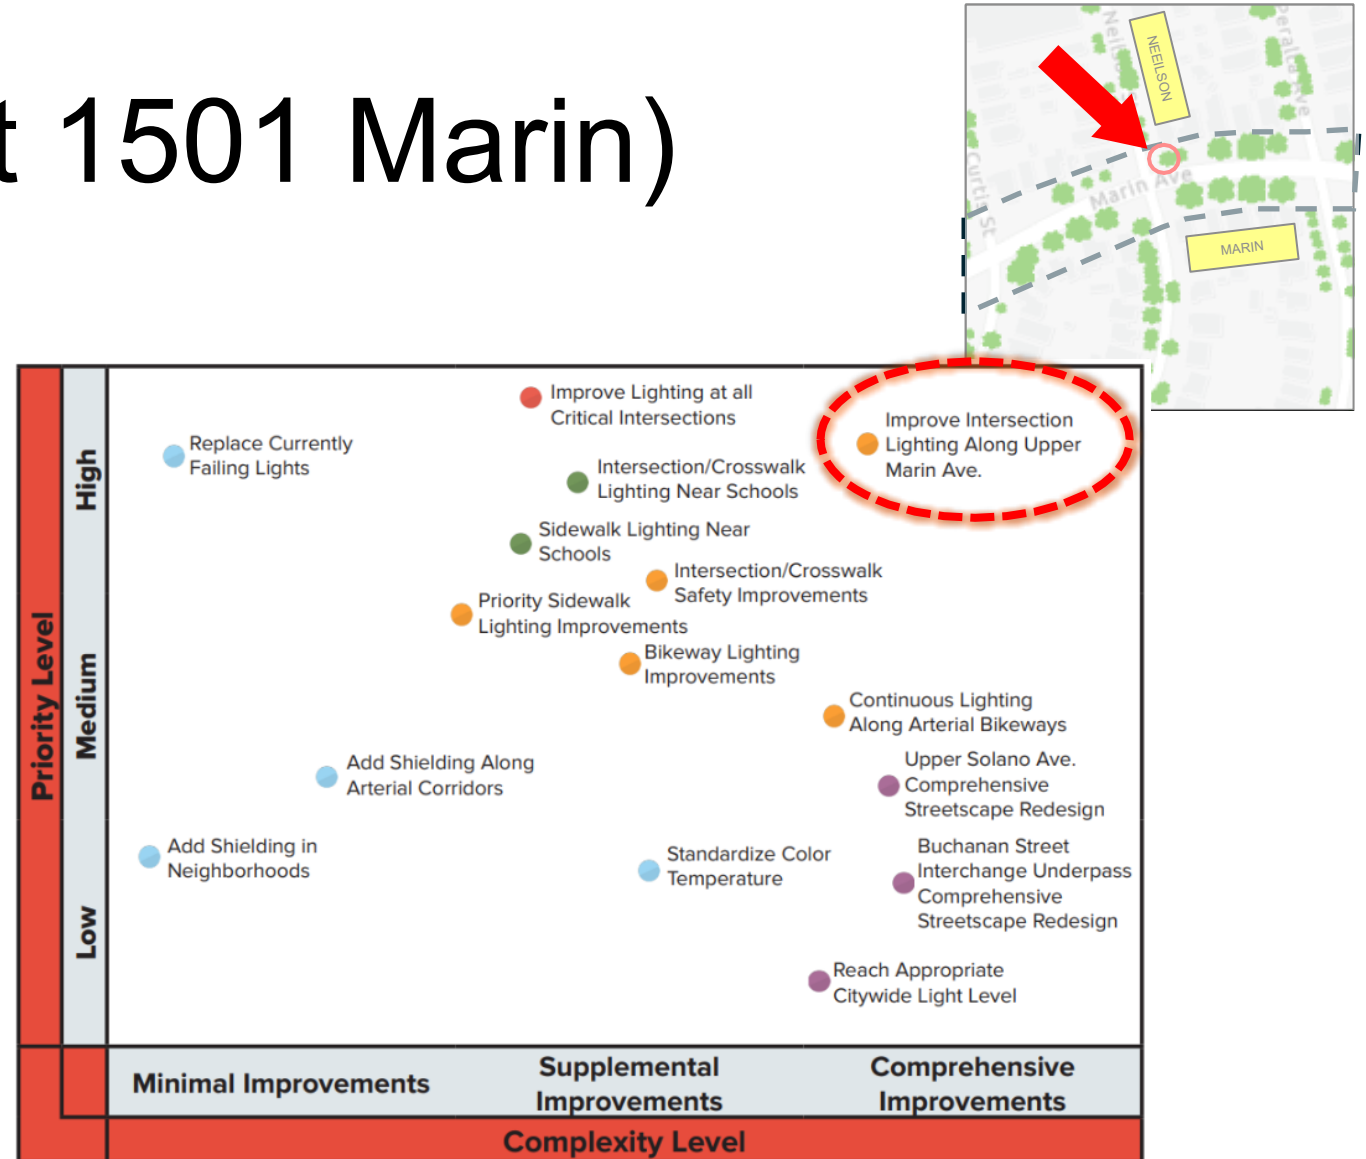
# Tree ID #1639 (at 1501 Marin)

- Background:
  - 2023 Citywide Streetlight Evaluation
- Marin Avenue
  - Low light
  - Unevenly lit
  - Safety concerns
- Upper Marin Avenue Intersection Lighting High Priority

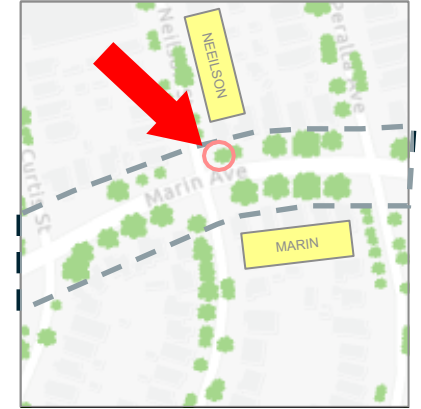
Tree #1639

- Specific measurements and study performed at Neilson/Marin

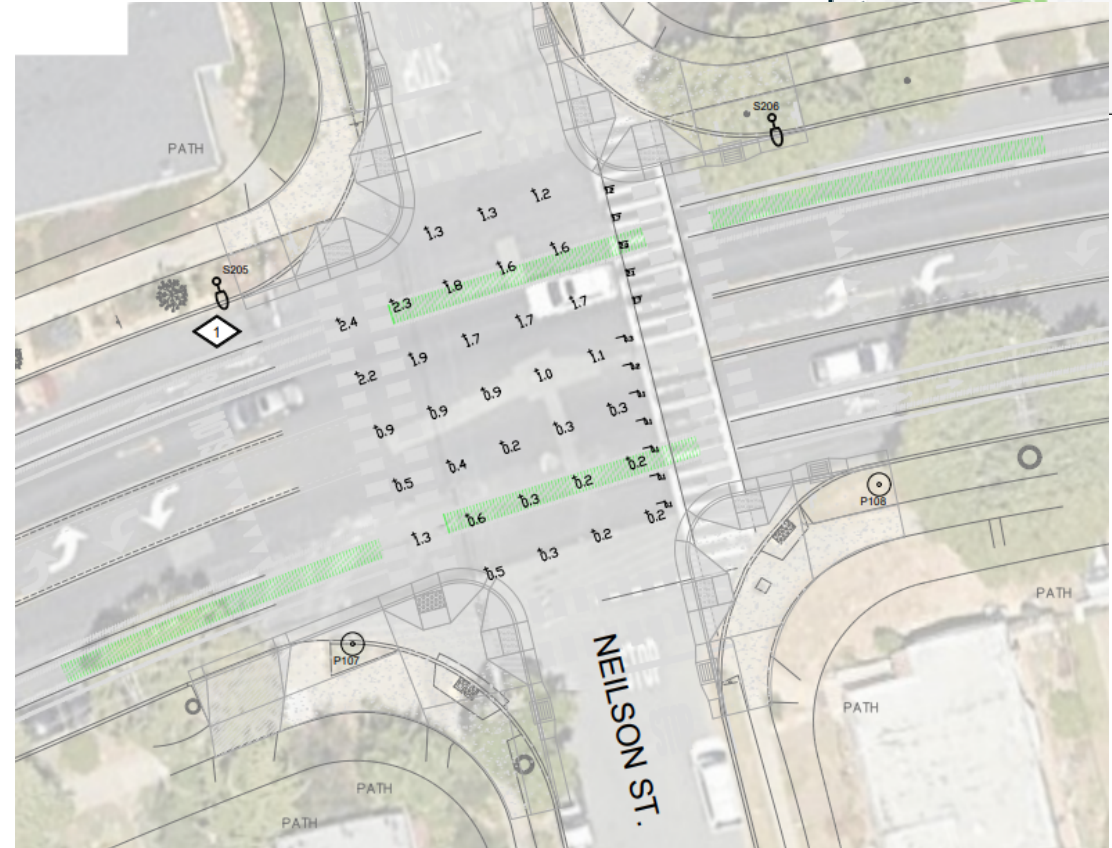
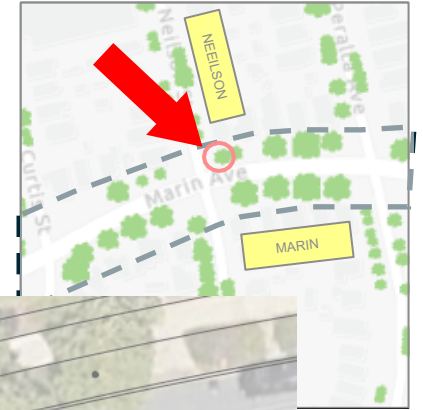
# Tree ID #1639 (at 1501 Marin)

- Site specific design through photometric studies

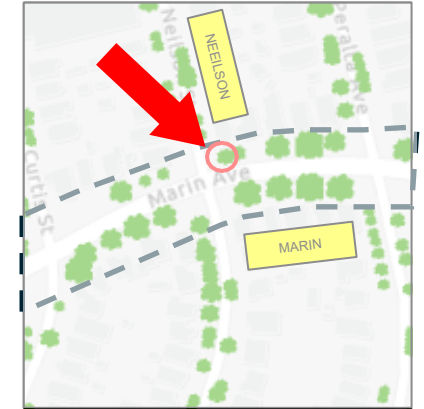
# Tree ID #1639 (at 1501 Marin)

Storm drain & curb ramp prevent moving streetlight closer to crosswalk; moving storm drain further from crosswalk will negatively impact drainage

Second tree prevents moving streetlight further east out of canopy.

Backlighting, poor lighting condition persists
