MCNEIL ARBORICULTURE CONSULTANTS LLC

March 18, 2022

Assessment of Tasmanian blue gum trees, *Eucalyptus globulus* in Albany Hill Park

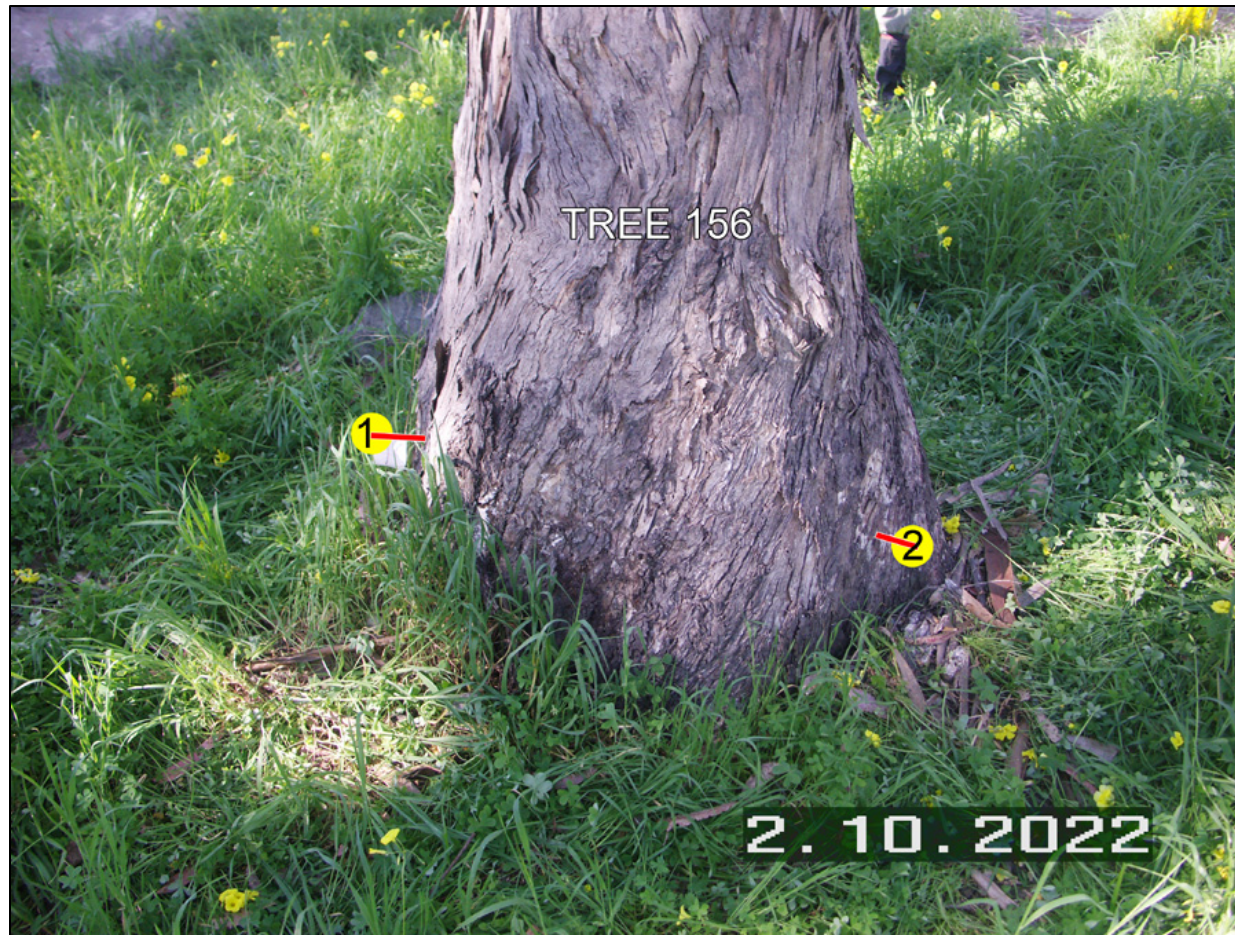
APPENDIX IV PHOTO KEY OF RESISTOGRAPH LOCATIONS, TREE #156

01560001 20220210 Albany Hill, Tree 156 Profile #1
Mixed sound with decay, functionally sound

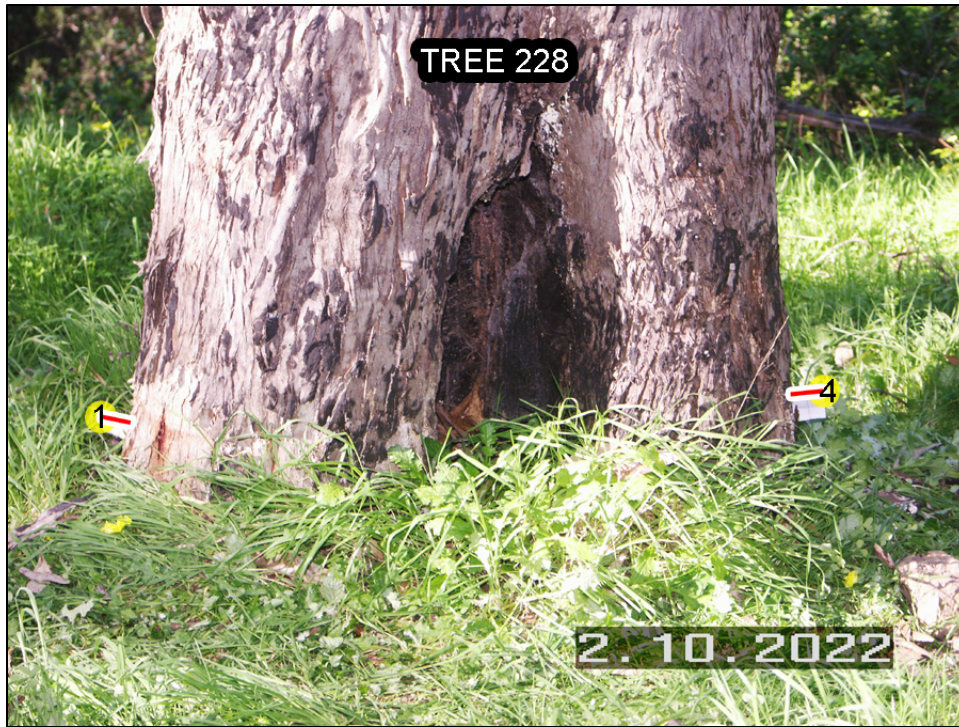
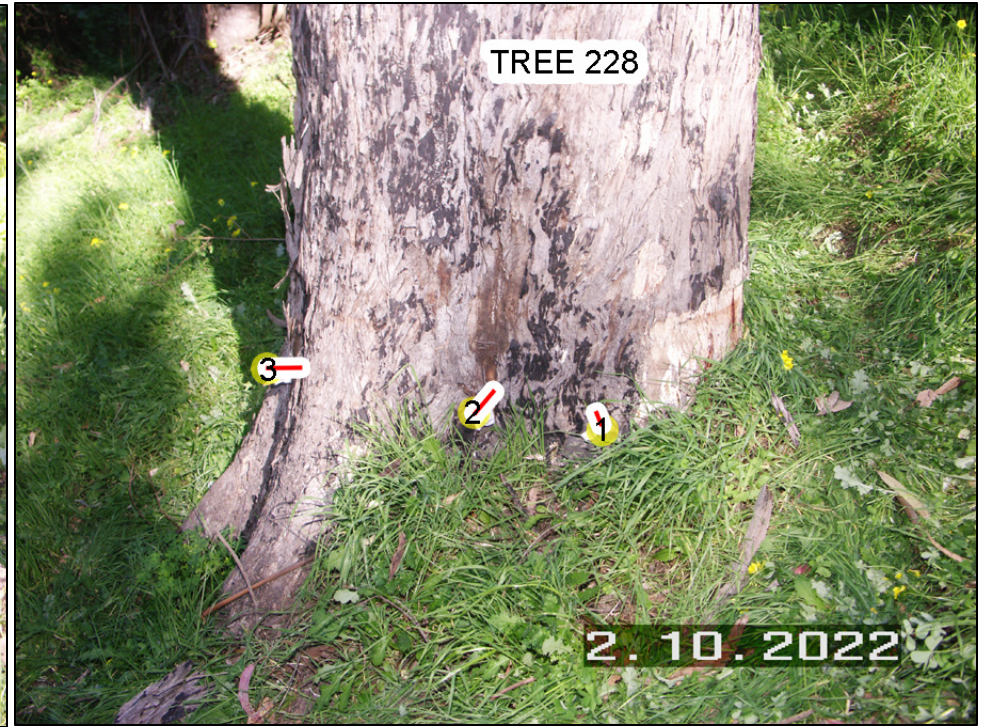
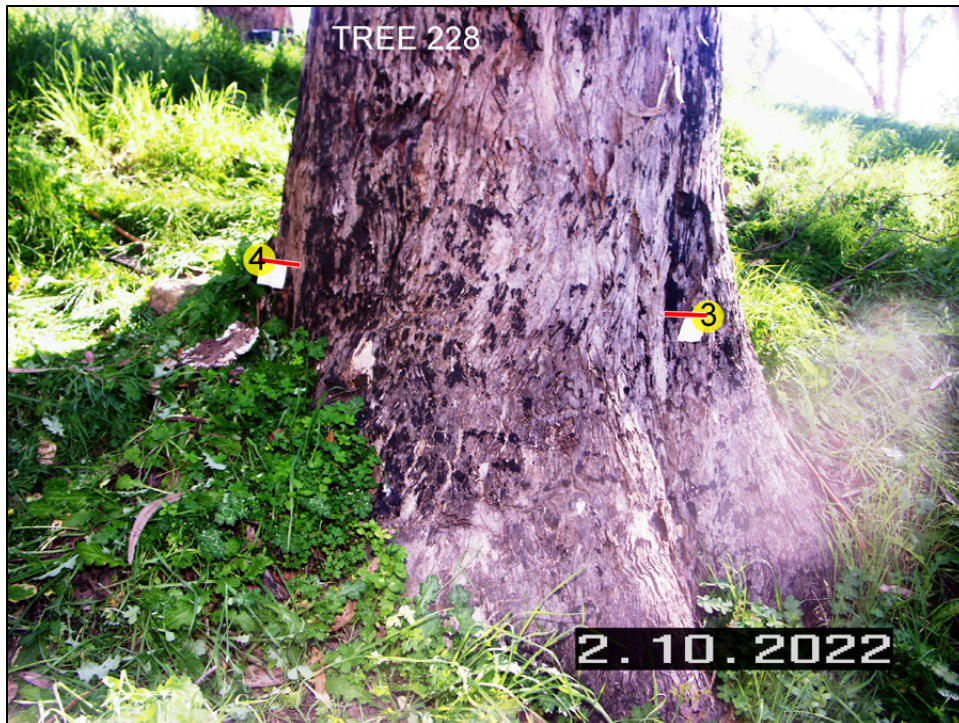
APPENDIX IV PHOTO KEY OF RESISTOGRAPH LOCATIONS, TREE #228

02280001 20220210 Albany Hill Tree 228 Profile #1

Mixed decay states past about 9.5 cm

Mixed sound with decay states

Mixed sound with decay, functionally sound

Mixed sound with decay, functionally sound given location in the tree

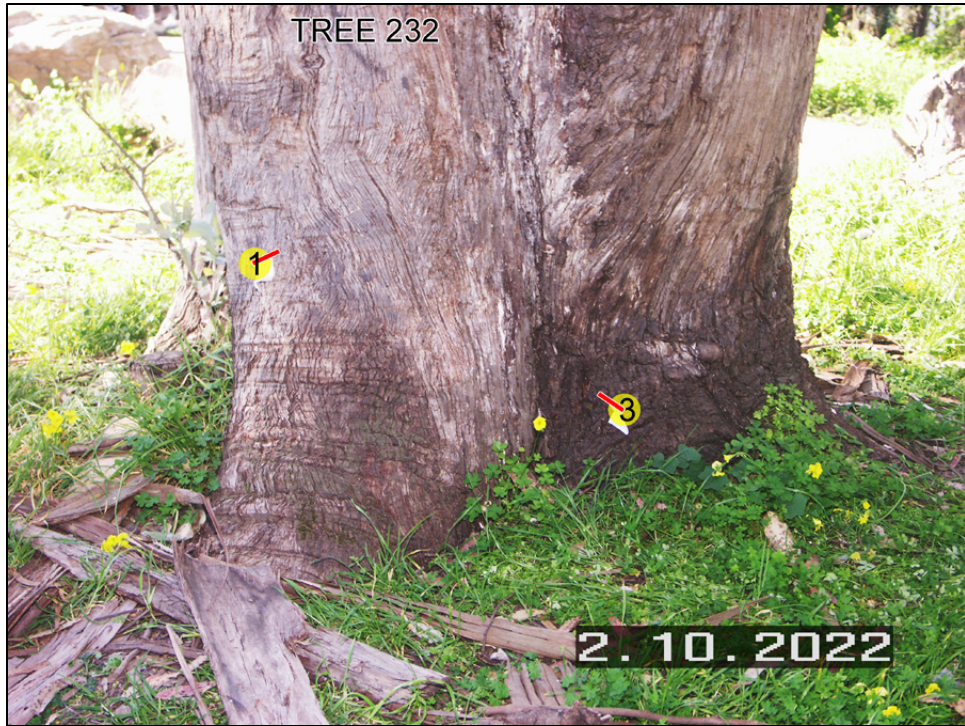
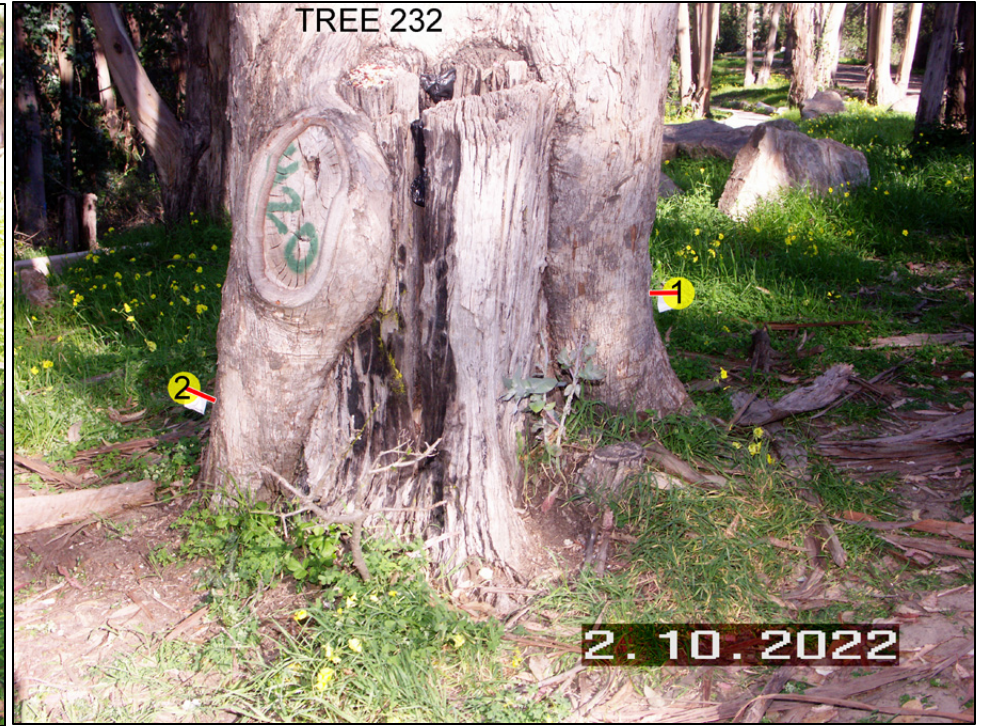
APPENDIX IV PHOTO KEY OF RESISTOGRAPH LOCATIONS, TREE #232

02320001 20220210 Albany Hill Tree 232 Profile #1
Sound

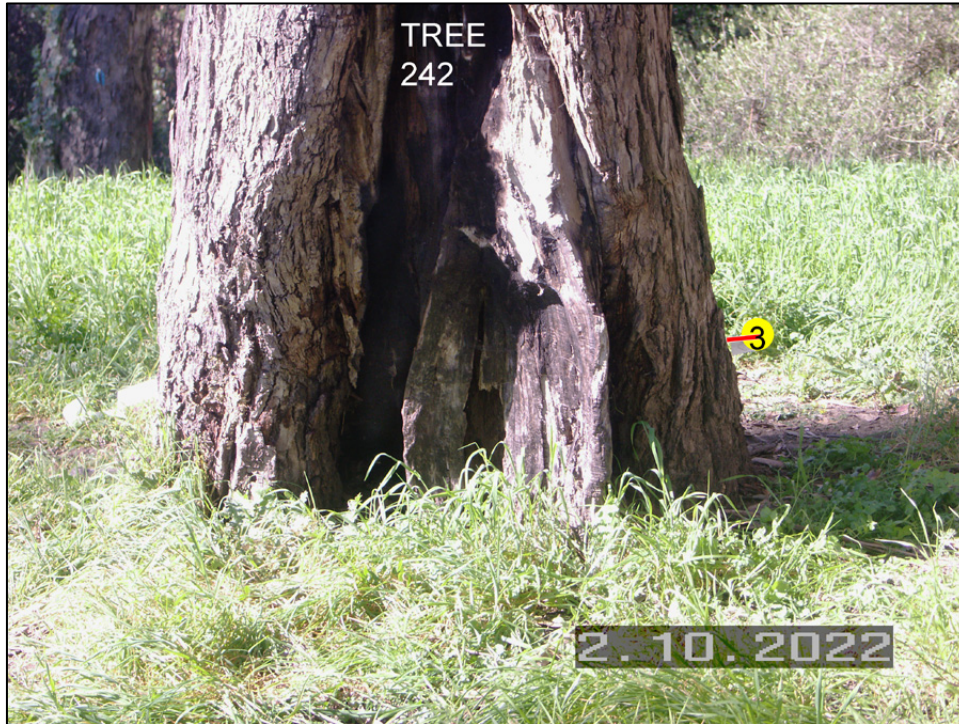
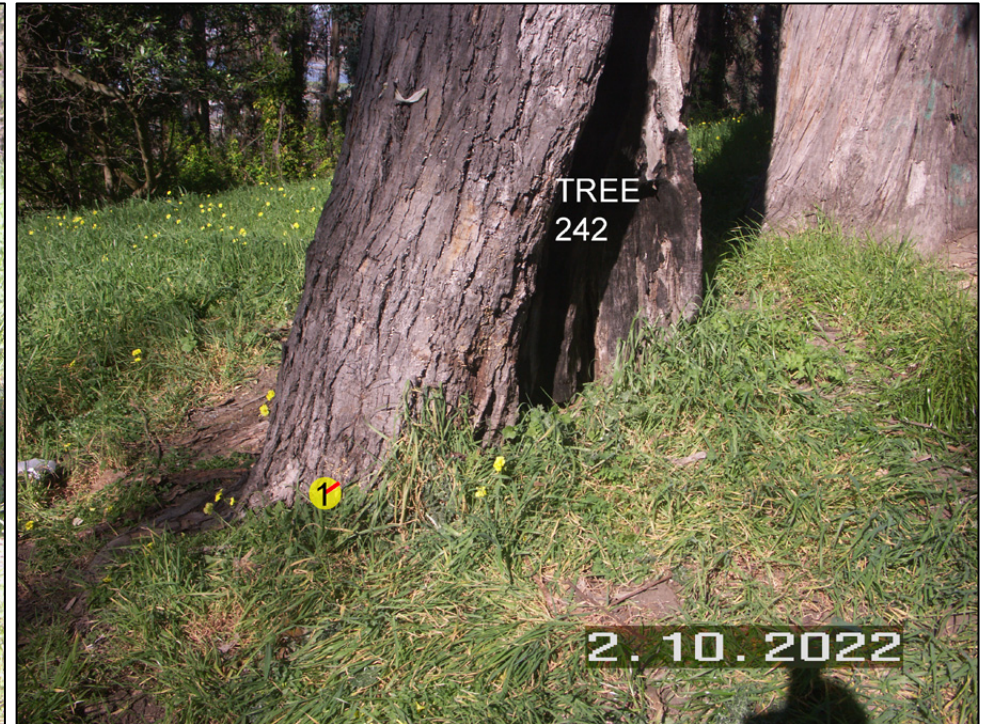
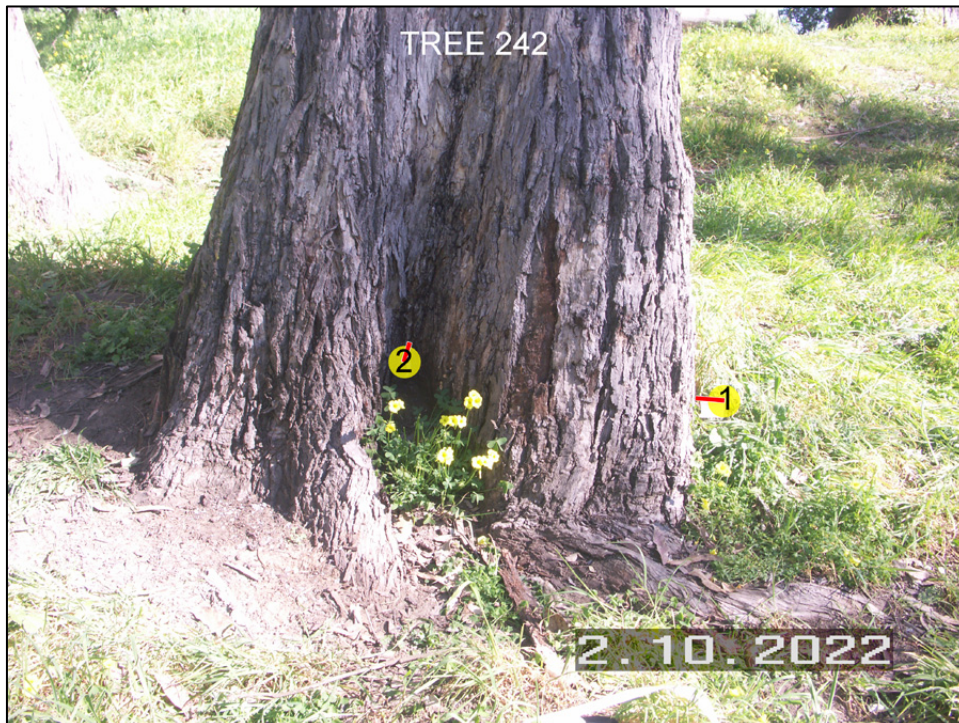
APPENDIX IV PHOTO KEY OF RESISTOGRAPH LOCATIONS, TREE #242

Tree #	Whole Failure Likelihood	Disposition	Resistograph	Tomograph	Comments
242	Possible	Remove	X		Leans downhill. Declining
246	Improbable	Remove			Current fair health, but declining.
247	Improbable	Remove			Severe decline
248	Improbable	Remove			Extreme decline
249	Improbable	EWR over path			Remove limb endweight
250	Improbable	Remove			Mechanically OK, but declining, could remove, or at minimum reduce limb endweight on the east side.
251	Improbable	Remove			Half dead currently
252	Improbable	Remove			
253	Improbable	Remove			
254	Improbable	EWR over path			Currently mechanically stable, remove limb endweight
255	Improbable	EWR over path			Currently mechanically stable, remove limb endweight
256	Improbable	Remove			Currently mechanically stable
258	Improbable	Retain	X	X	Fair to good health, full canopy. Mechanically it has excellent trunk and limb taper, foliage distribution vertically. Remove deadwood of two inch or larger diameter from the east half of the tree, toward the path.

02420001 20220210 Albany Hill Tree 242 Profile #1

Sound to 15 cm in fissured zone opposite open wound, sufficient

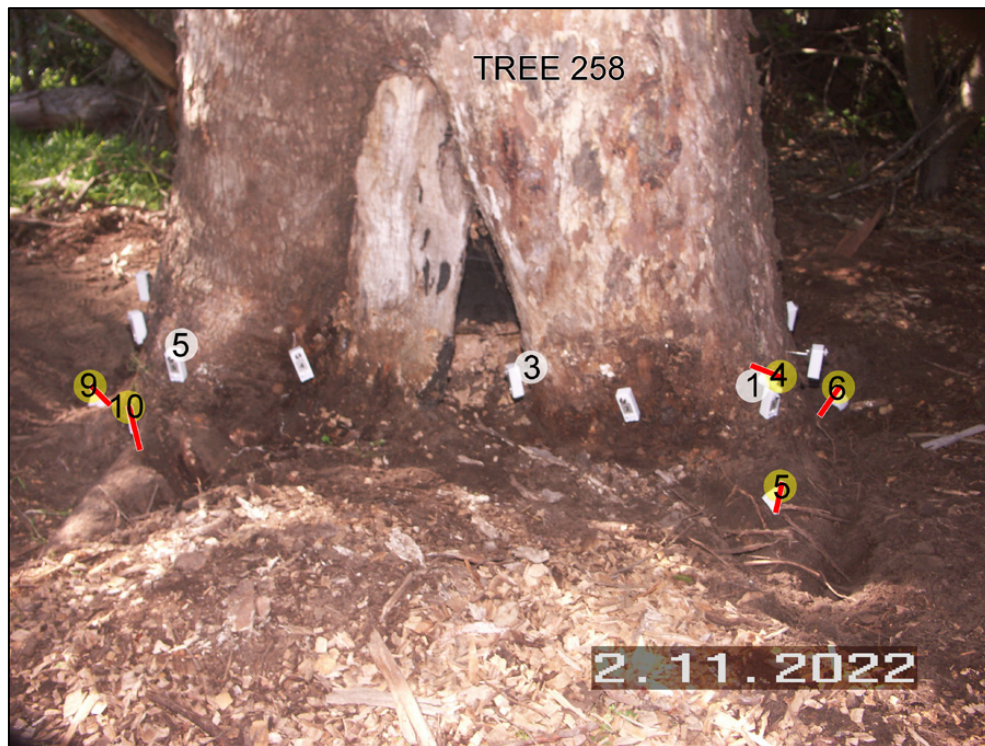
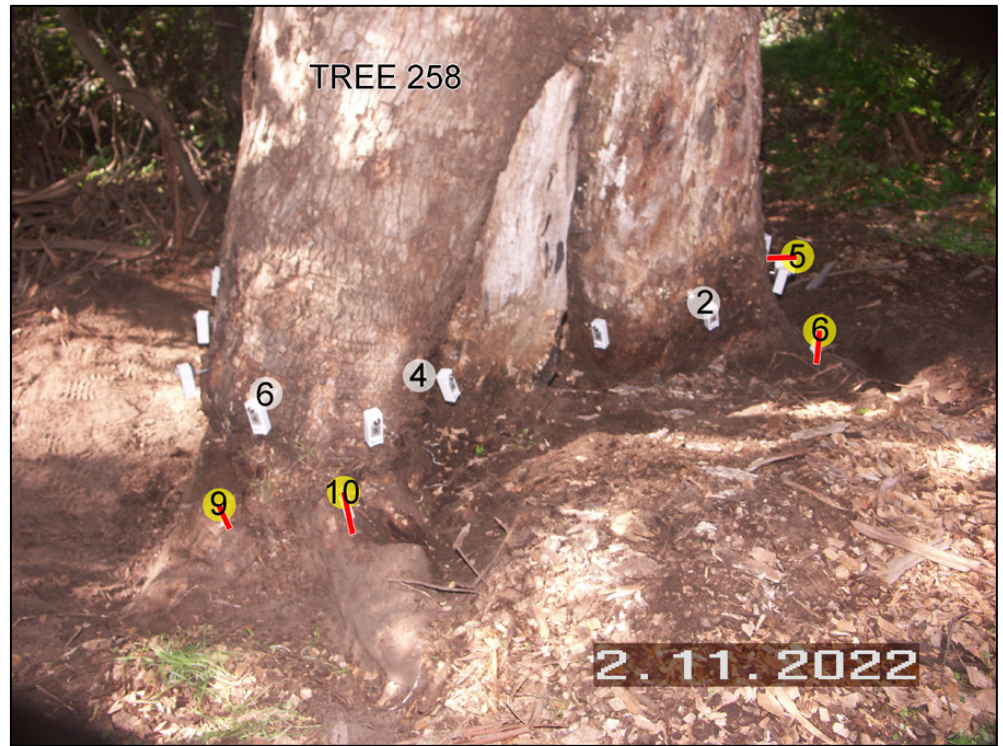
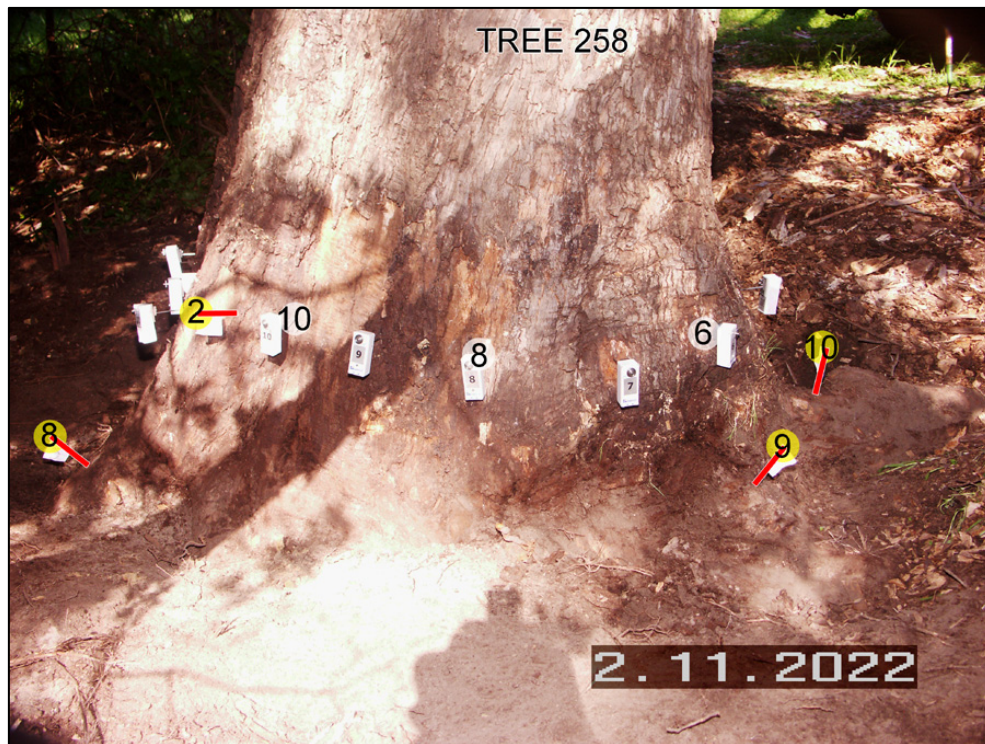
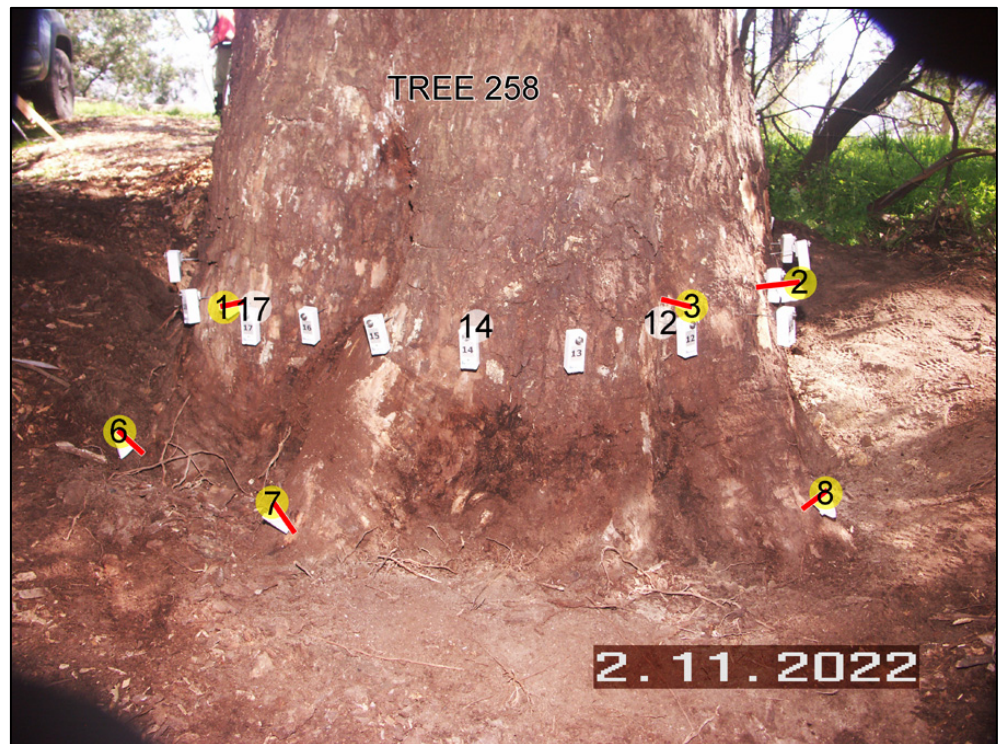
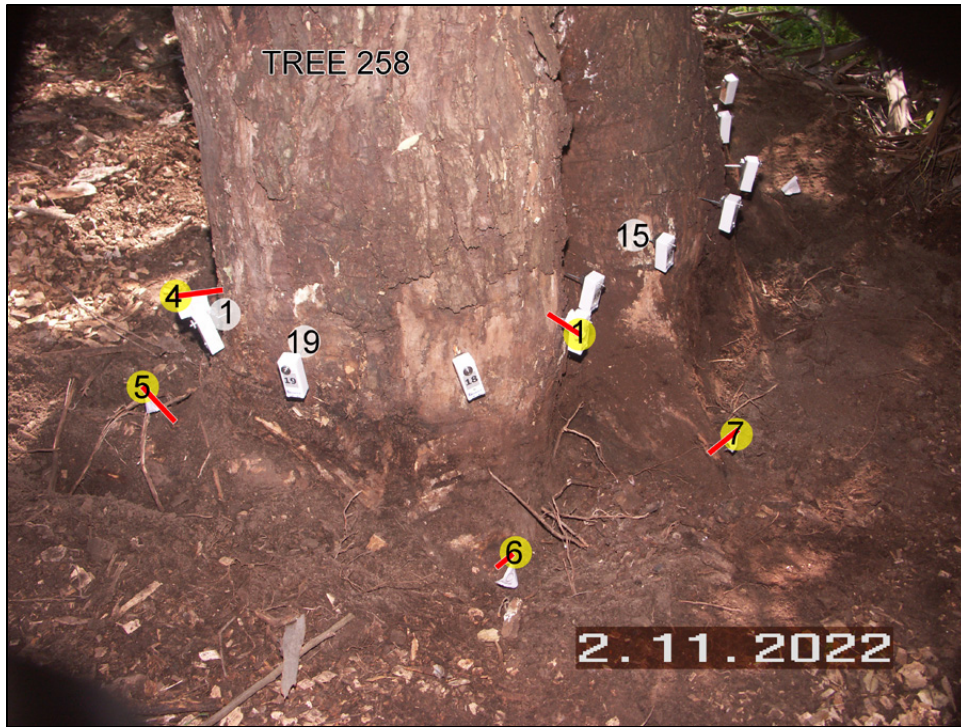
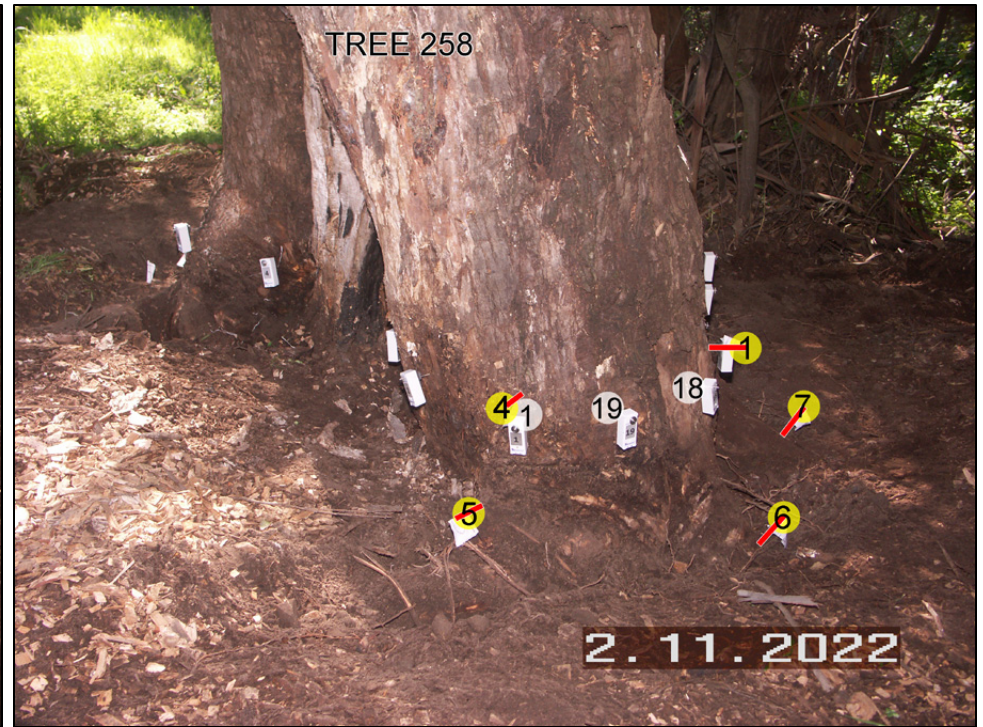
APPENDIX IV PHOTO KEY OF RESISTOGRAPH/TOMOGRAPH LOCATIONS, TREE #258

02580001 20220211 Albany Hill, Tree #258 Profile 1, by Arbortom Sensor 17
Functionally sound

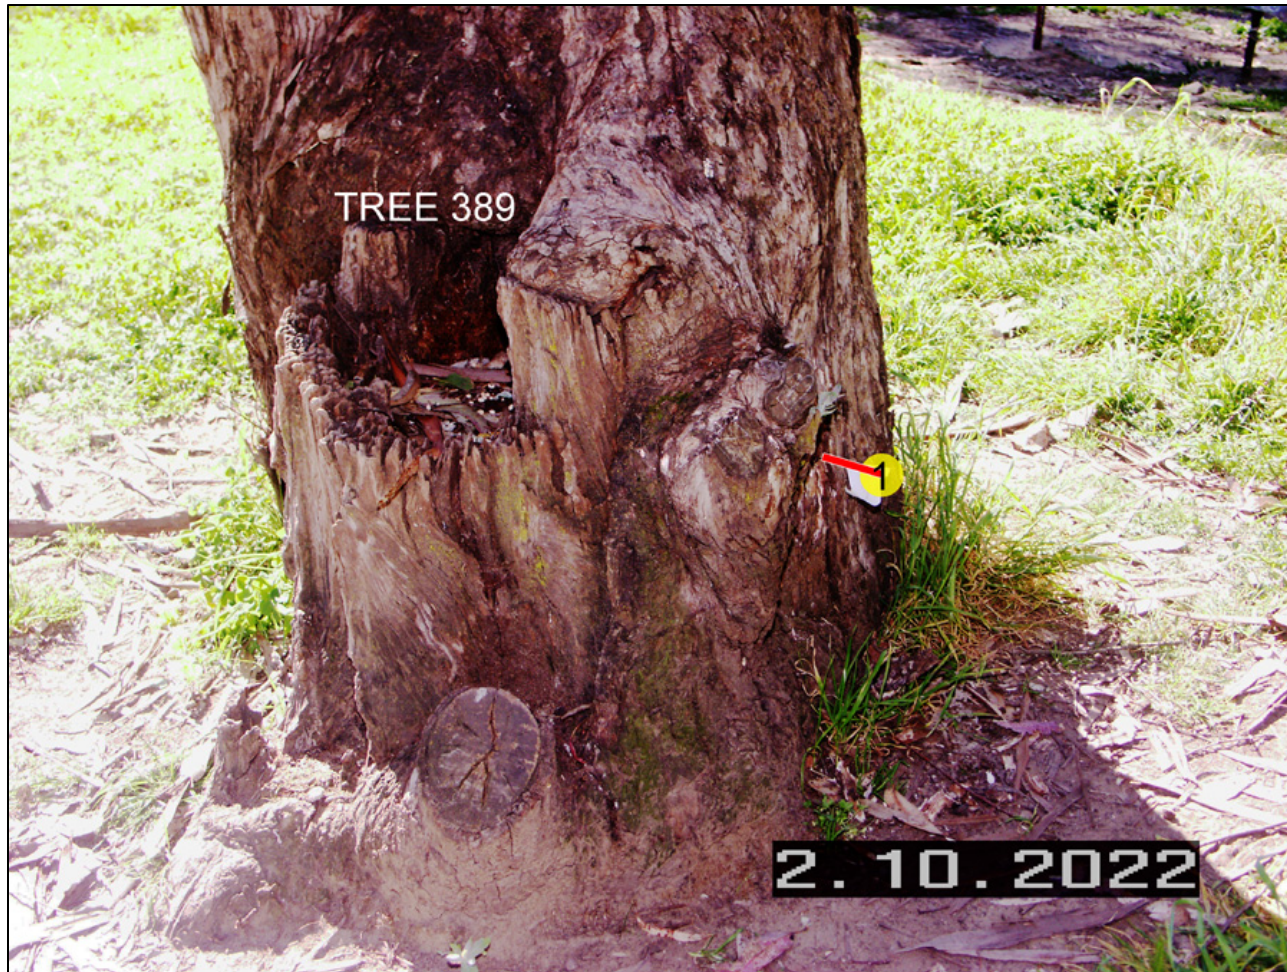
APPENDIX IV PHOTO KEY OF RESISTOGRAPH LOCATIONS, TREE #389

389	Improbable	Remove	X		Removal accomplishes clearing the area for replanting
390	Improbable	Remove			Will be orphaned, exposed if 241 and 242 are removed. One of two trunks of this tree is poorly attached. Removal of 390 will preclude risk from newly exposed tree.

03890001 20220210 Albany Hill Tree 389 Profile #1
Sound as expected, in all new tissues outside the old stump
