Sidewalk Repair Program

GIS Data Overview & Phase 5 Scope

Transportation Commission
January 27, 2022

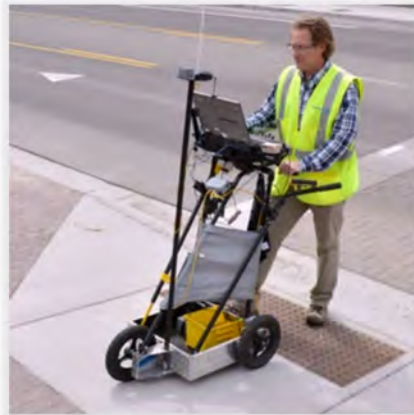
assessment **cart**

- Beneficial Designs contracted for comprehensive sidewalk survey
 - Specialized in ADA compliance for PROW
 - Survey performed in late 2020 / early 2021
 - Survey completed prior to Phase 4 repairs

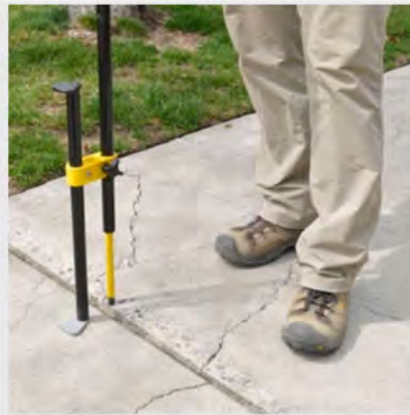
measure **height**

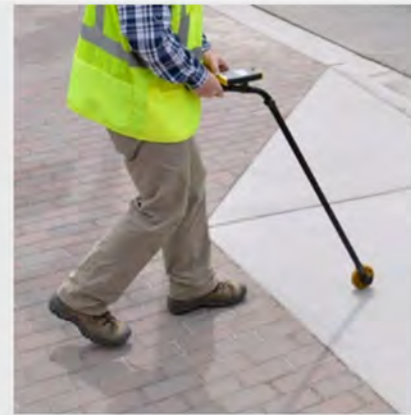
measure **length**

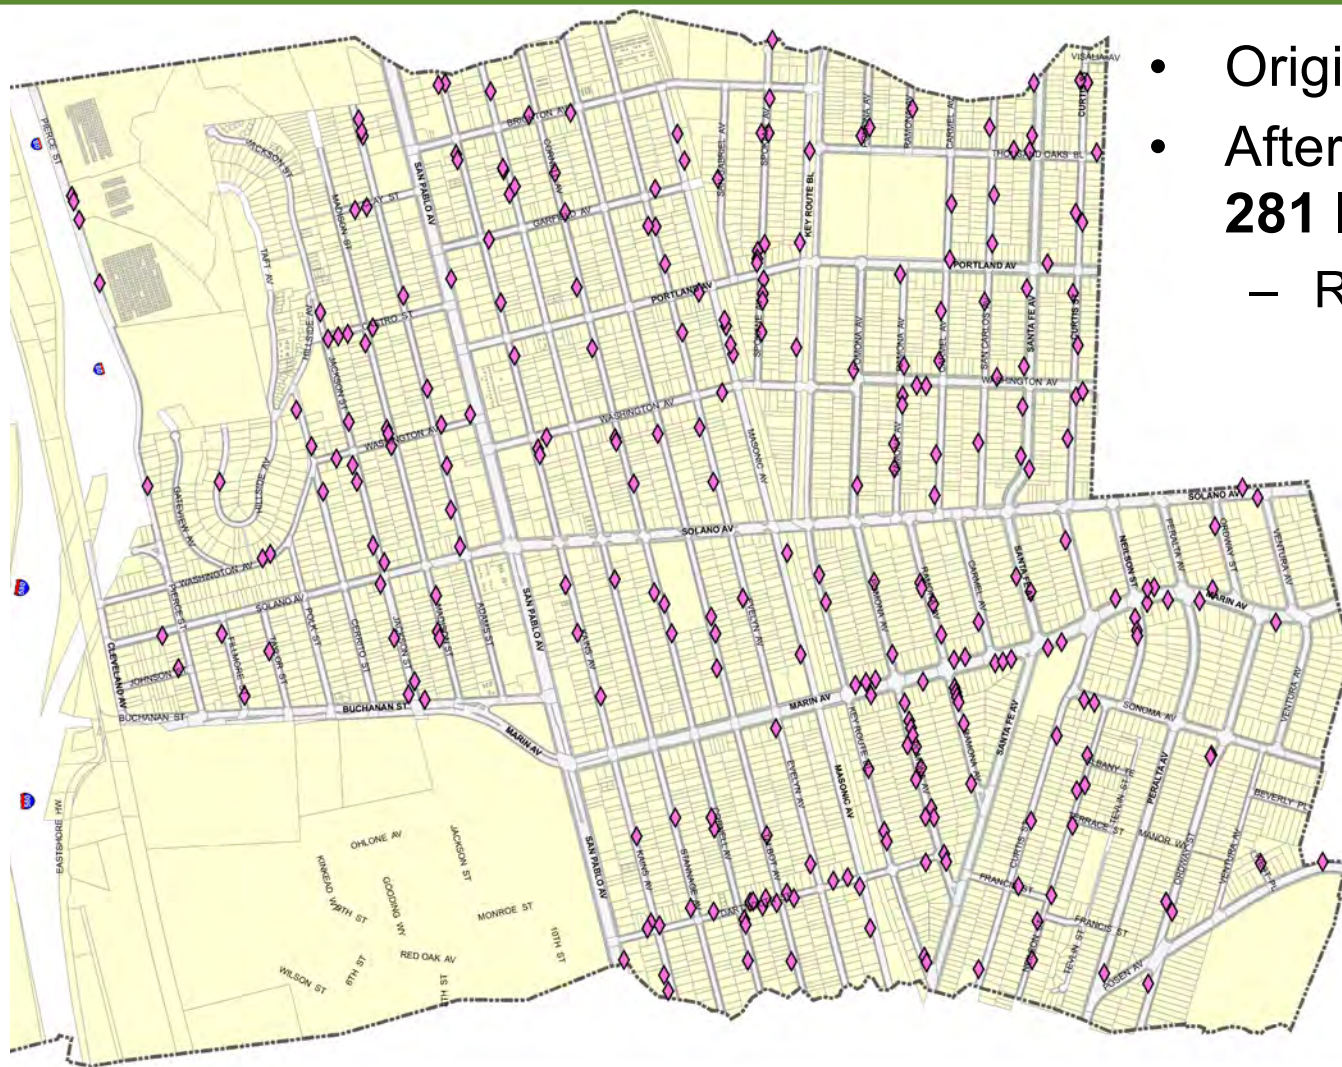
No Best Path of Travel (NoBPOT) locations with $\geq 2''$ vertical discontinuity

- Originally ~320 locations
- After data review, **281 locations**
 - Removed locations:
 - Phase 4 repairs
 - homeowner repairs
 - future repairs in separate CIP

- Unique BD-created features for repair prioritization
 - No Best Path of Travel (NoBPOT)
 - Surfaces that had ≥ 2 issues
 - Denotes surfaces that include ≥ 2 " vertical discontinuity
 - 1,207 locations; ~320 with ≥ 2 " vertical discontinuity
 - Non-planar Pedestrian Access Route
 - "...capture some of the most hazardous surfaces." – BD
 - Typically used at tree upheaval sites
 - Quick review of BD photos show many locations in good to fair conditions
 - If using non-planar PAR, suggest prioritizing w/ **cross-slope** attribute
 - 97 locations; ~37 with $> 2\%$ cross slope
